Road Shoulder Hazards along
Lake Woodlands – January 2015

Hazards on road shoulders, that could pose a risk to cyclists, were identified in January 2015 by volunteers from Bike The Woodlands Coalition.

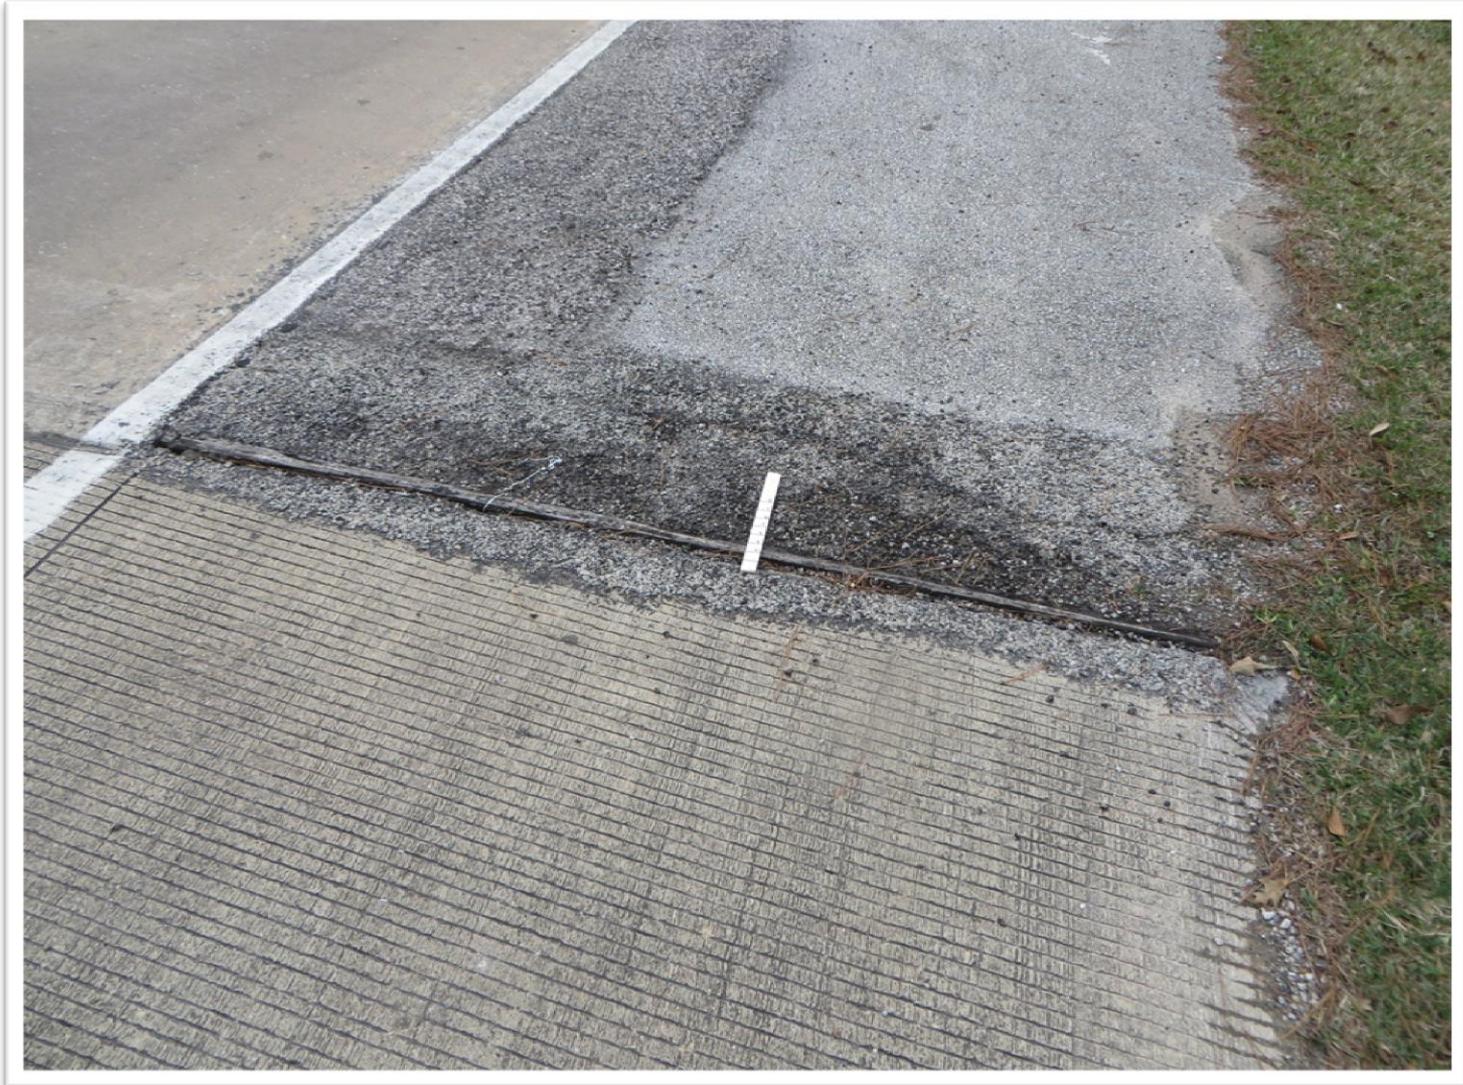
LW-1
Lake Woodlands
Westbound

Hazard type: Rough area
Severity: 3

Rough enough that cyclists will try to avoid by riding into traffic lanes; nearby rough patches on next three slides.

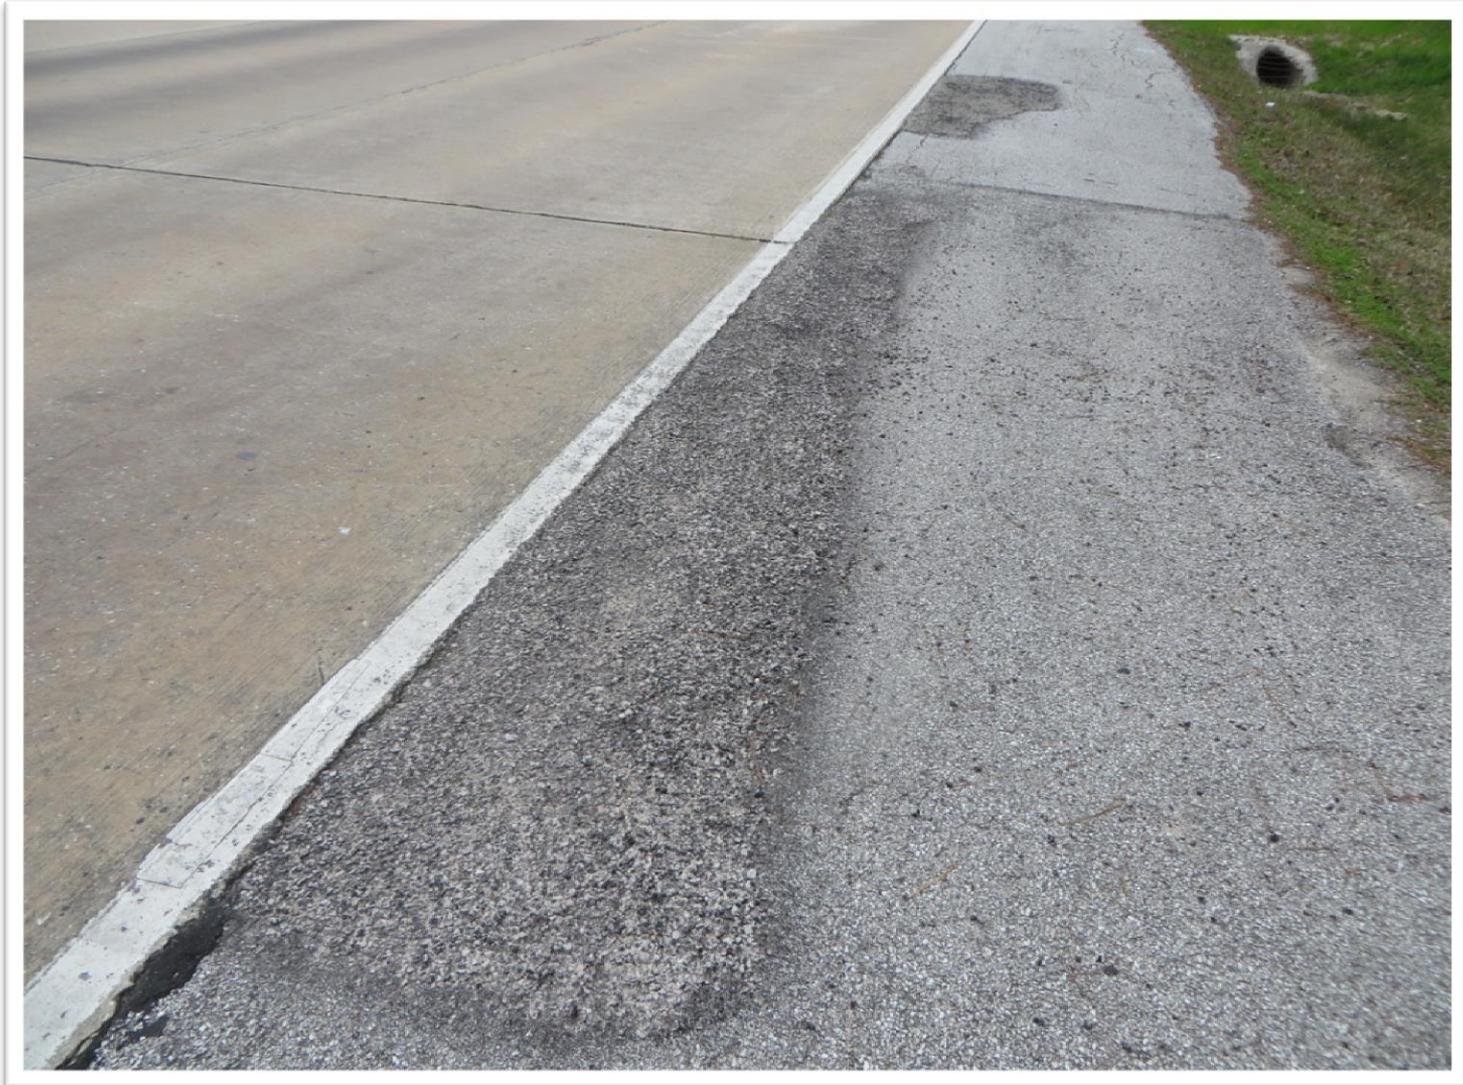
LW-1
Lake Woodlands
Westbound

Hazard type: Rough area
Severity: 2

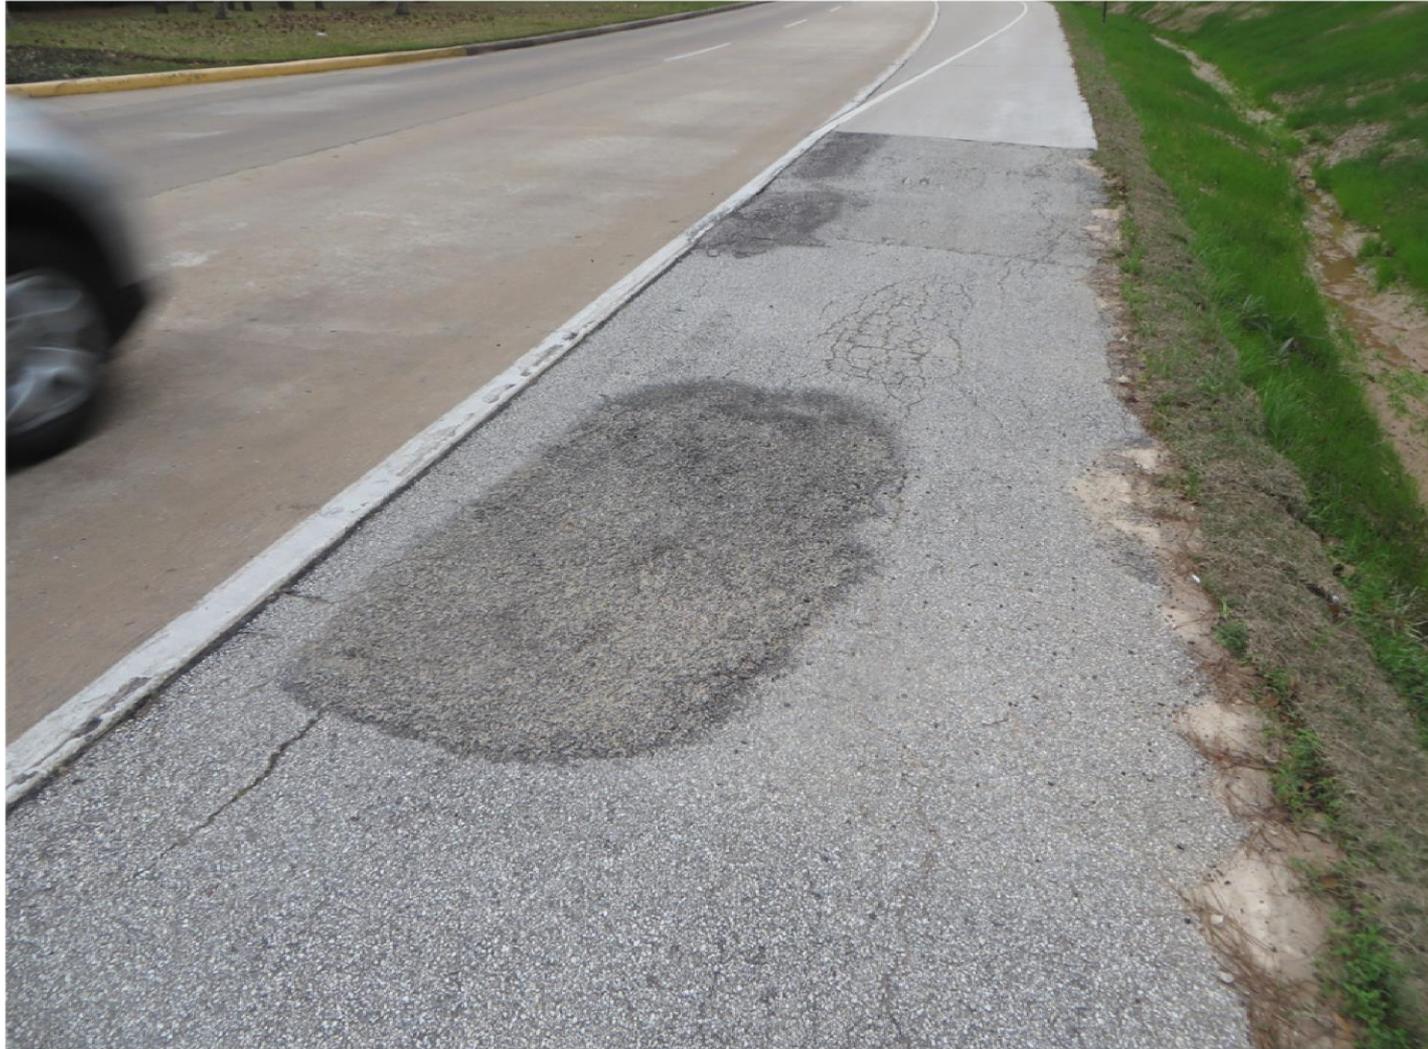
LW-1
Lake Woodlands
Westbound

Hazard type: Rough area
Severity: 2

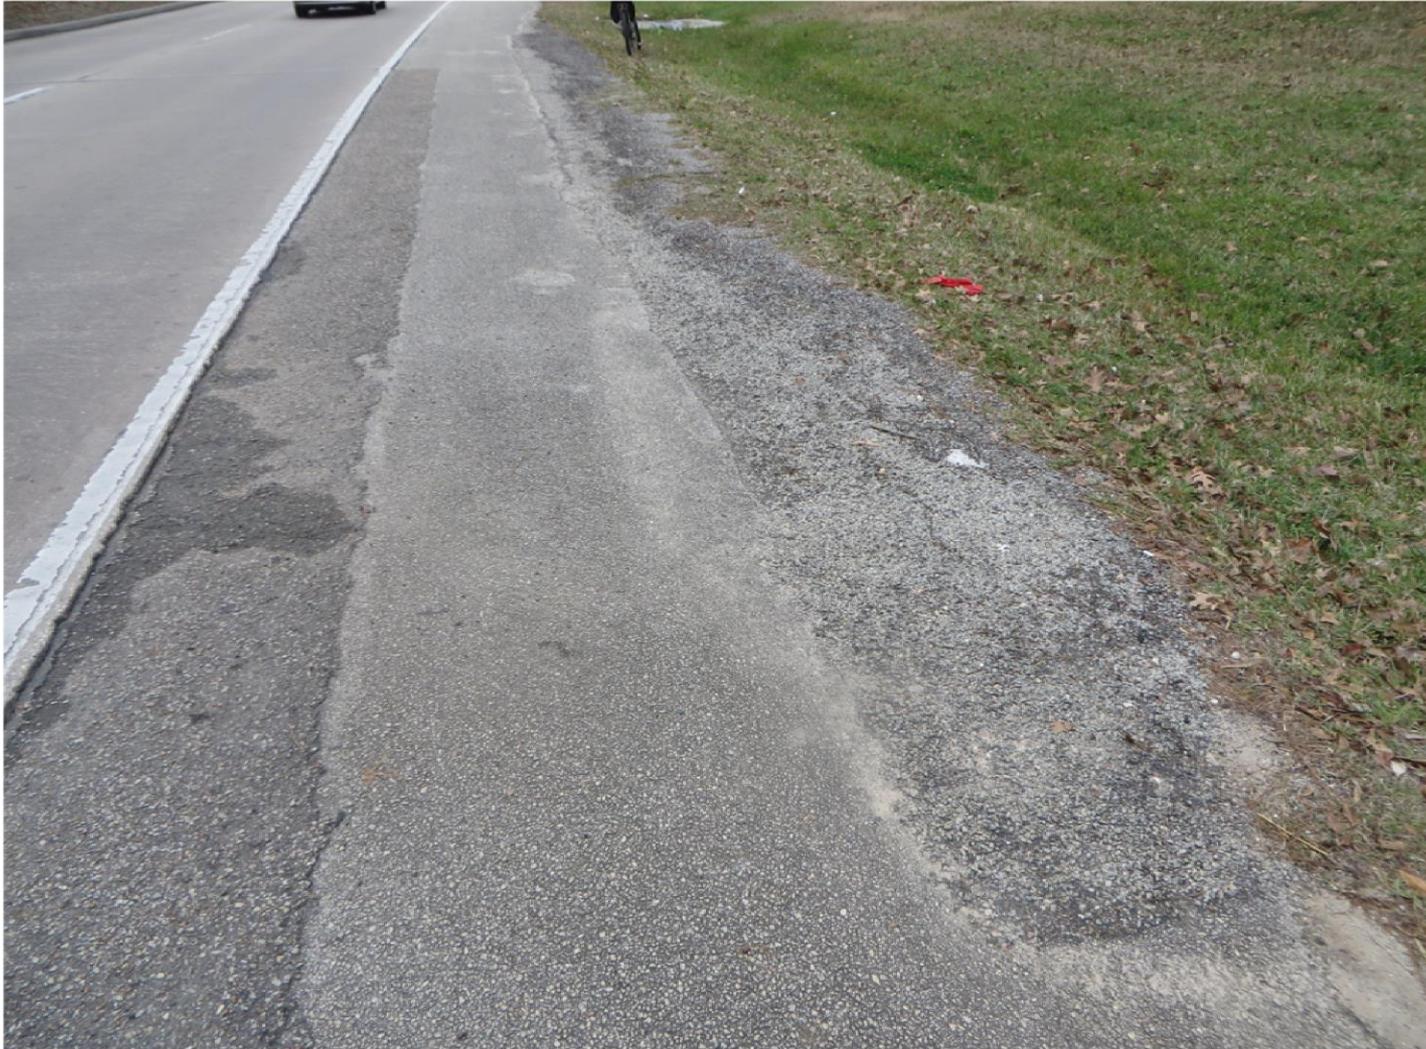
LW-2
Lake Woodlands
Westbound

Hazard type: Rough area Many feet of deteriorating shoulder
Severity: 2

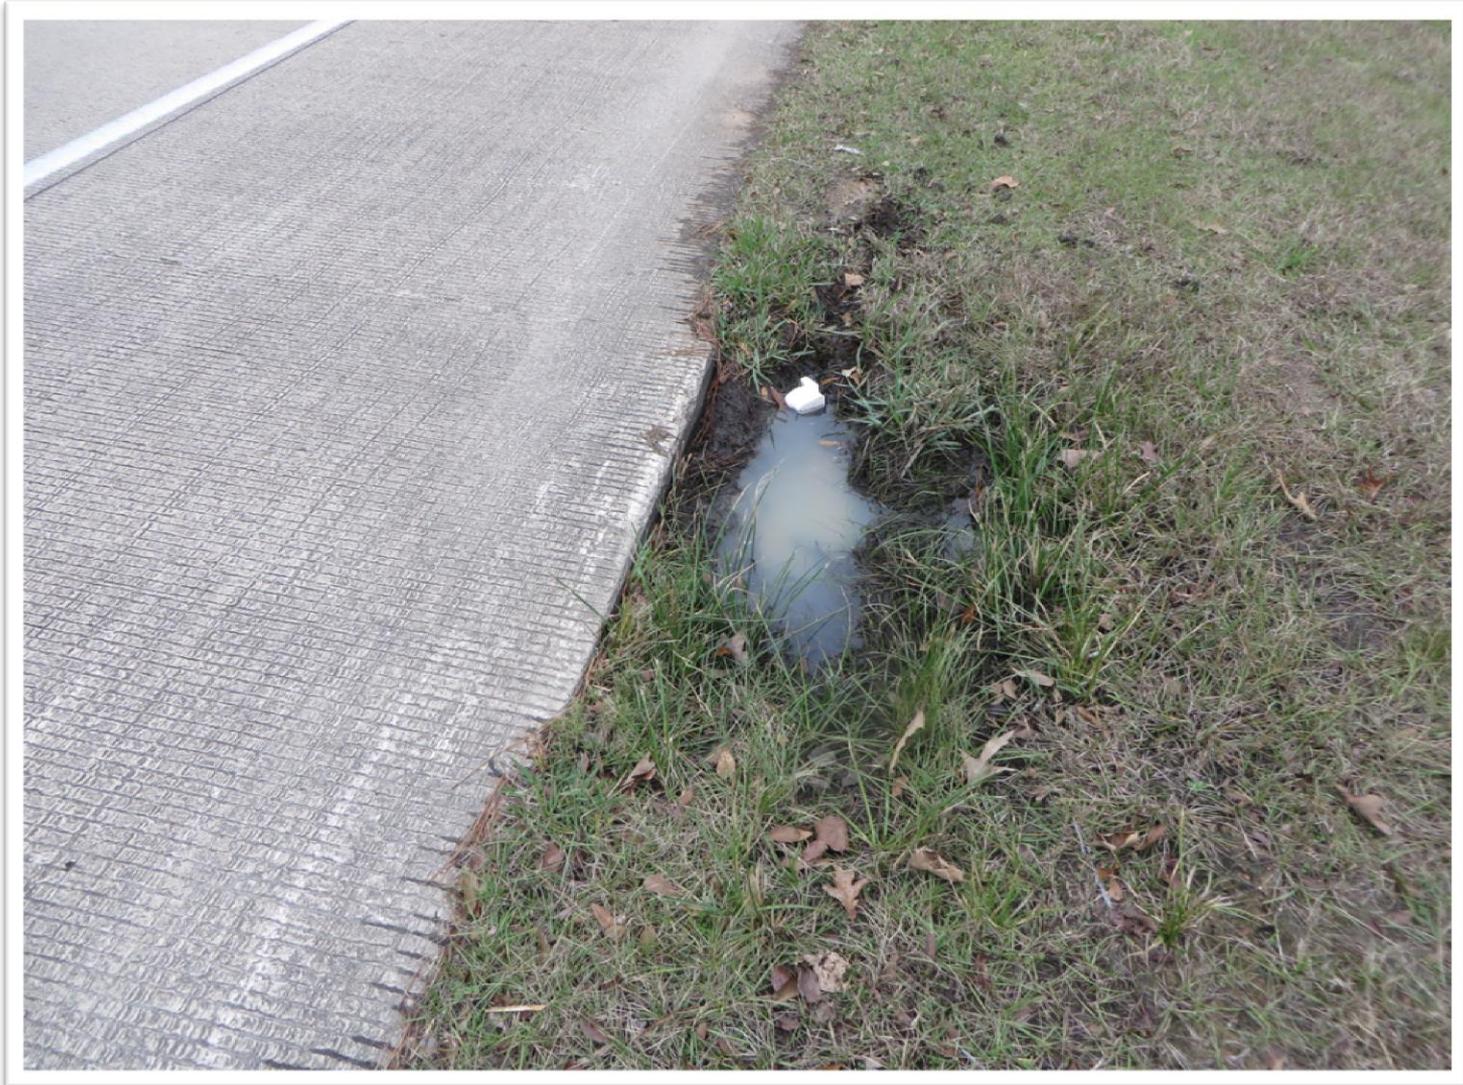
LW-3
Lake Woodlands
Westbound

Hazard type: Misc
Severity: 4

Deep hole off edge of shoulder - could be
dangerous for cars or cyclists; it is > 18" wide
and car-axle deep

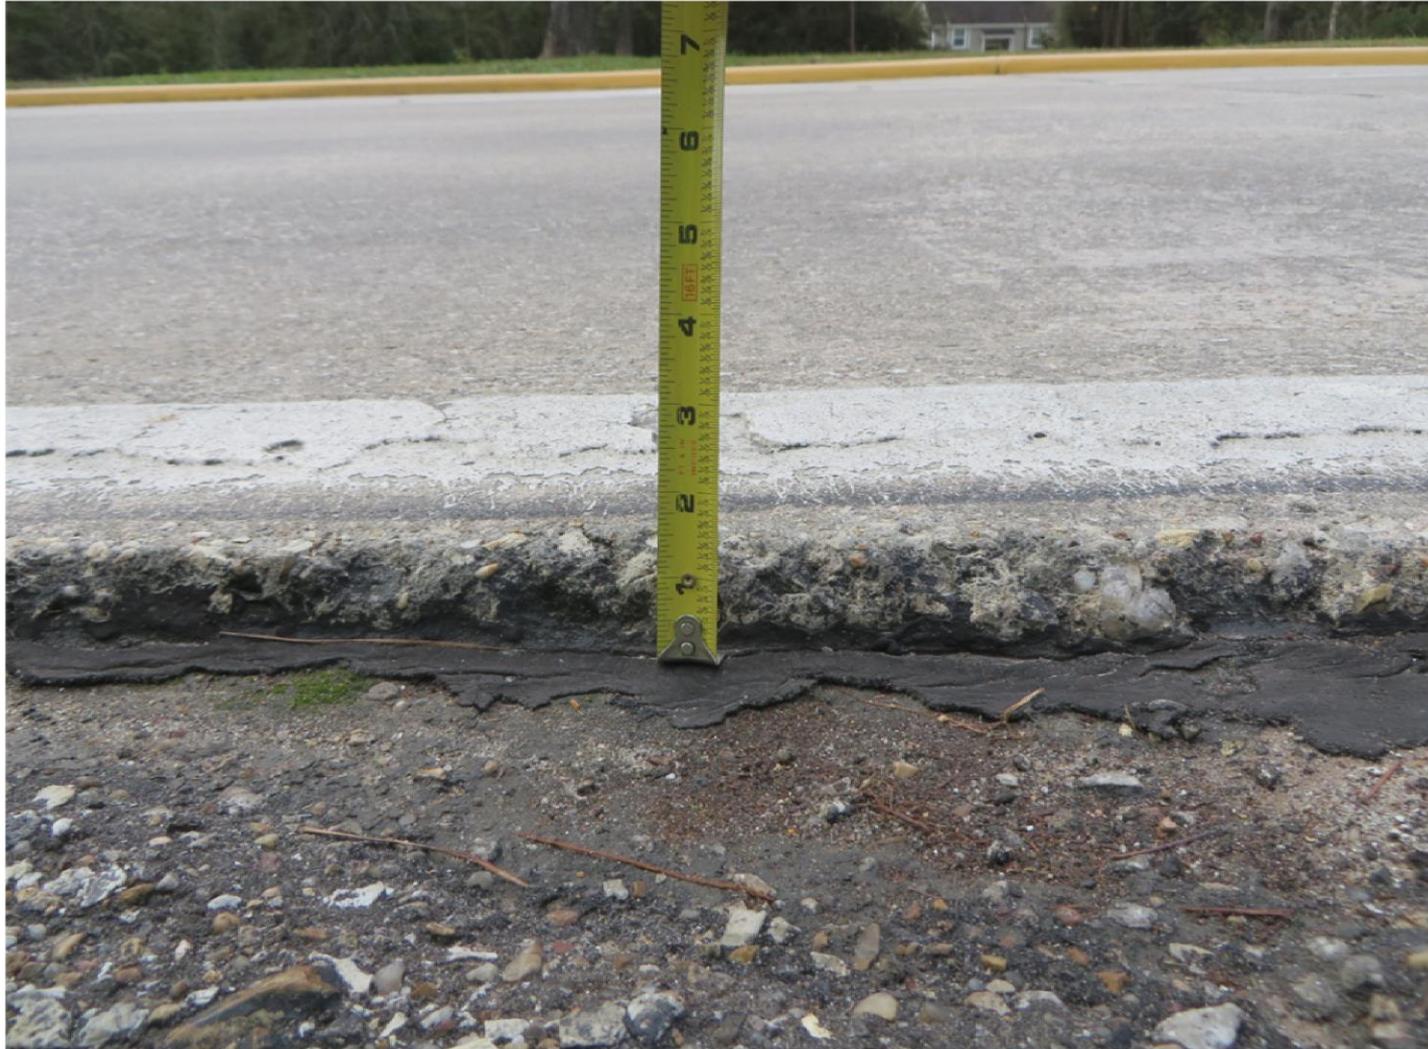
LW-4
Lake Woodlands
Westbound

Hazard type: Lip
Severity: 3

~ 2" lip- this and other lips along Lake Woodlands can be a serious hazard to cyclists because a bike tire can get caught, causing the cyclist to fall into the roadway. This and other lips are getting a rating of '3' rather than '4' because of the wide shoulder on Lak Woodlands, making it less likely that cyclists will be caught by this hazard.

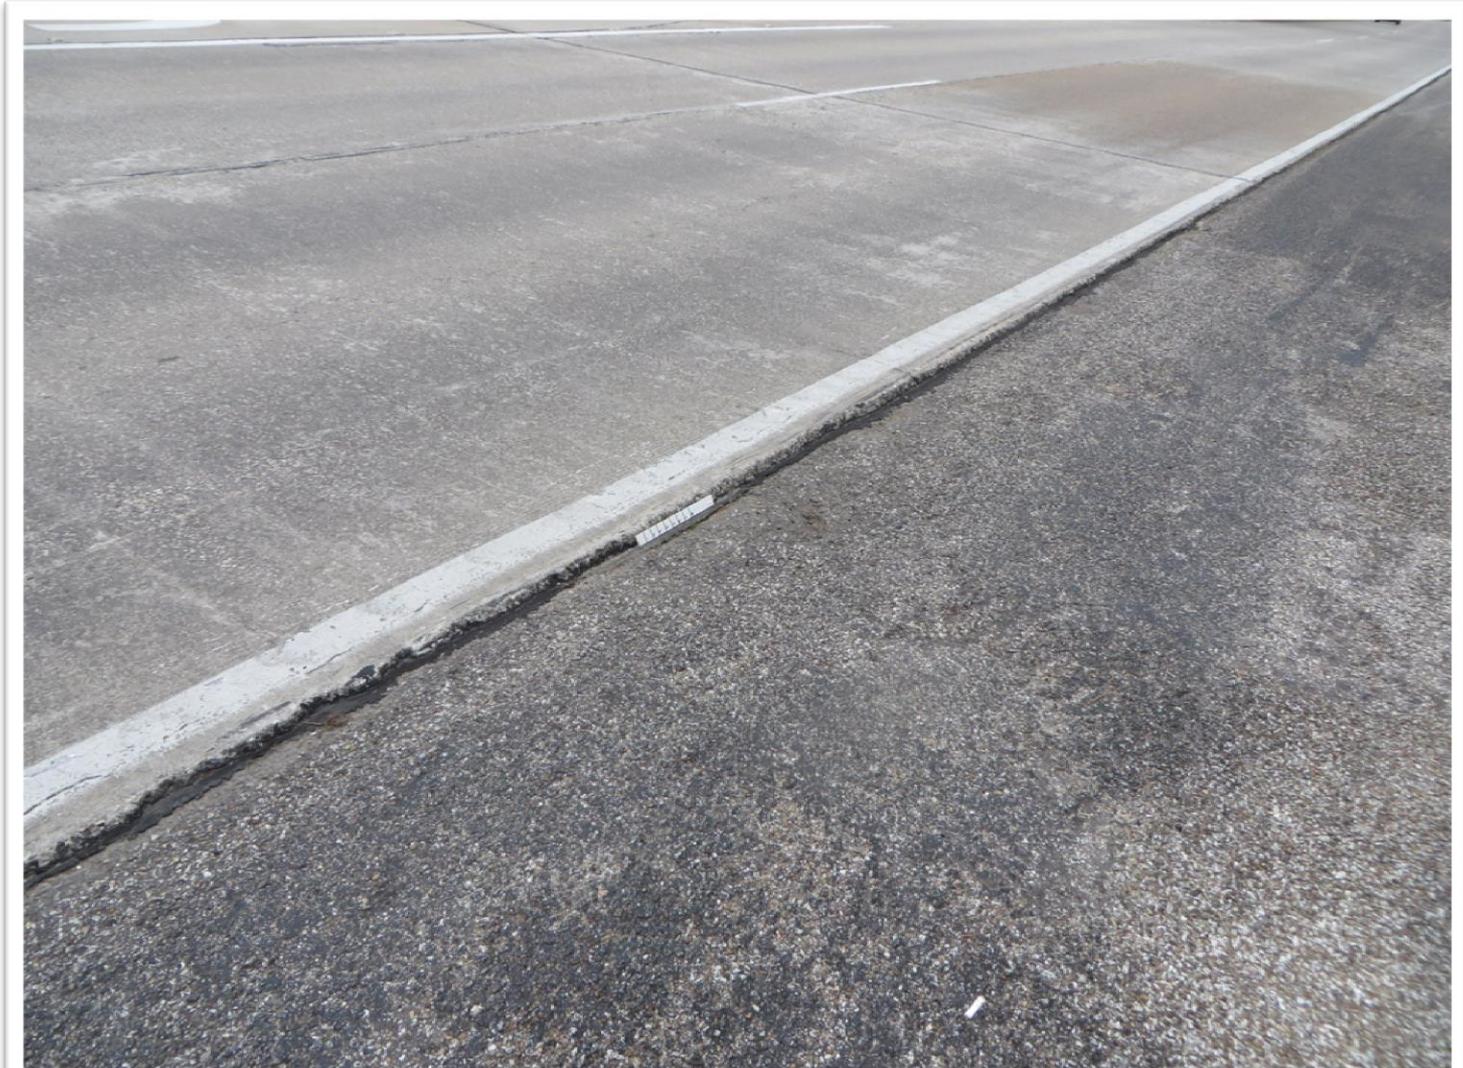
LW-4
Lake Woodlands
Westbound

Hazard type: Lip
Severity: 3

Up to 1 1/2" lip off and on at many locations
in this area.

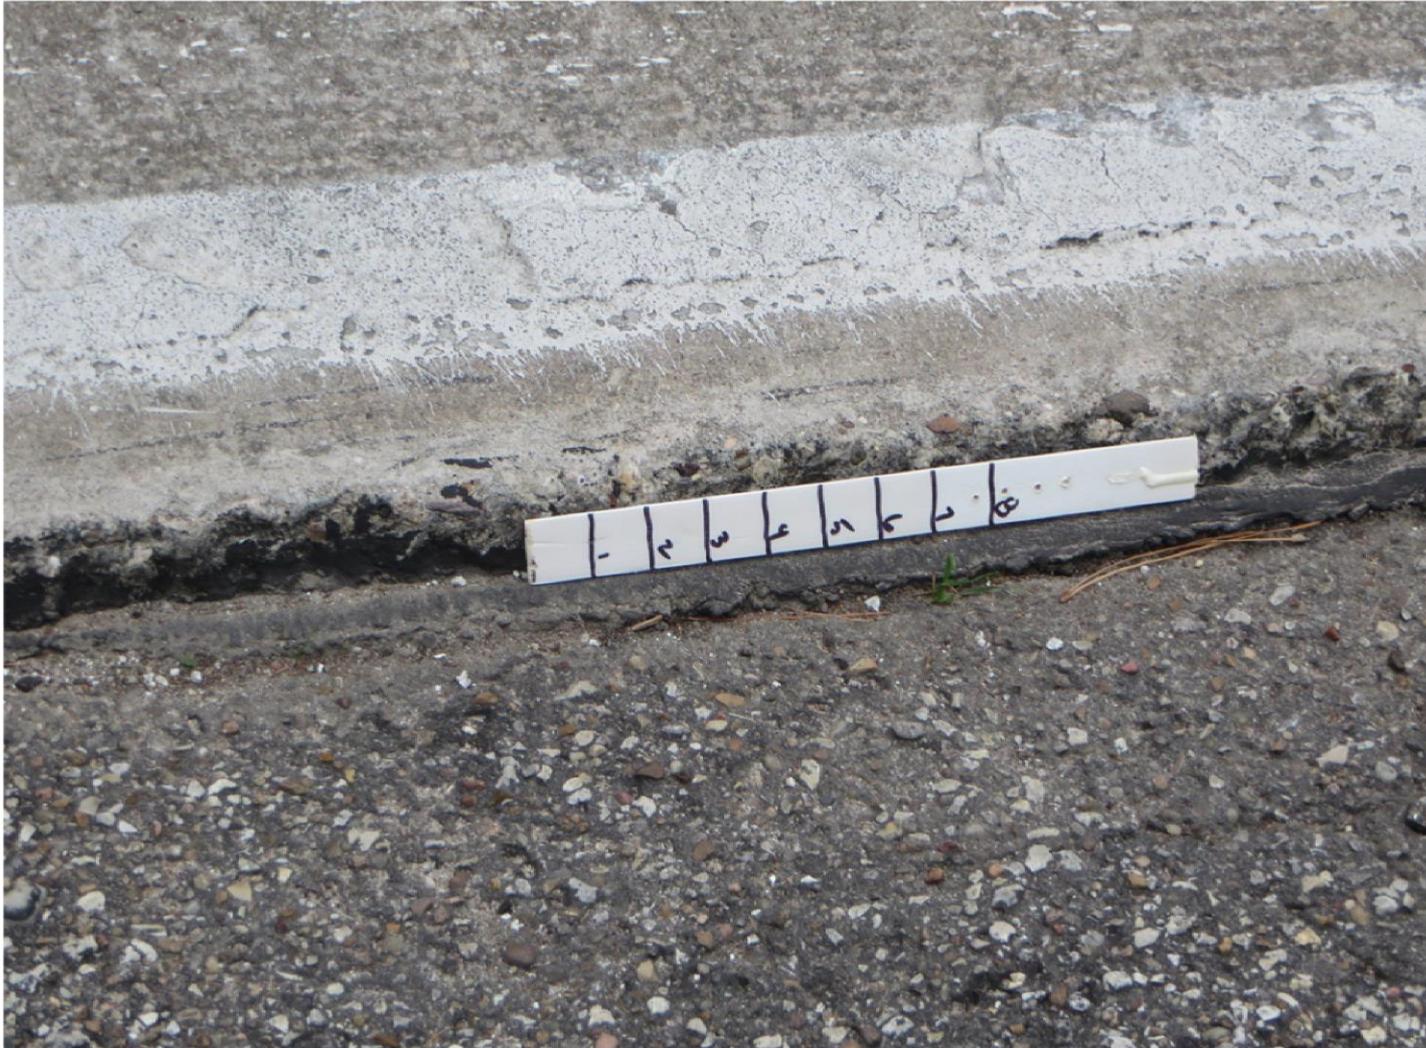
LW-4
Lake Woodlands
Westbound

Hazard type: Lip
Severity: 3

Up to 1 1/2" lip off and on at many locations
in this area. The ruler is 1 1/8" wide and
marked in 1" increments.

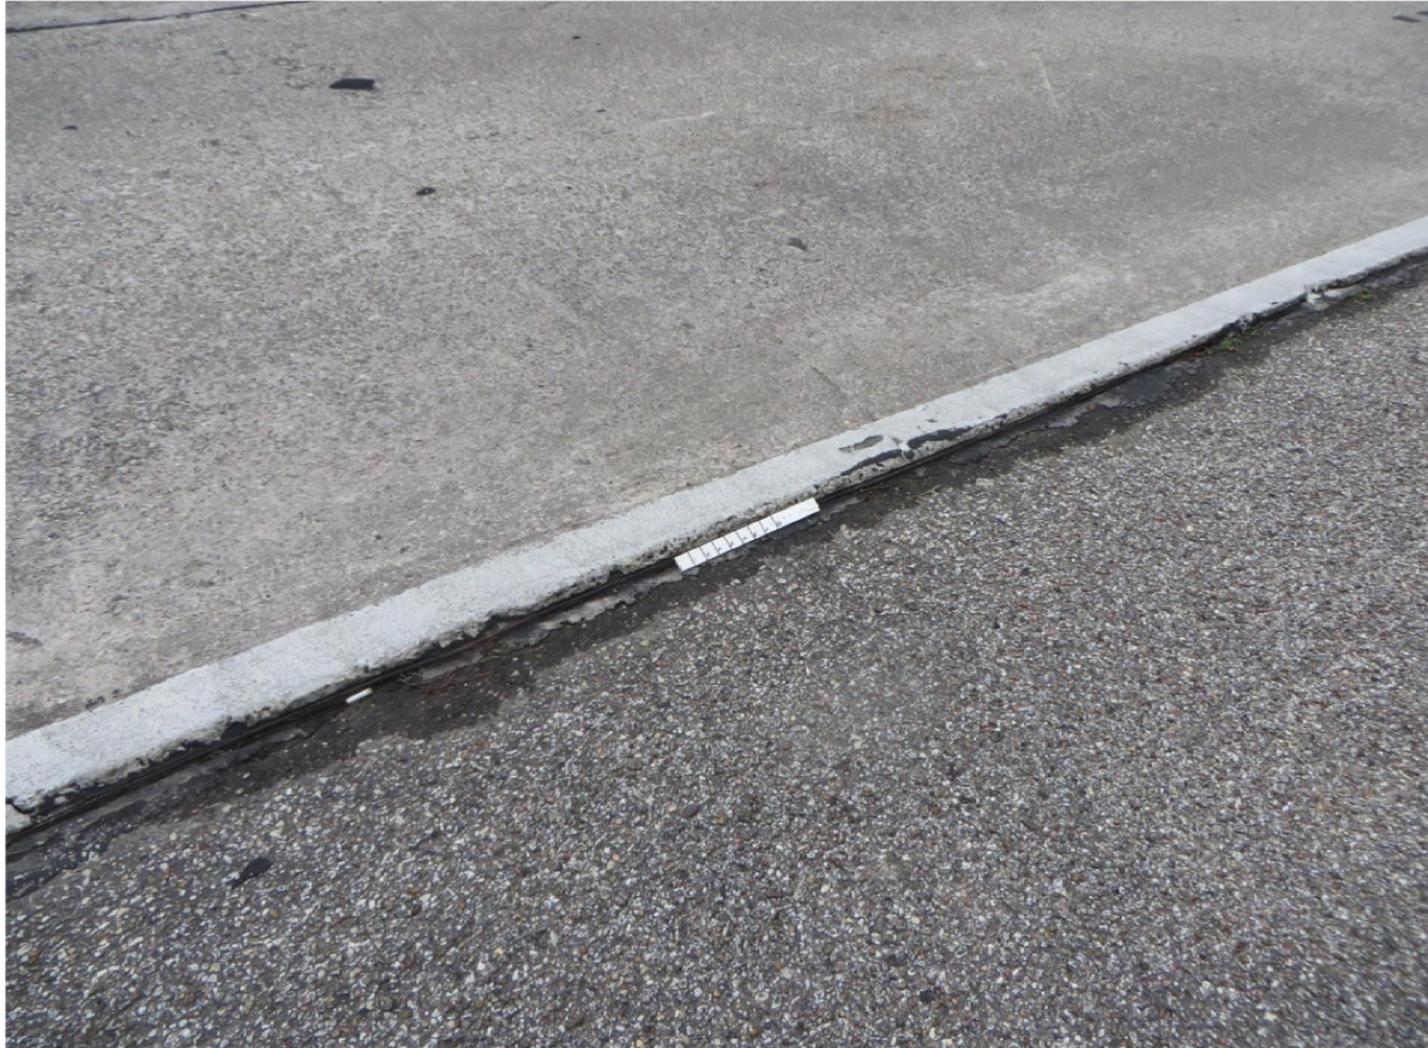
LW-5
Lake Woodlands
Westbound

Hazard type: Lip
Severity: 3

Up to 1 1/2" lip off and on at many locations
in this area.

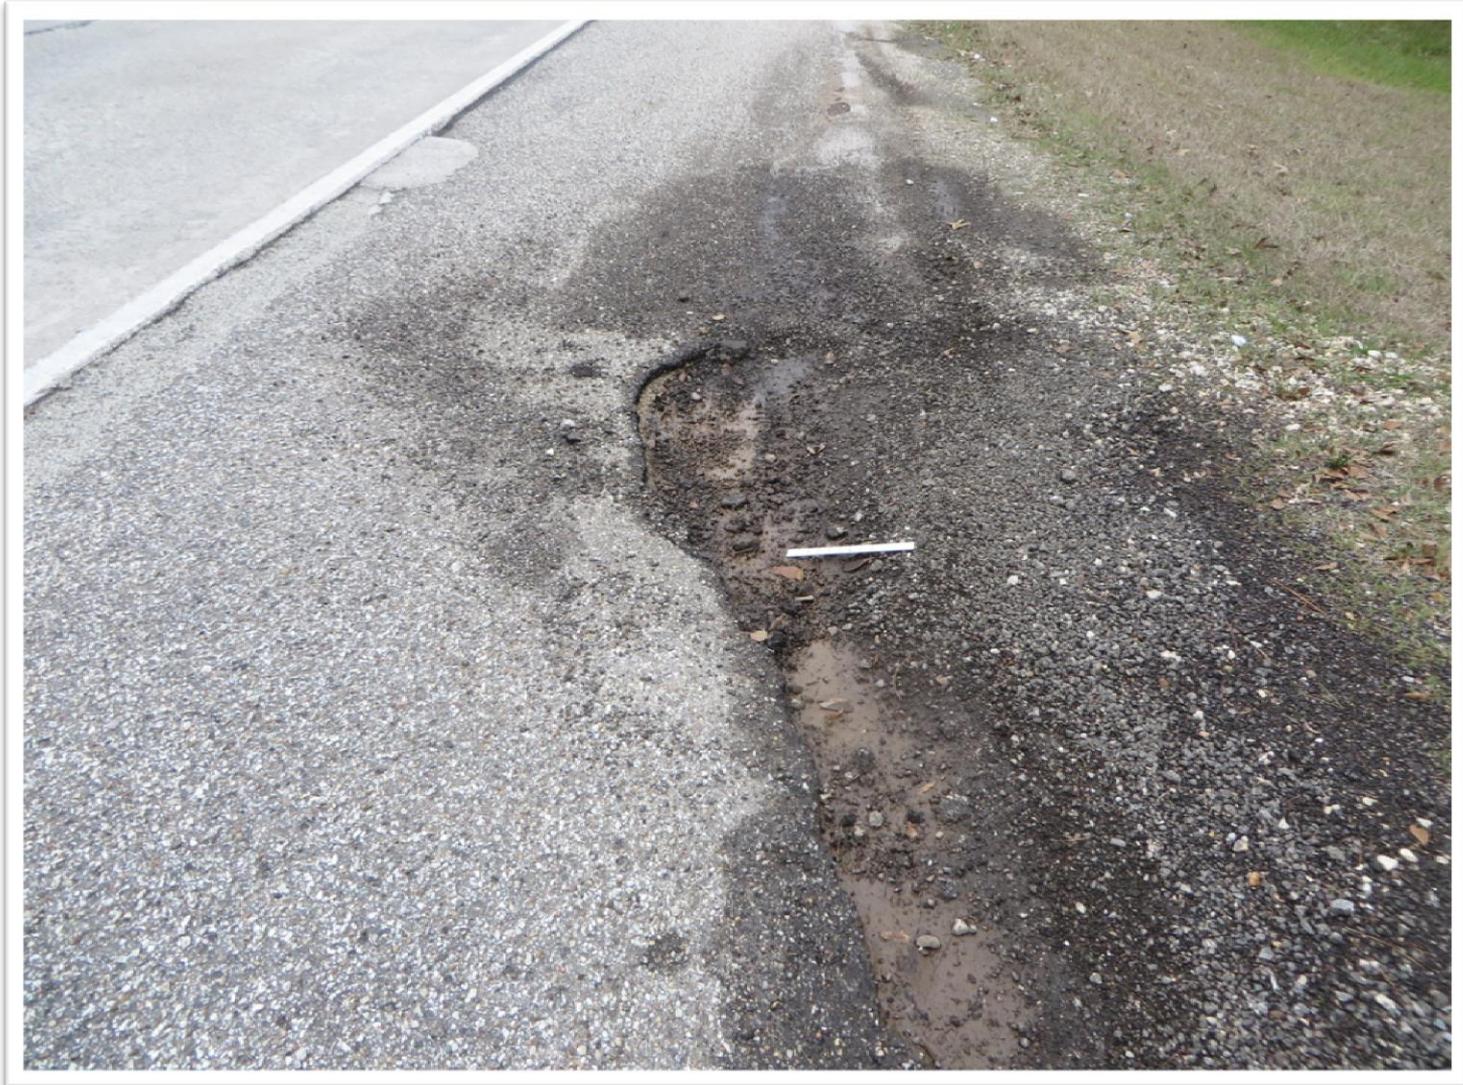
LW-6
Lake Woodlands
Westbound

Hazard type: Pothole
Severity: 4

Serious deterioration of the shoulder with
pothole

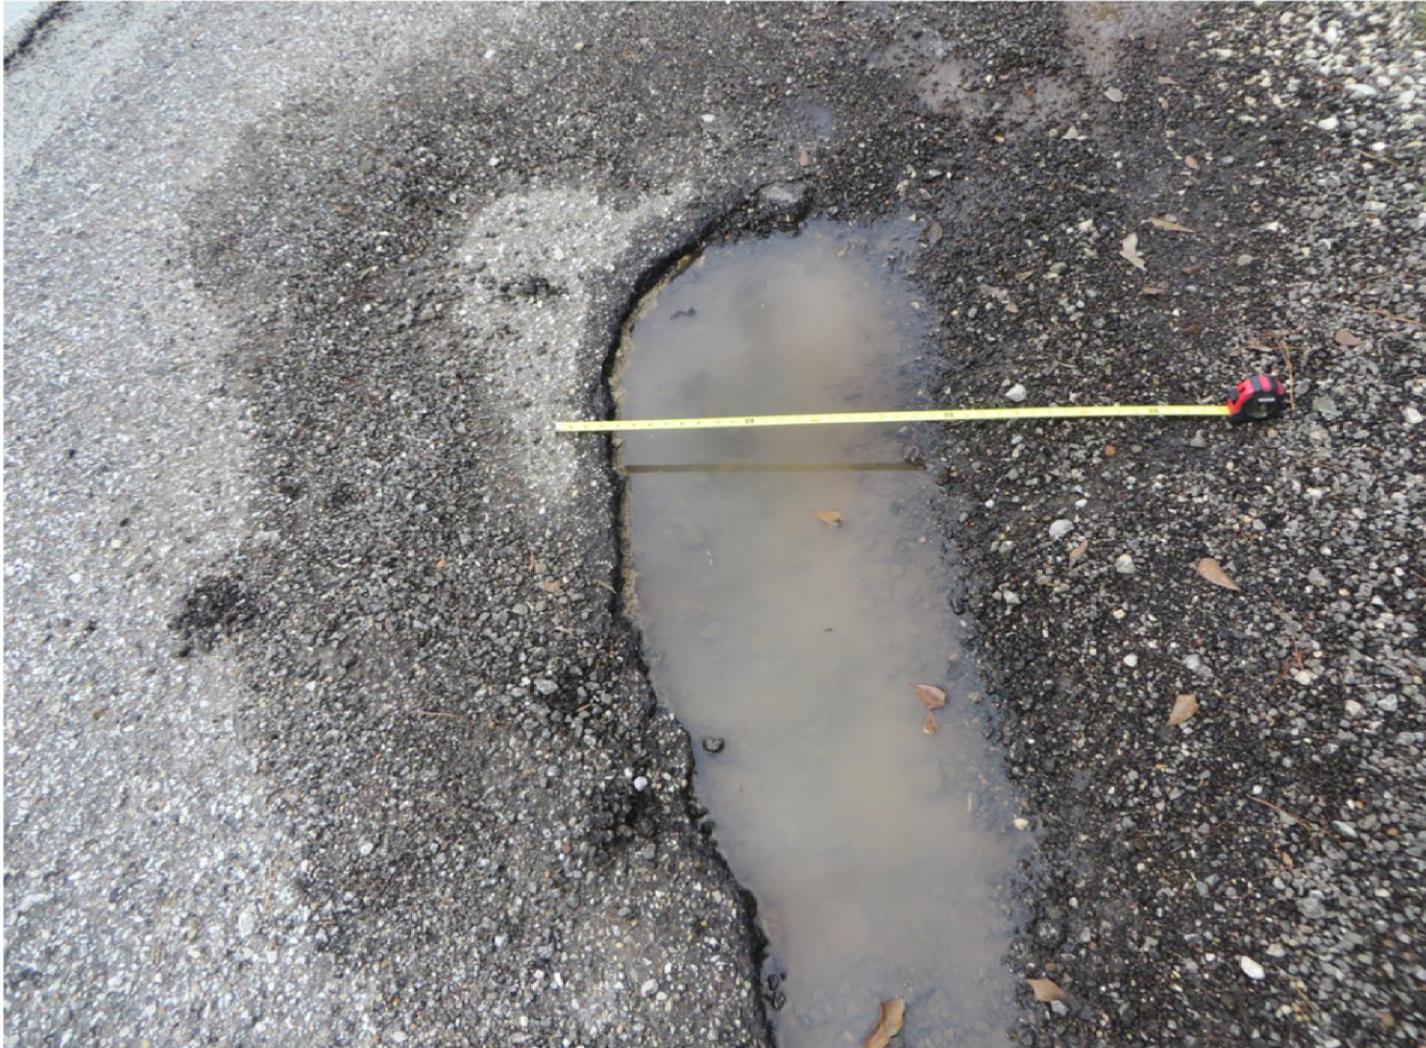
LW-7
Lake Woodlands
Westbound

Hazard type: Pothole
Severity: 4

Serious pothole

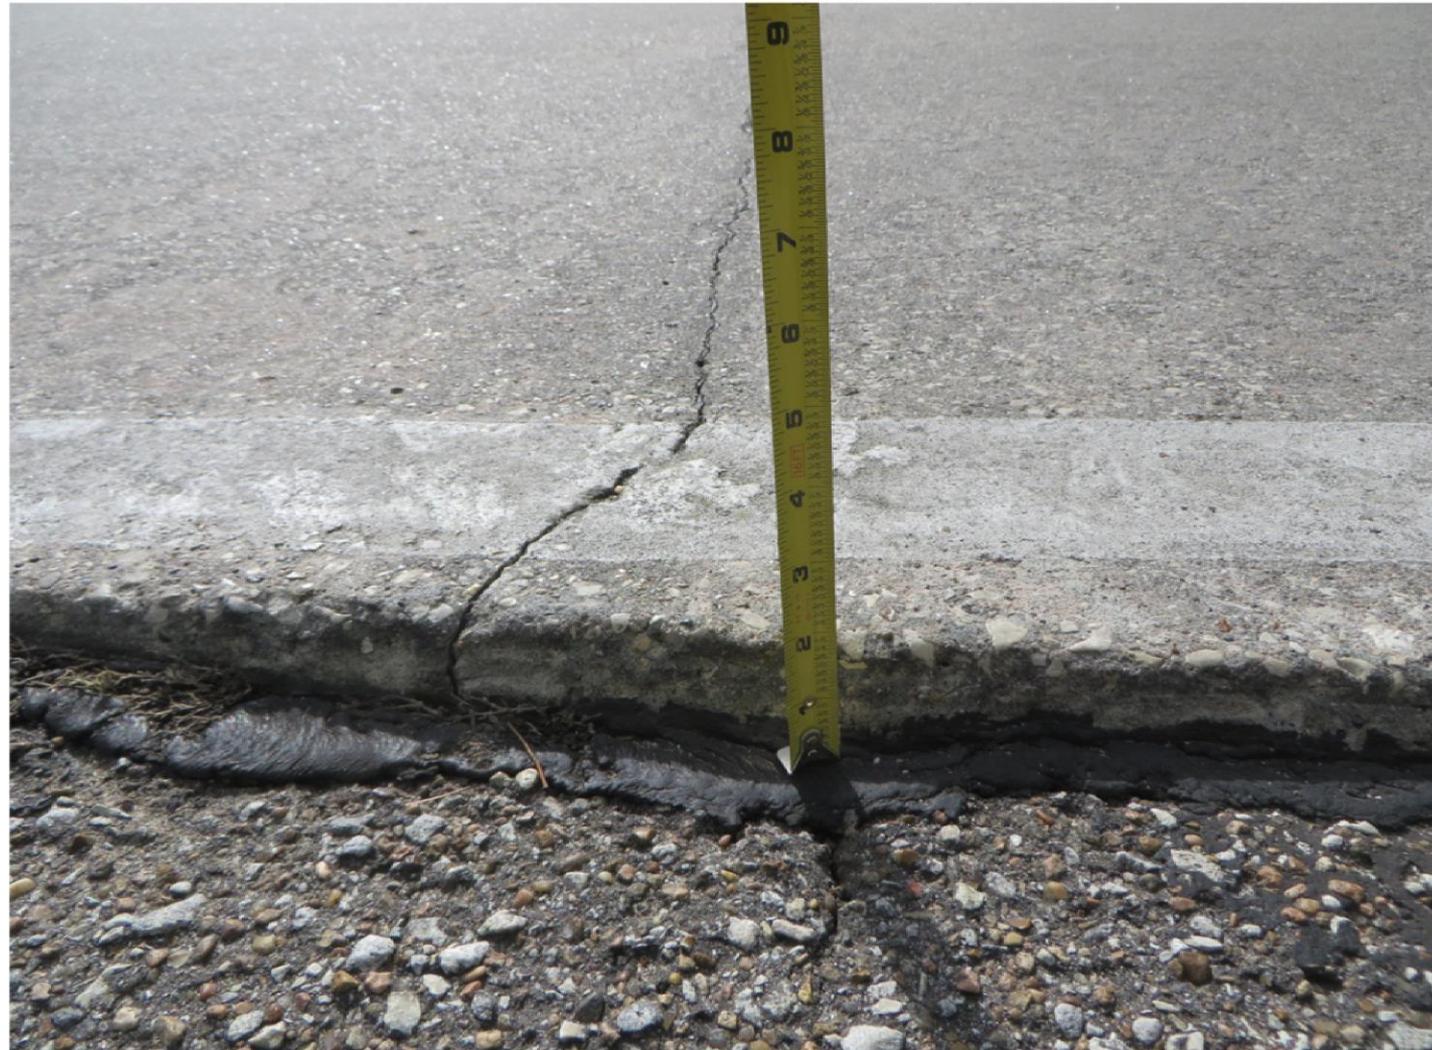
LW-8
Lake Woodlands
Westbound

Hazard type: Lip
Severity: 3

Many lips in this area

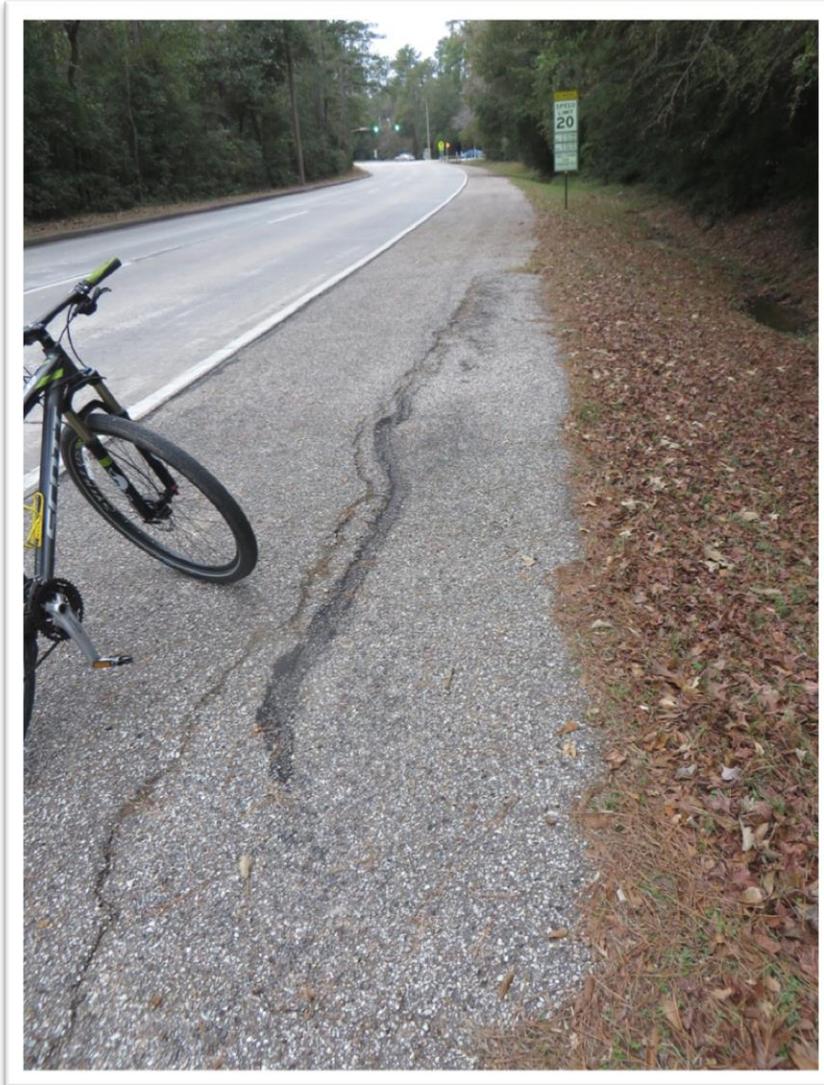
LW-9
Lake Woodlands
Westbound

Hazard type: Misc
Severity: 1

Subsidence occurring

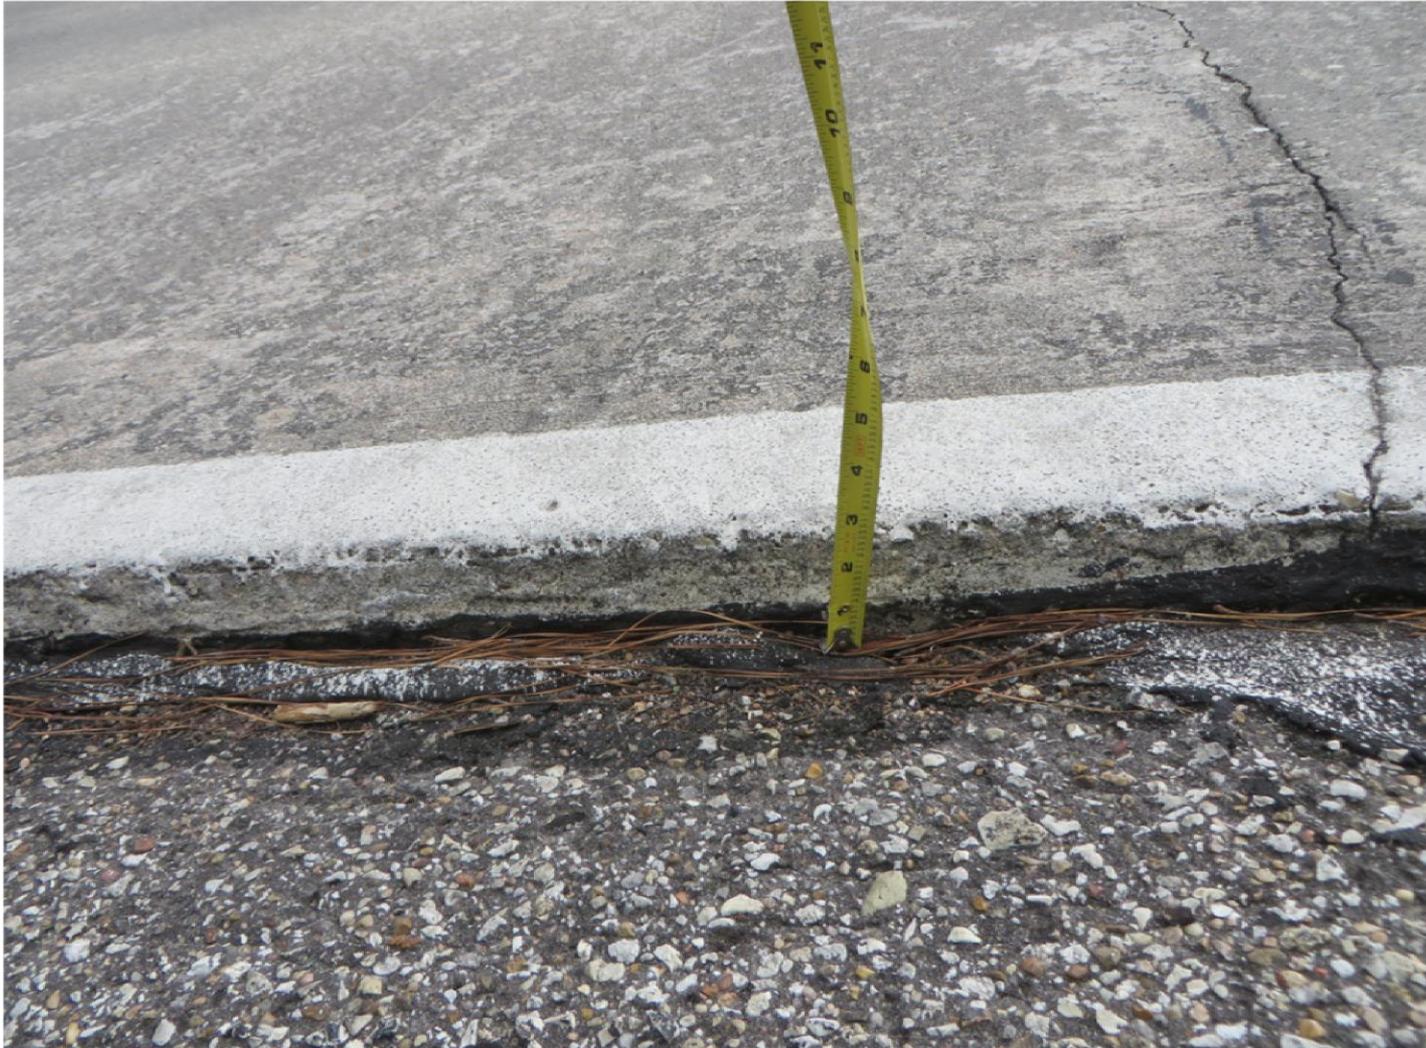
LW-10
Lake Woodlands
Westbound

Hazard type: Lip
Severity: 4

~ 3" lip

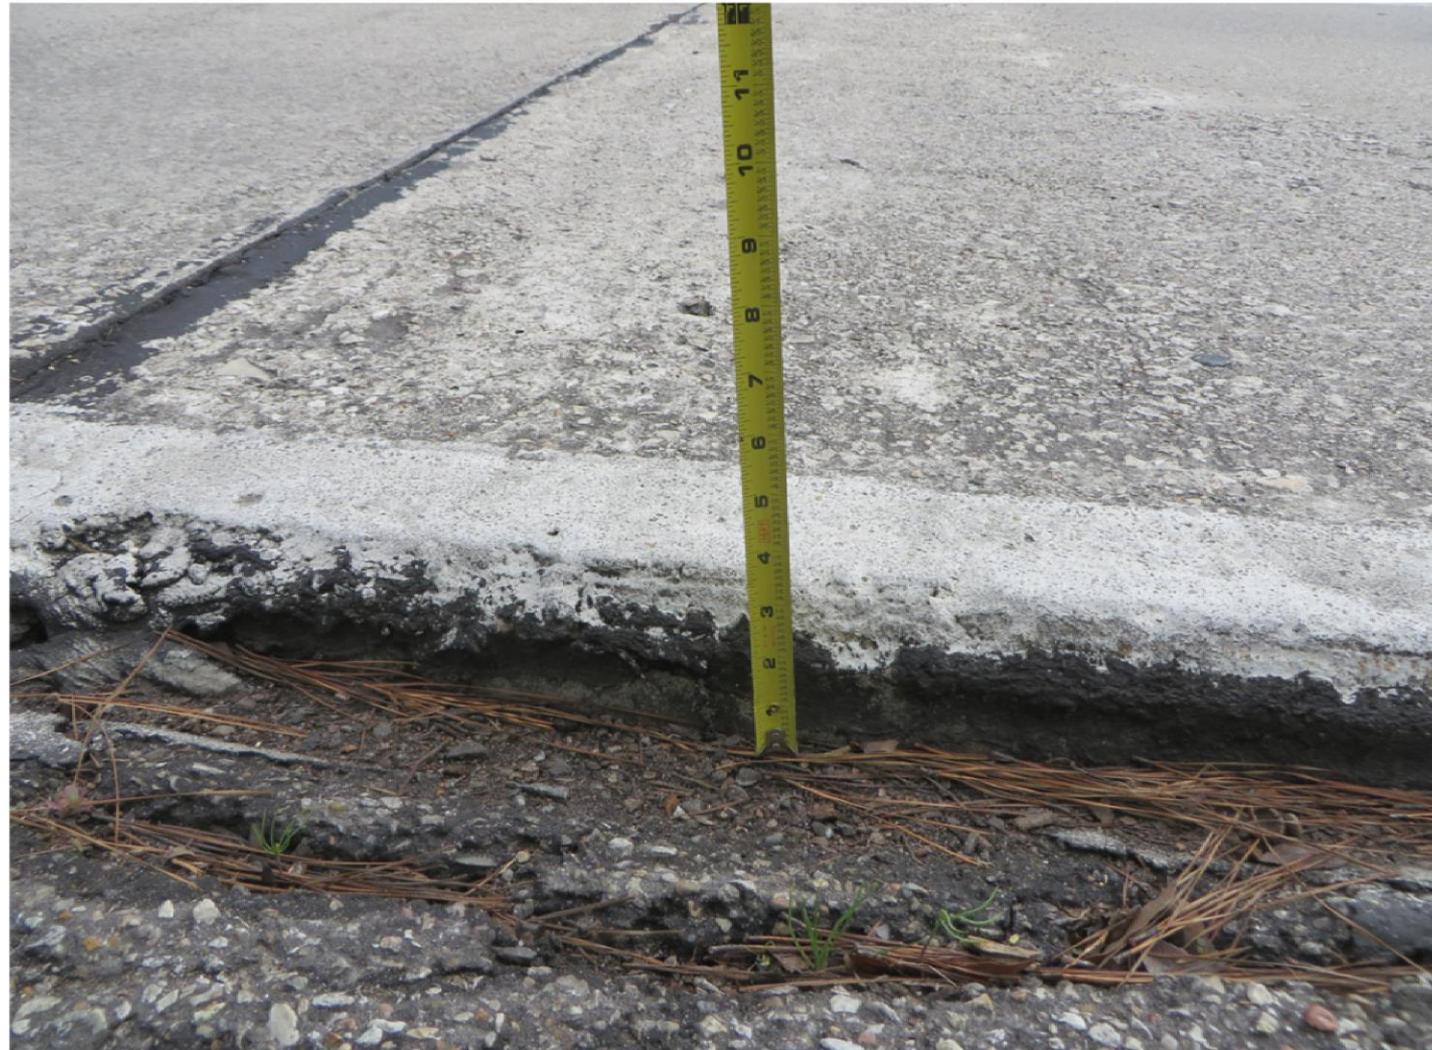
LW-11
Lake Woodlands
Westbound

Hazard type: Lip
Severity: 4

Nearly 4" lip with pothole
