Road Shoulder Hazards along
Lake Woodlands – January 2015

Hazards on road shoulders, that could pose a risk to cyclists, were identified in January 2015 by volunteers from Bike The Woodlands Coalition.

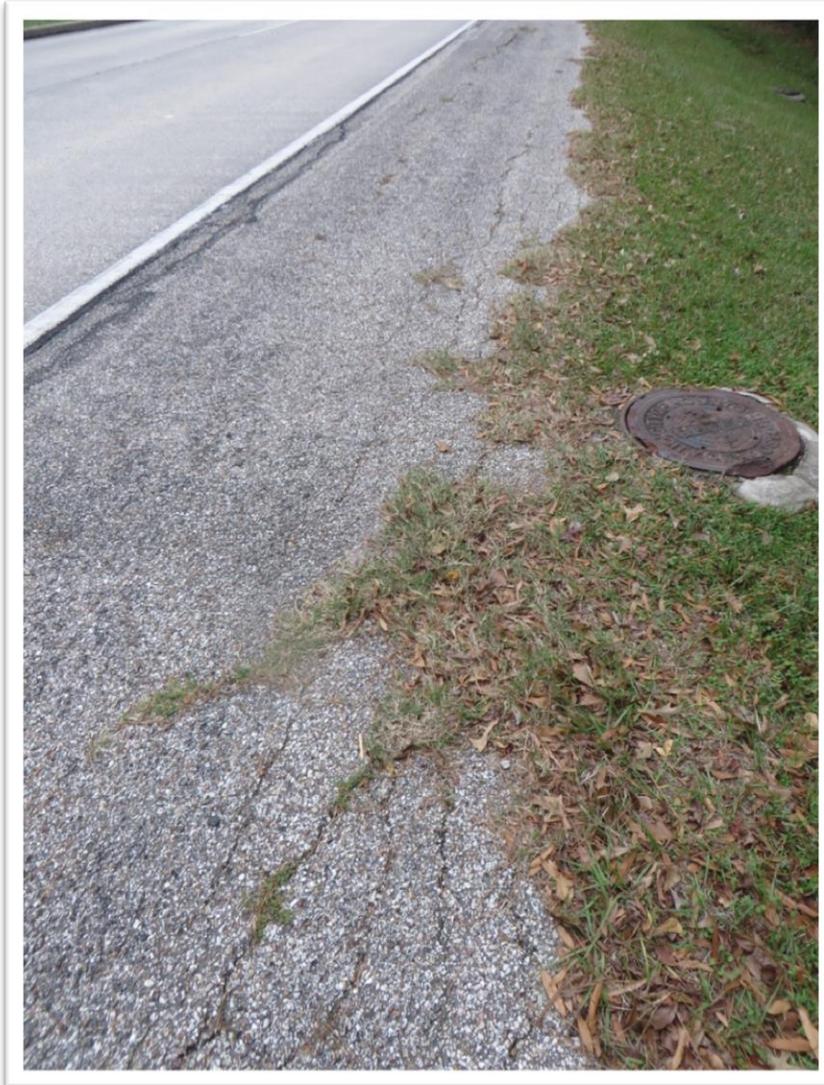
LW-12
Lake Woodlands
Westbound

Hazard type: Misc
Severity: 1

Subsidence and encroachment

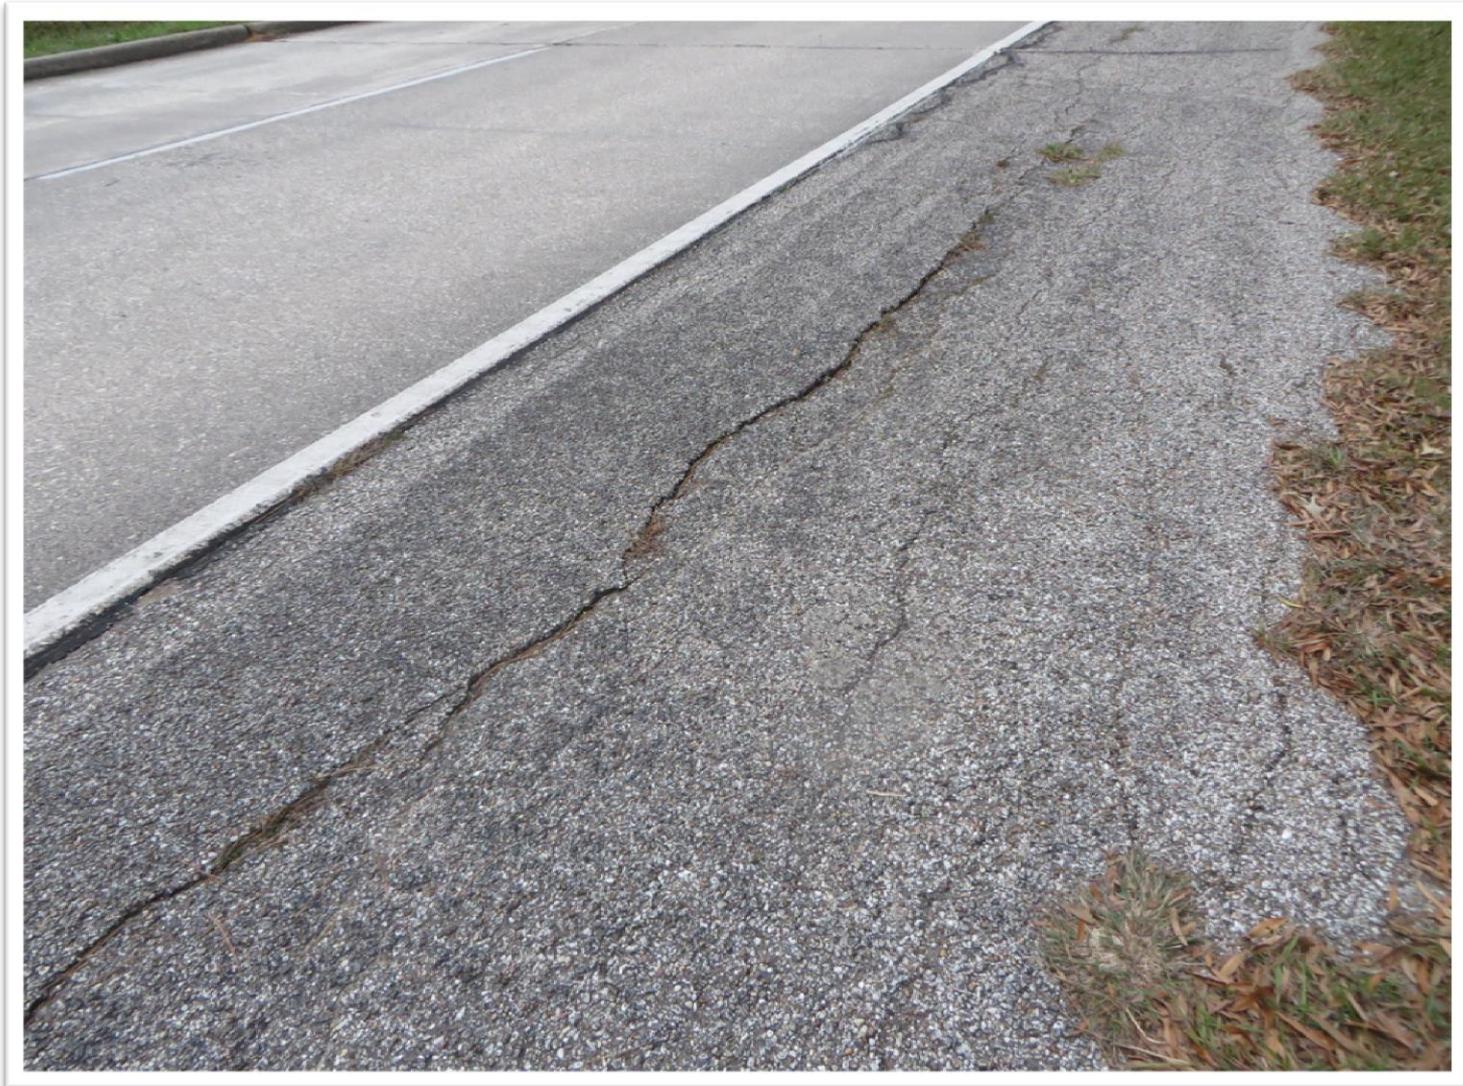
LW-13
Lake Woodlands
Westbound

Hazard type: Misc
Severity: 1

Subsidence and growing crack

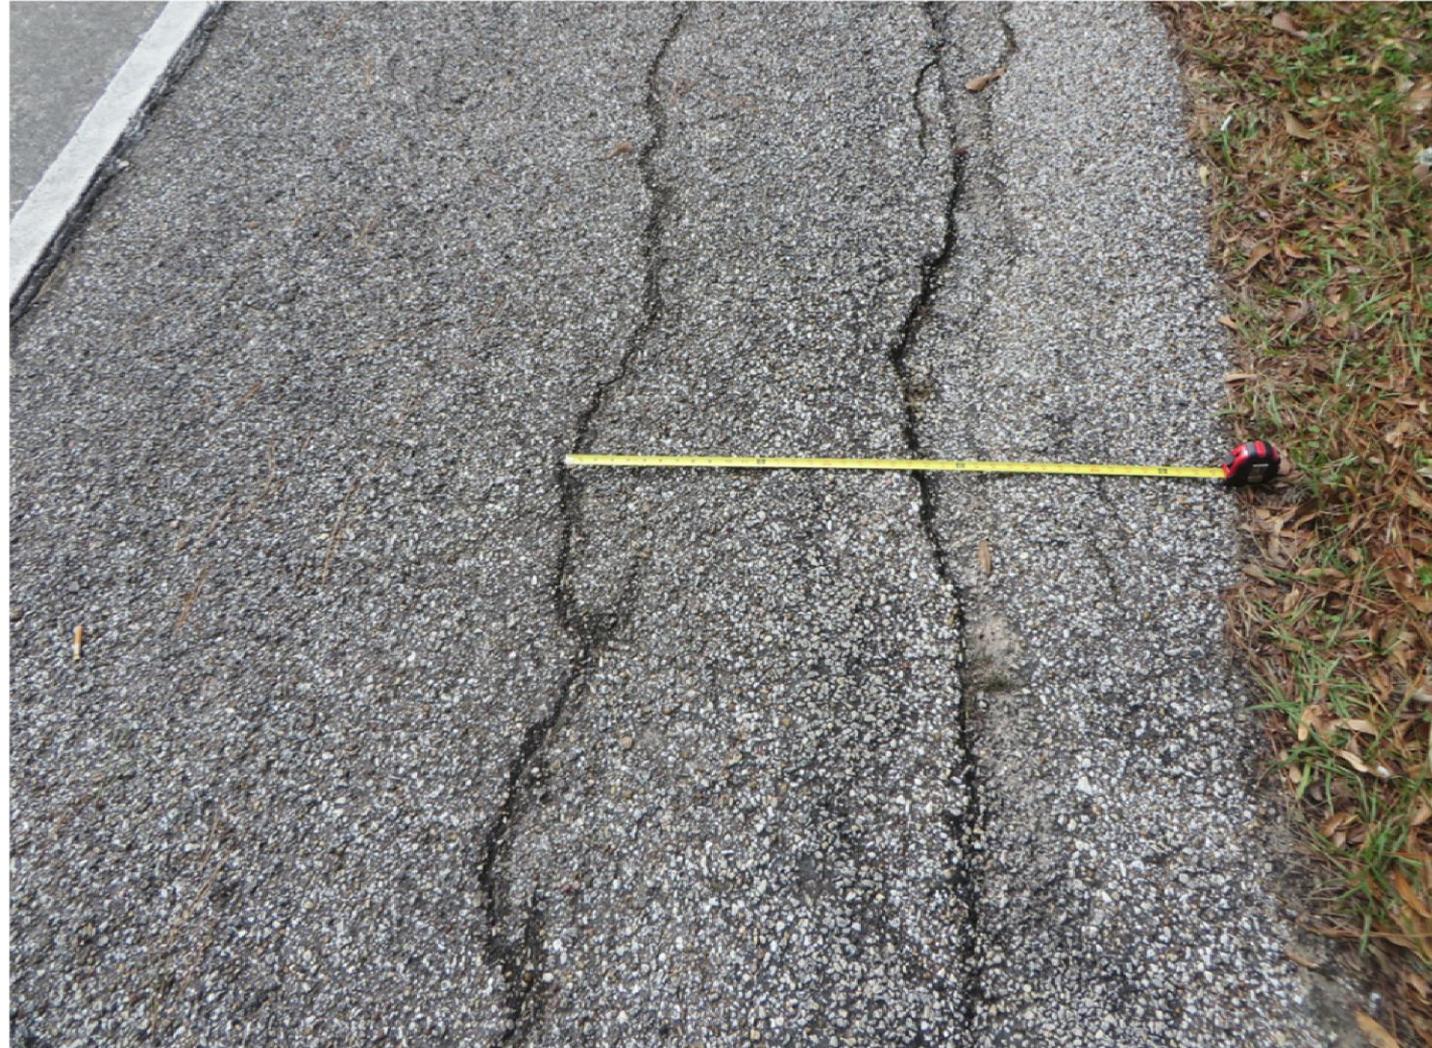
LW-14
Lake Woodlands
Westbound

Hazard type: Misc
Severity: 1

Starting cracks and subsidence

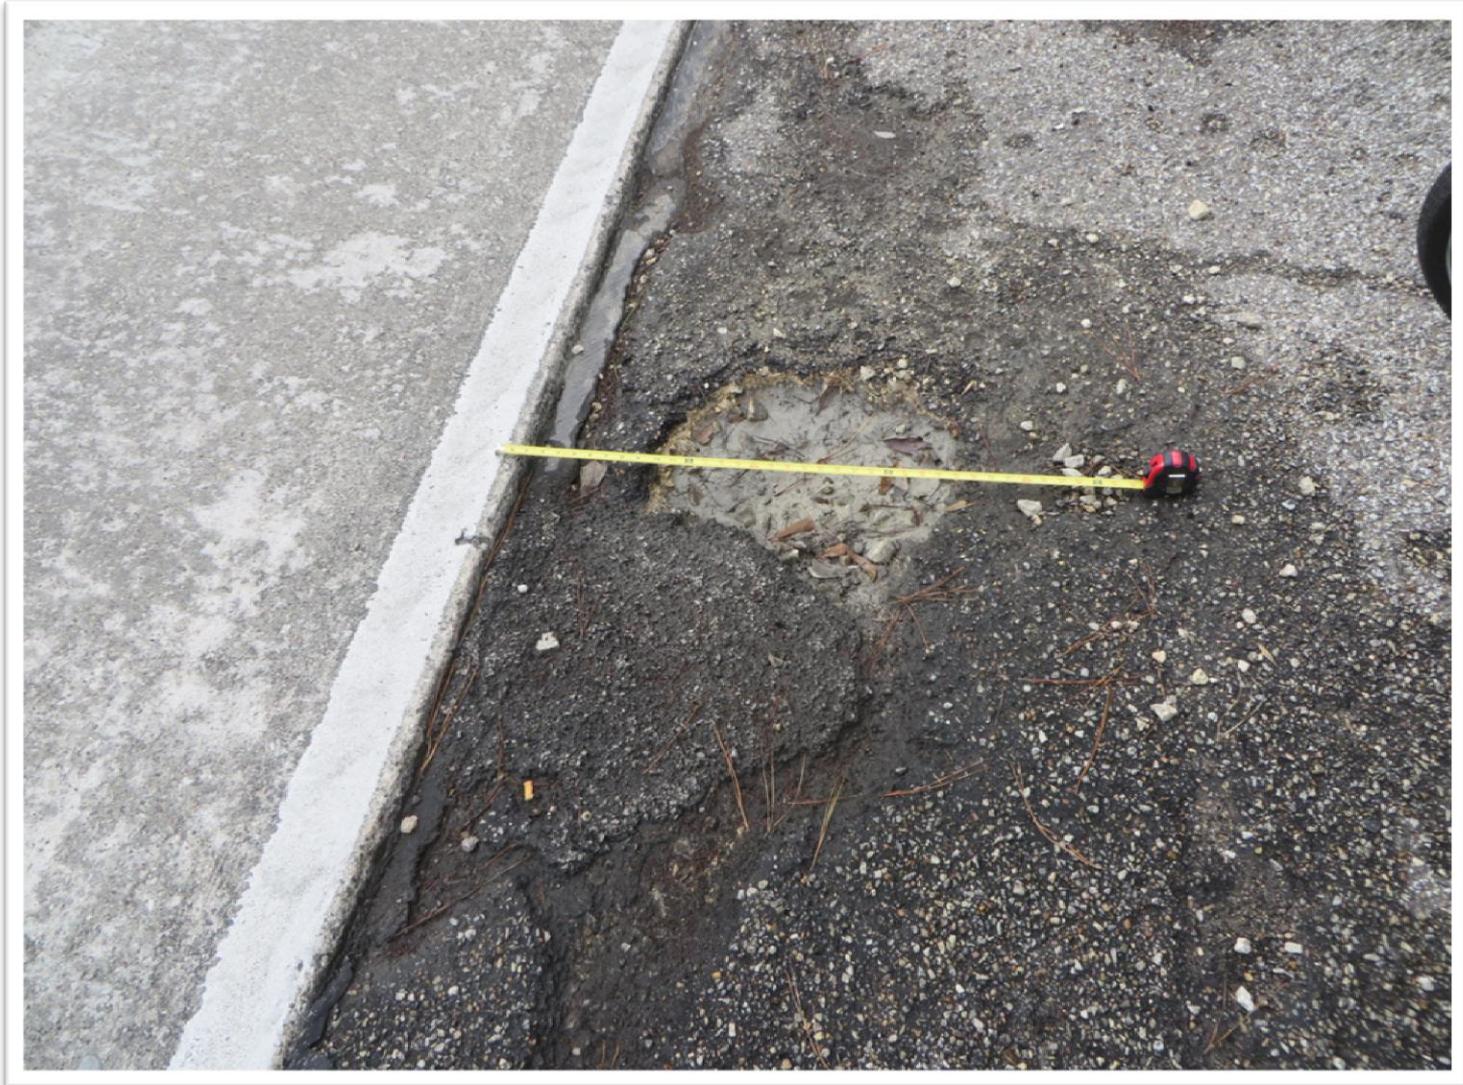
LW-15
Lake Woodlands
Westbound

Hazard type: Rough area and Pothole
Severity: 3

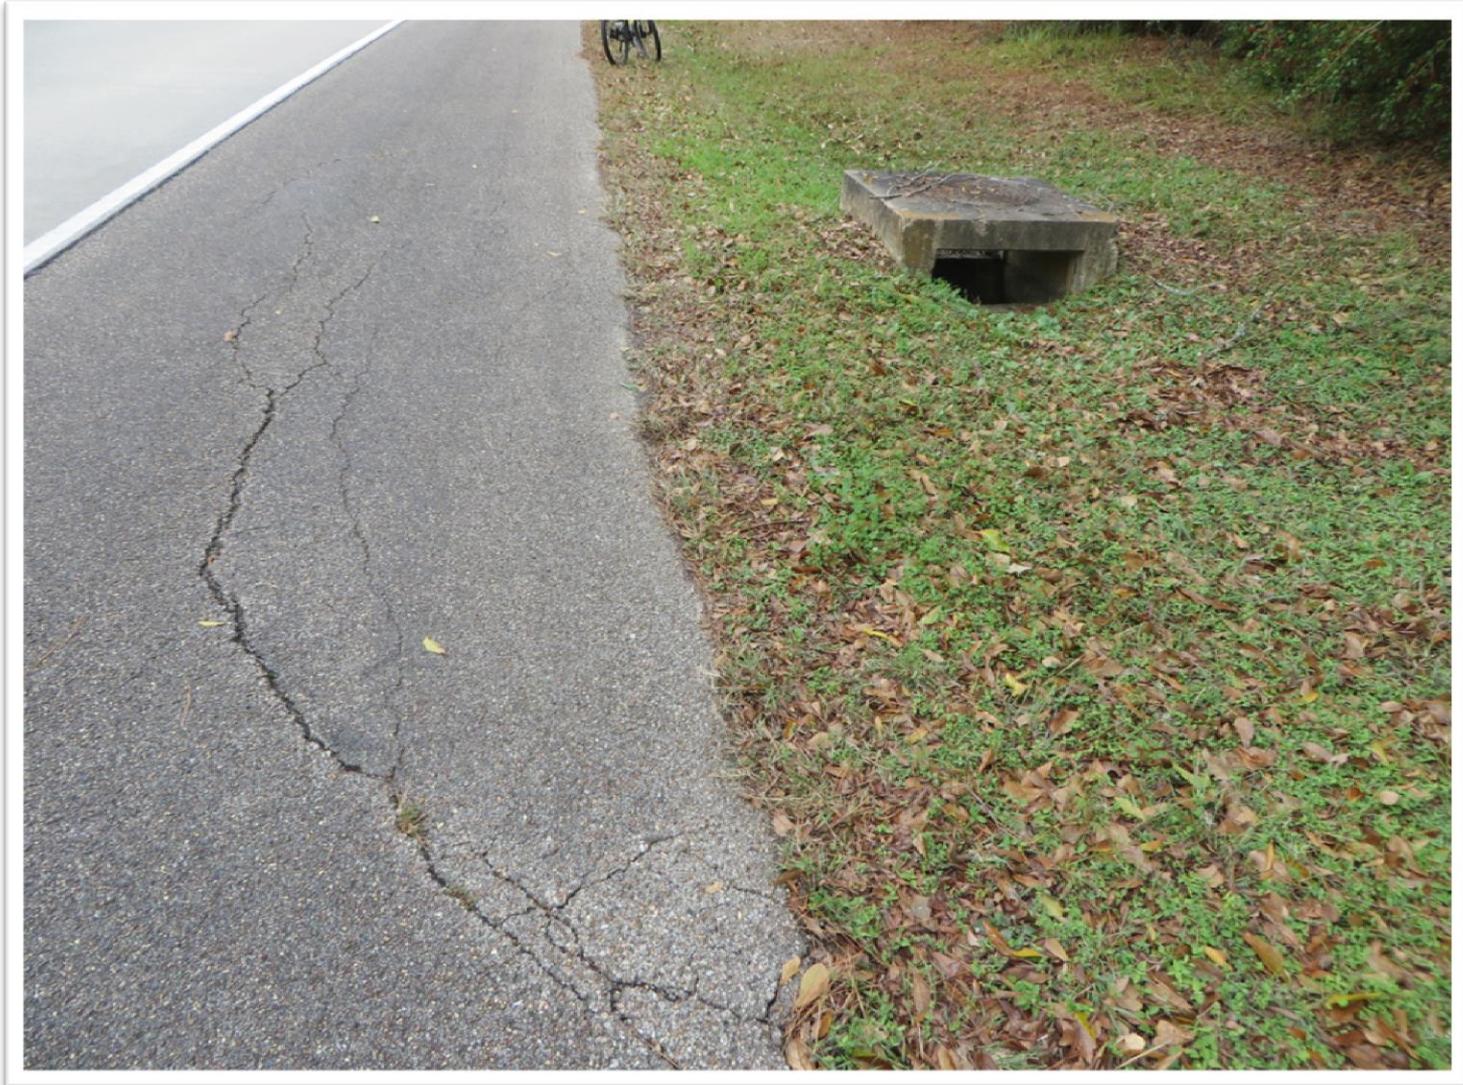
LW-16
Lake Woodlands
Westbound

Hazard type: Misc
Severity: 1

Subsidence starting near storm sewer

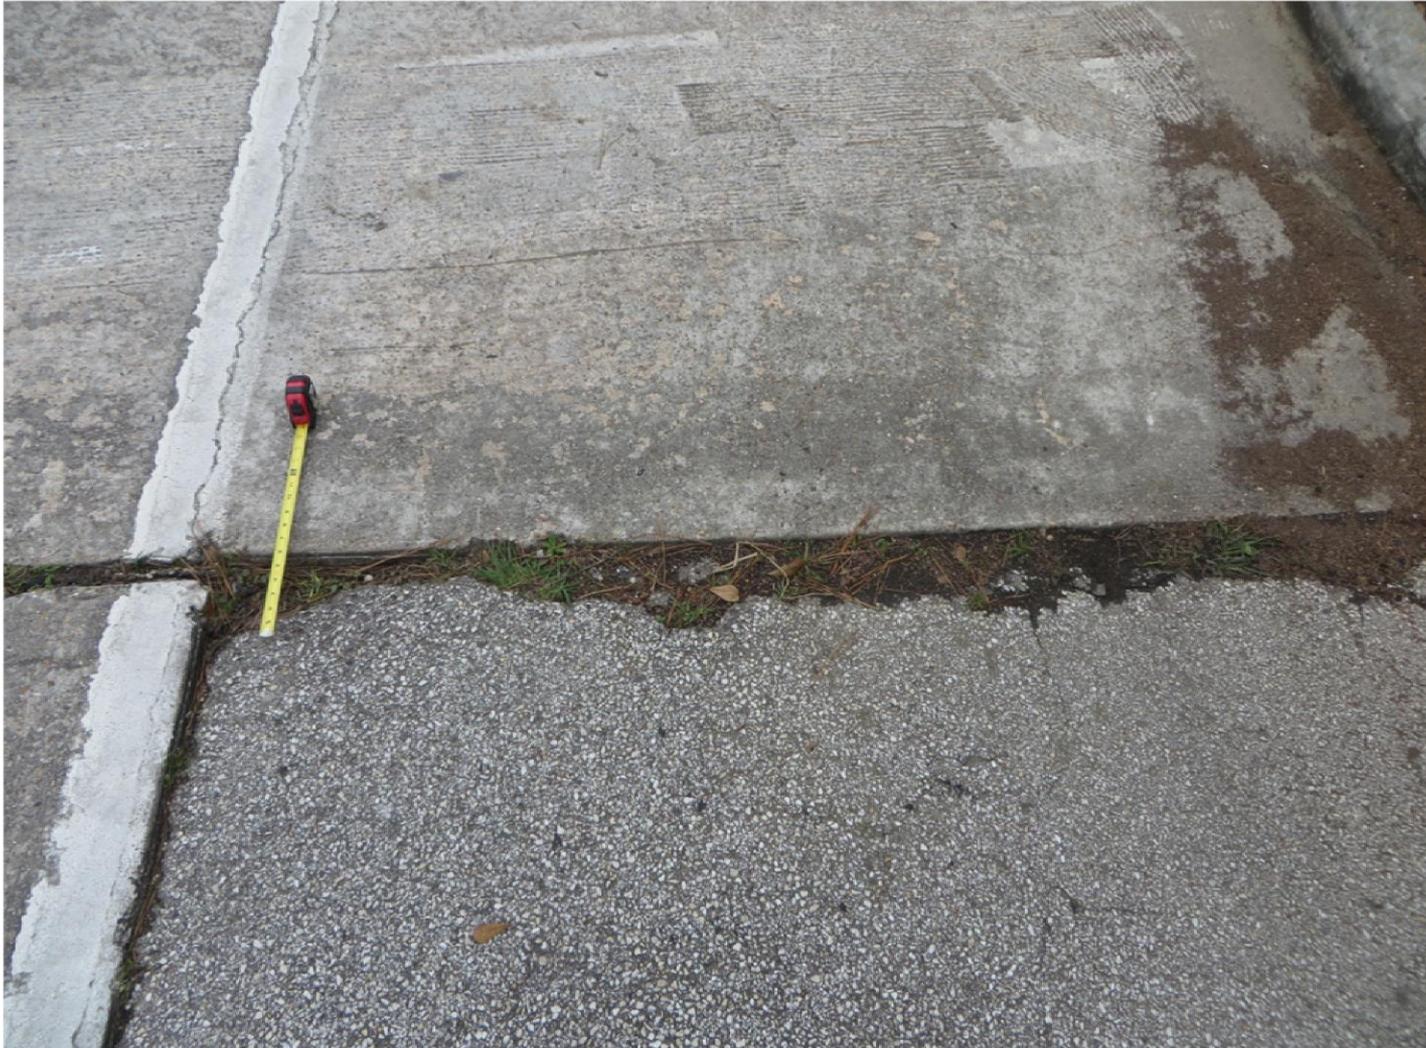
LW-17
Lake Woodlands
Westbound

Hazard type: Rough area Rough area
Severity: 2

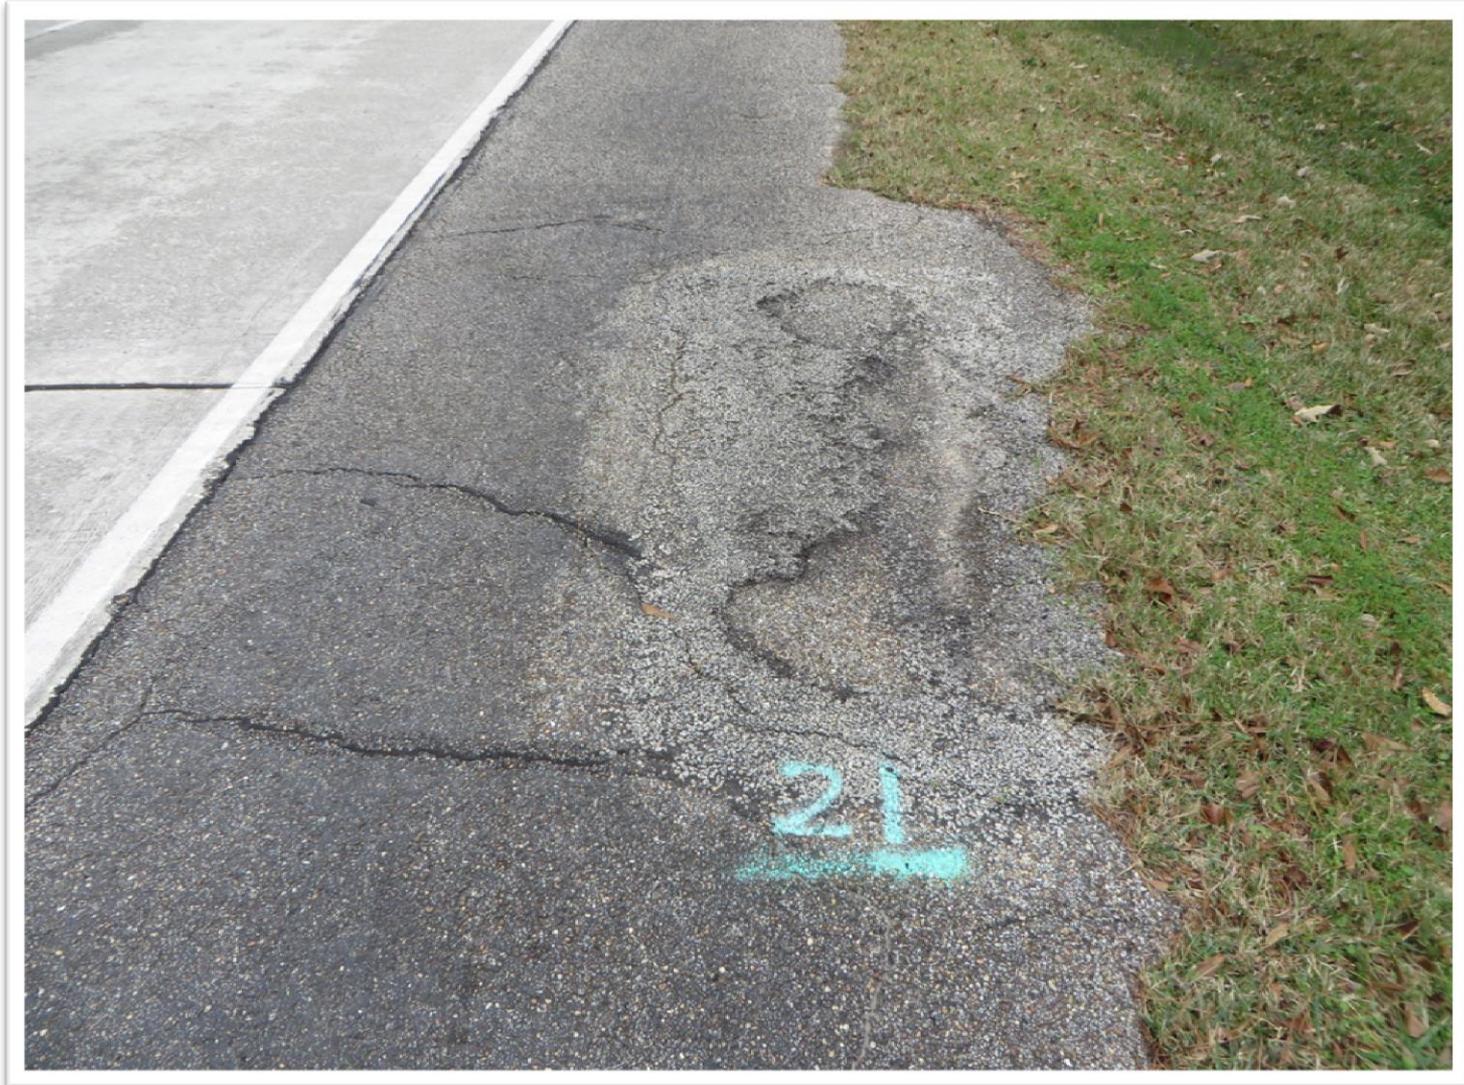
LW-18
Lake Woodlands
Eastbound

Hazard type: Rough area
Severity: 2

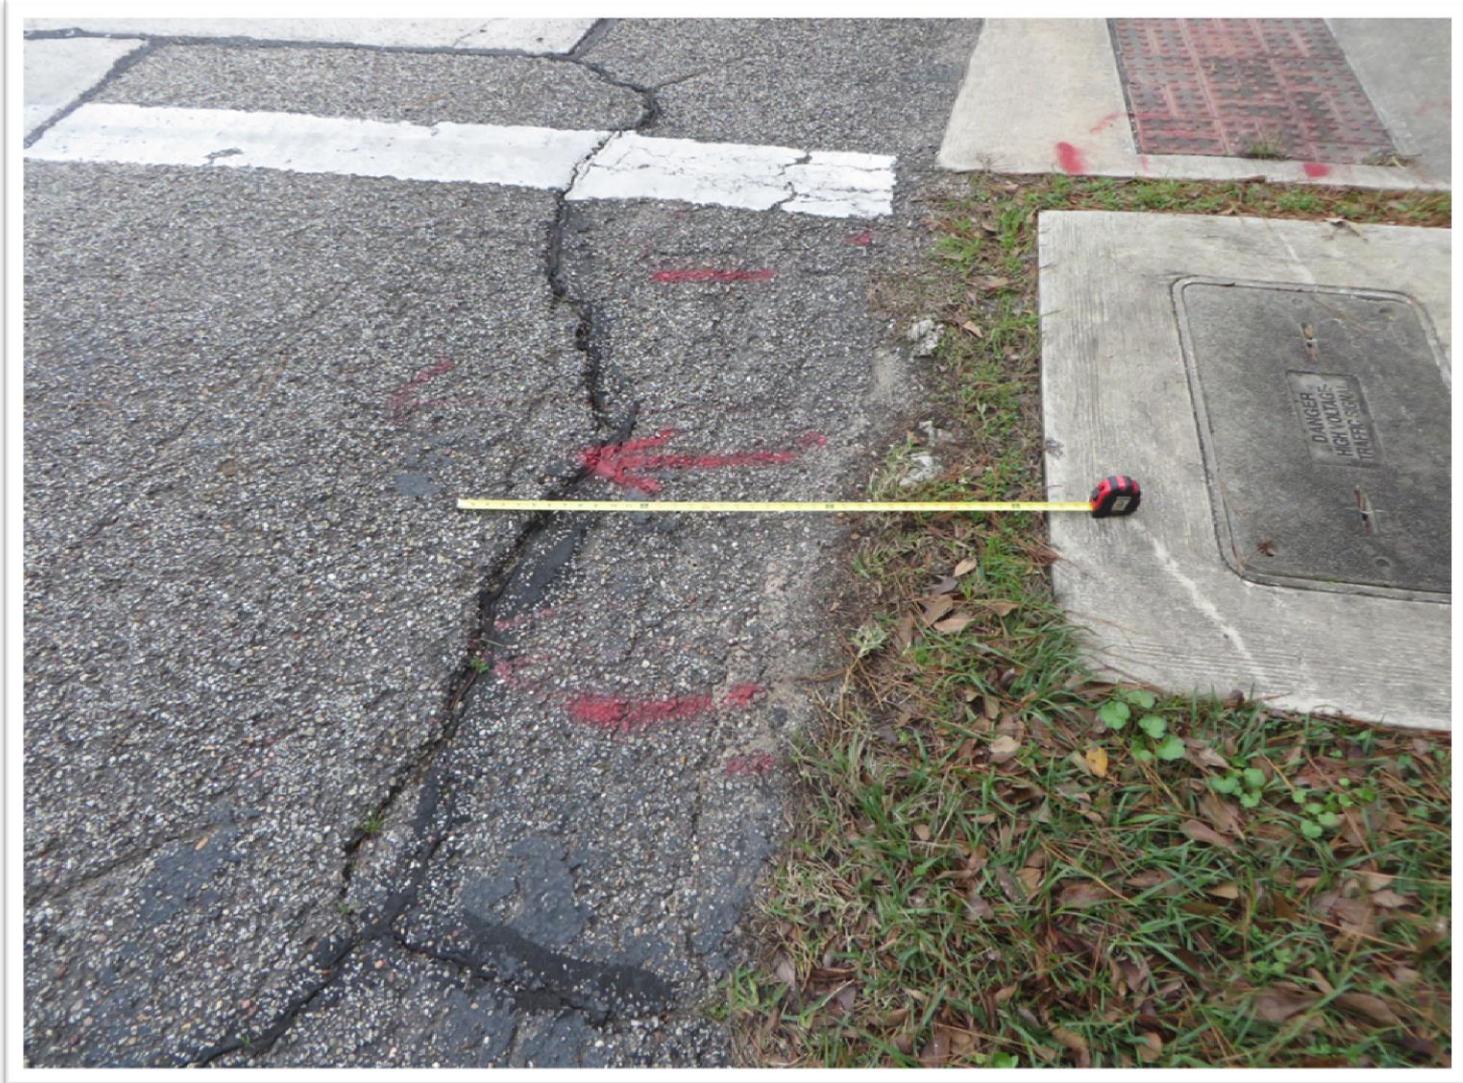
LW-19
Lake Woodlands
Eastbound

Hazard type: Misc
Severity: 1

Subsidence and cracks starting

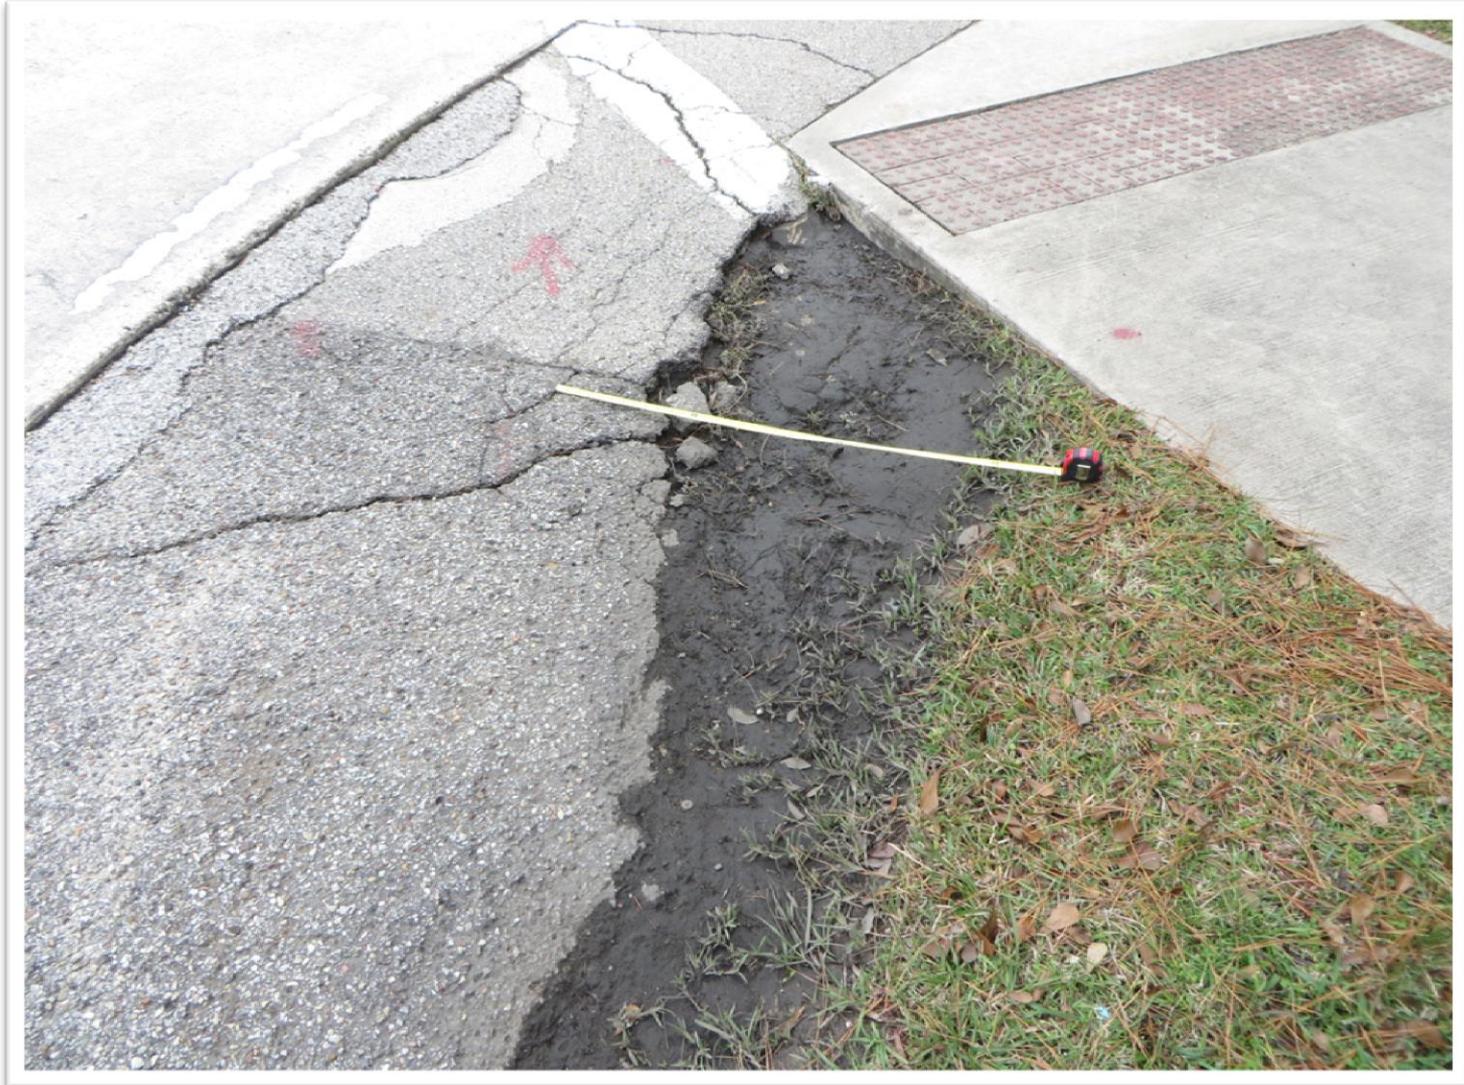
LW-20
Lake Woodlands
Eastbound

Hazard type: Rough area
Severity: 3

Shoulder deterioration
leading to narrower-than-
expected shoulder.

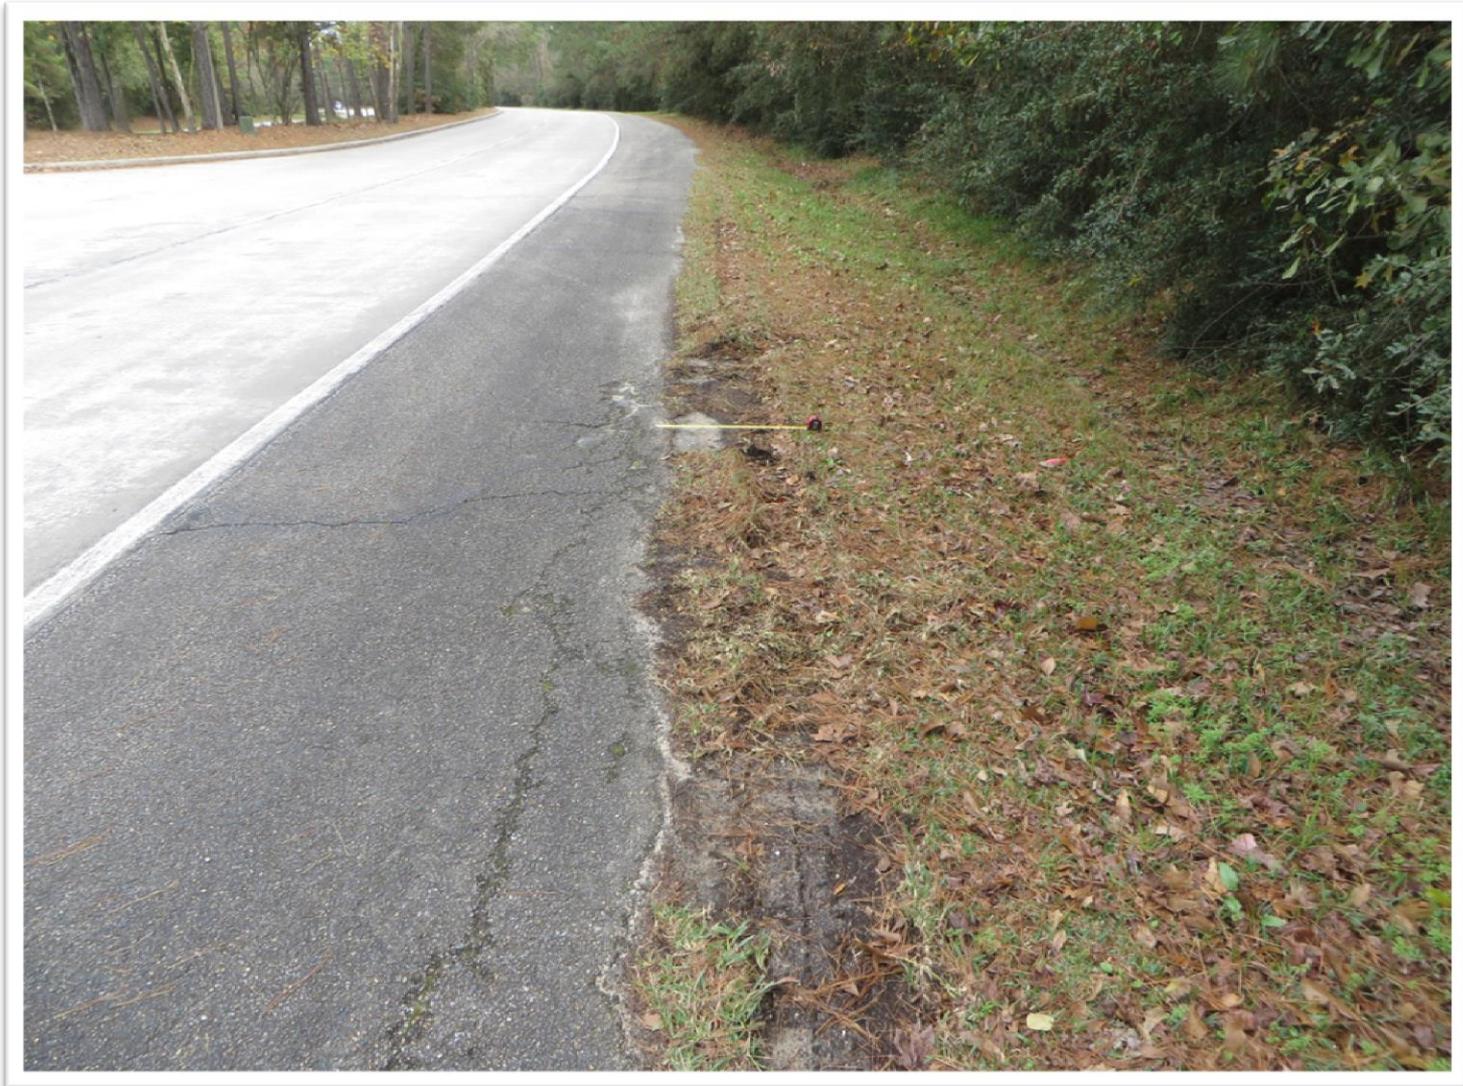
LW-21
Lake Woodlands
Eastbound

Hazard type: Misc
Severity: 1

Encroachment of ~ 2 ft for 100+ feet along
road

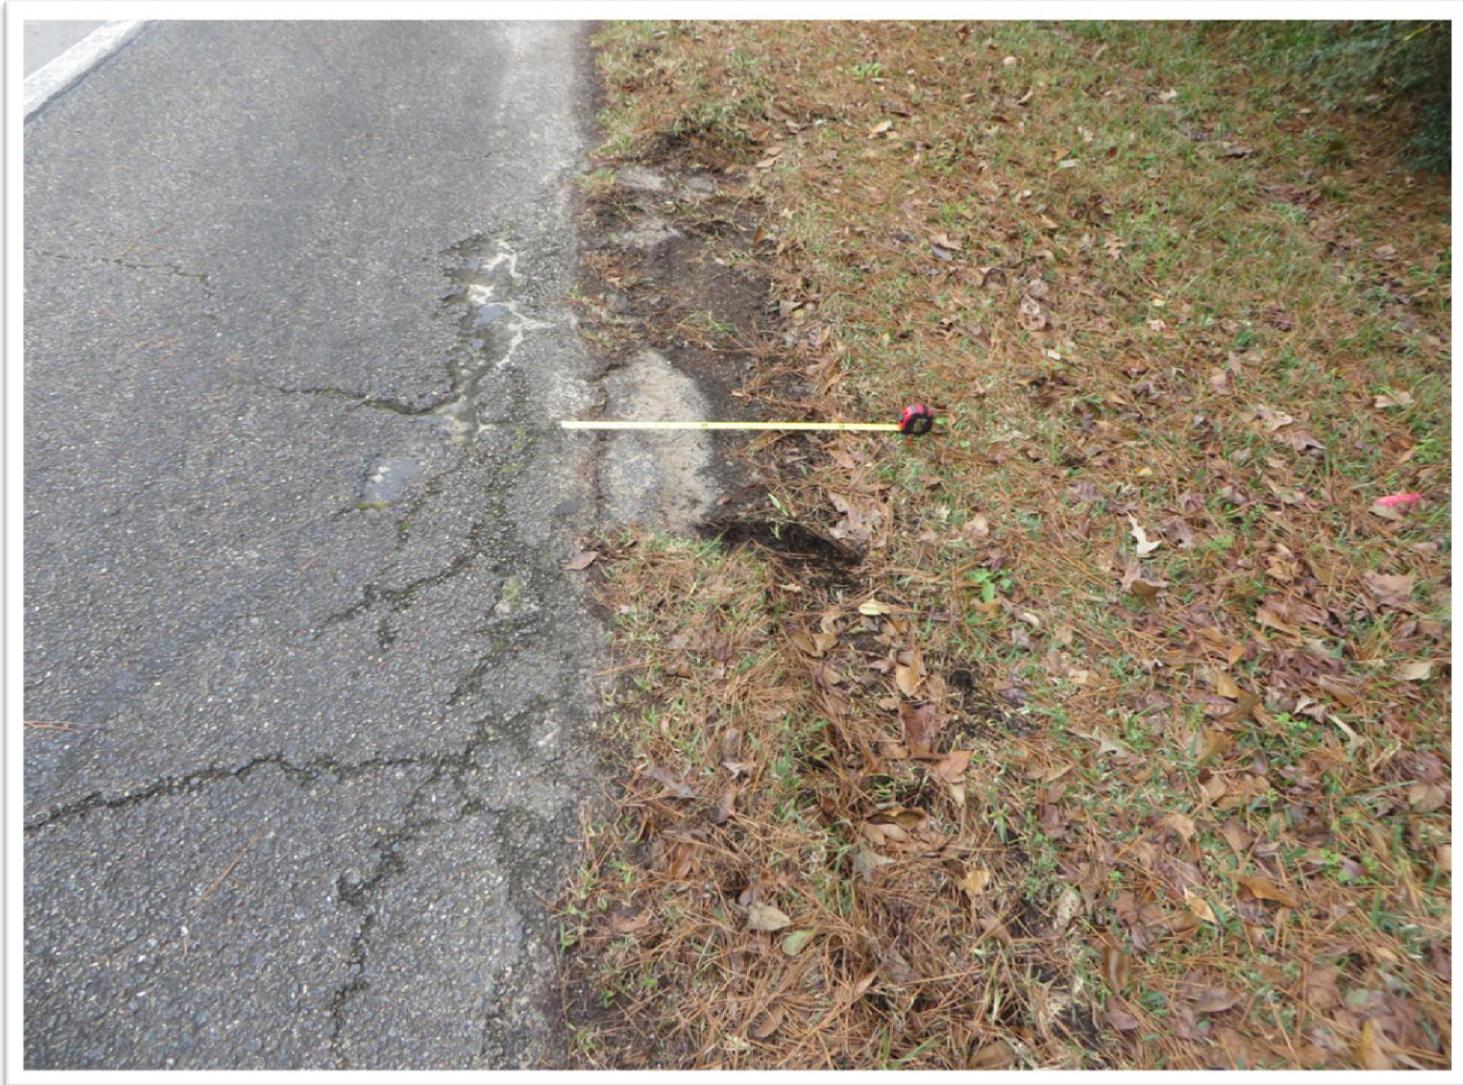
LW-21
Lake Woodlands
Eastbound

Hazard type: Misc
Severity: 1

Closeup of encroachment on previous slide

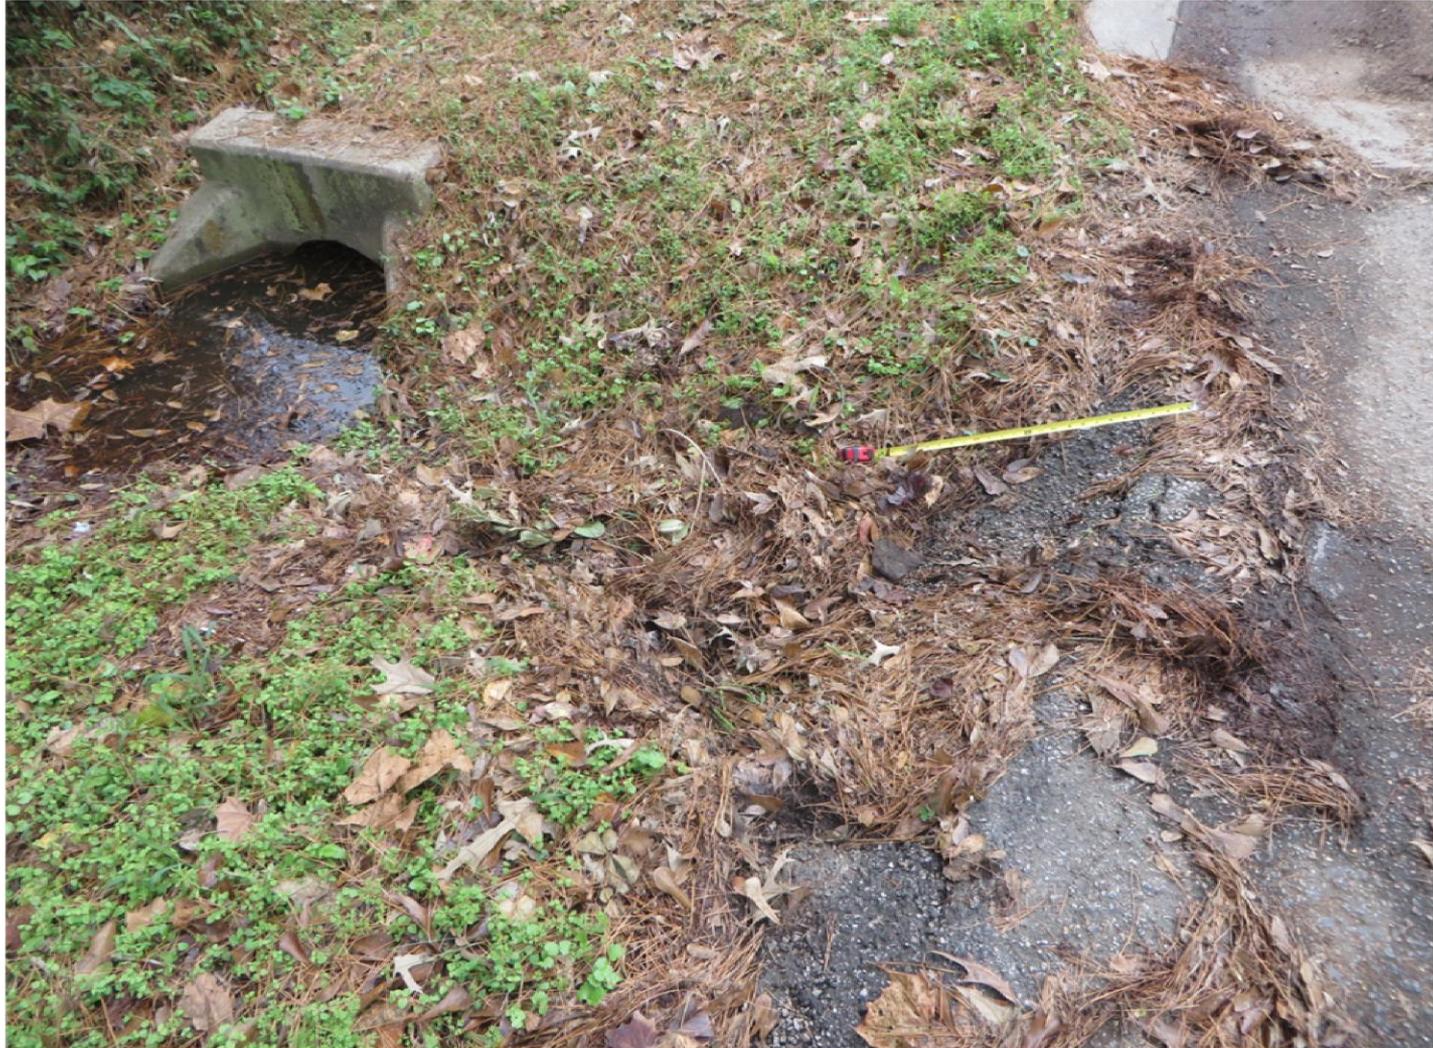
LW-22
Lake Woodlands
Eastbound

Hazard type: Other
Severity: 4

Serious drop off and deterioration of shoulder

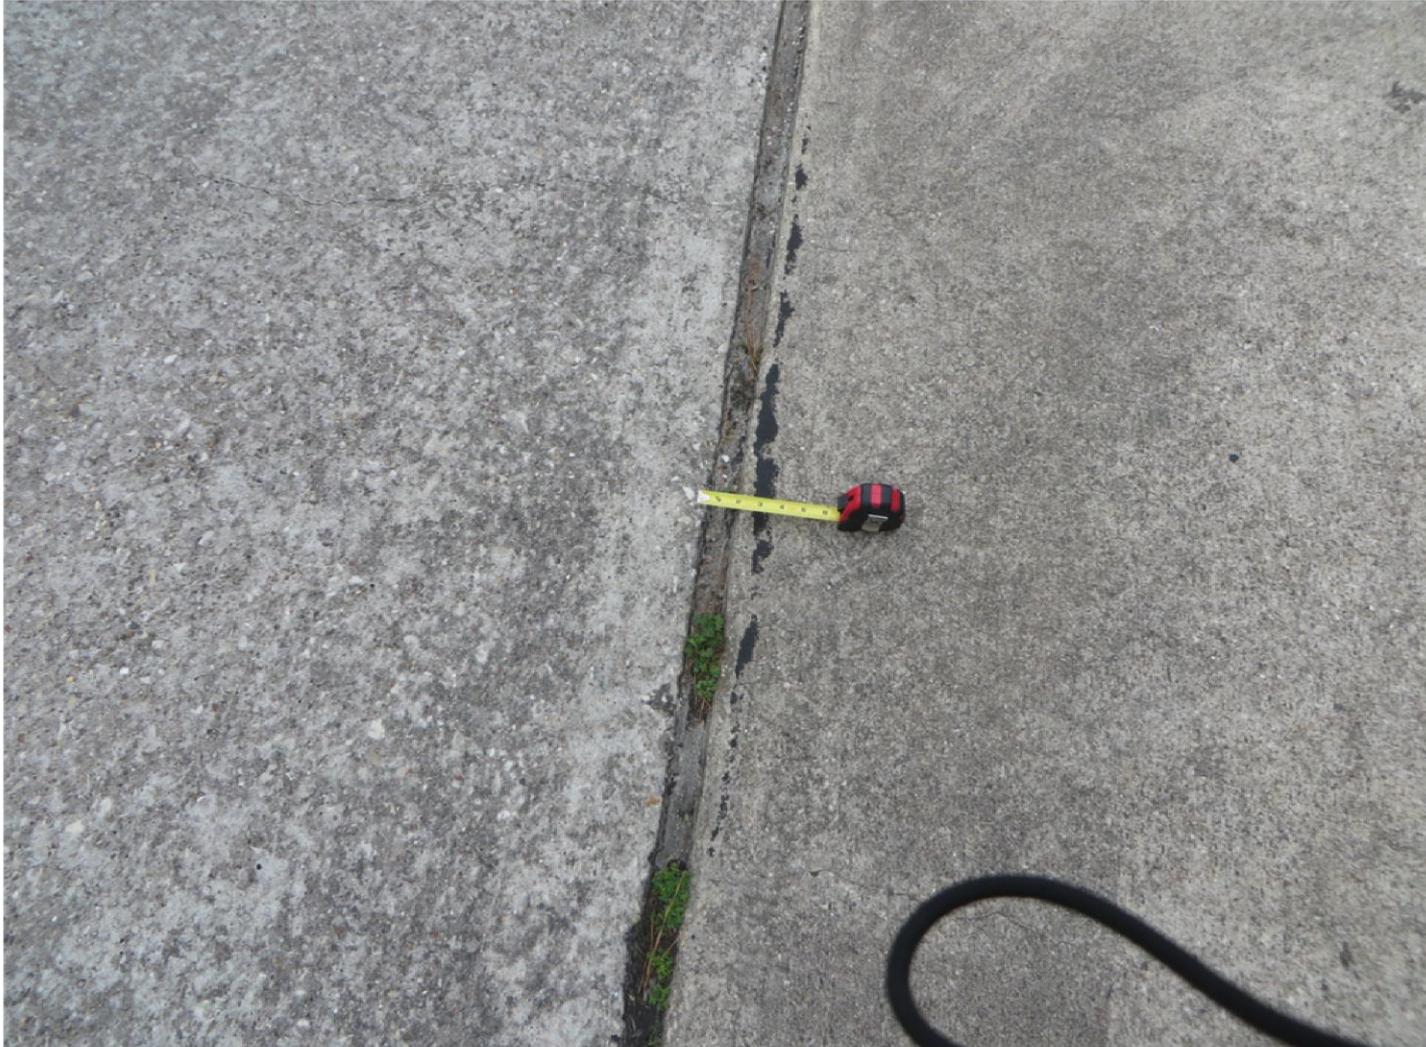
LW-23
Lake Woodlands
Eastbound

Hazard type: Gap
Severity: 2

Narrower bike tires can get caught in gaps like this.

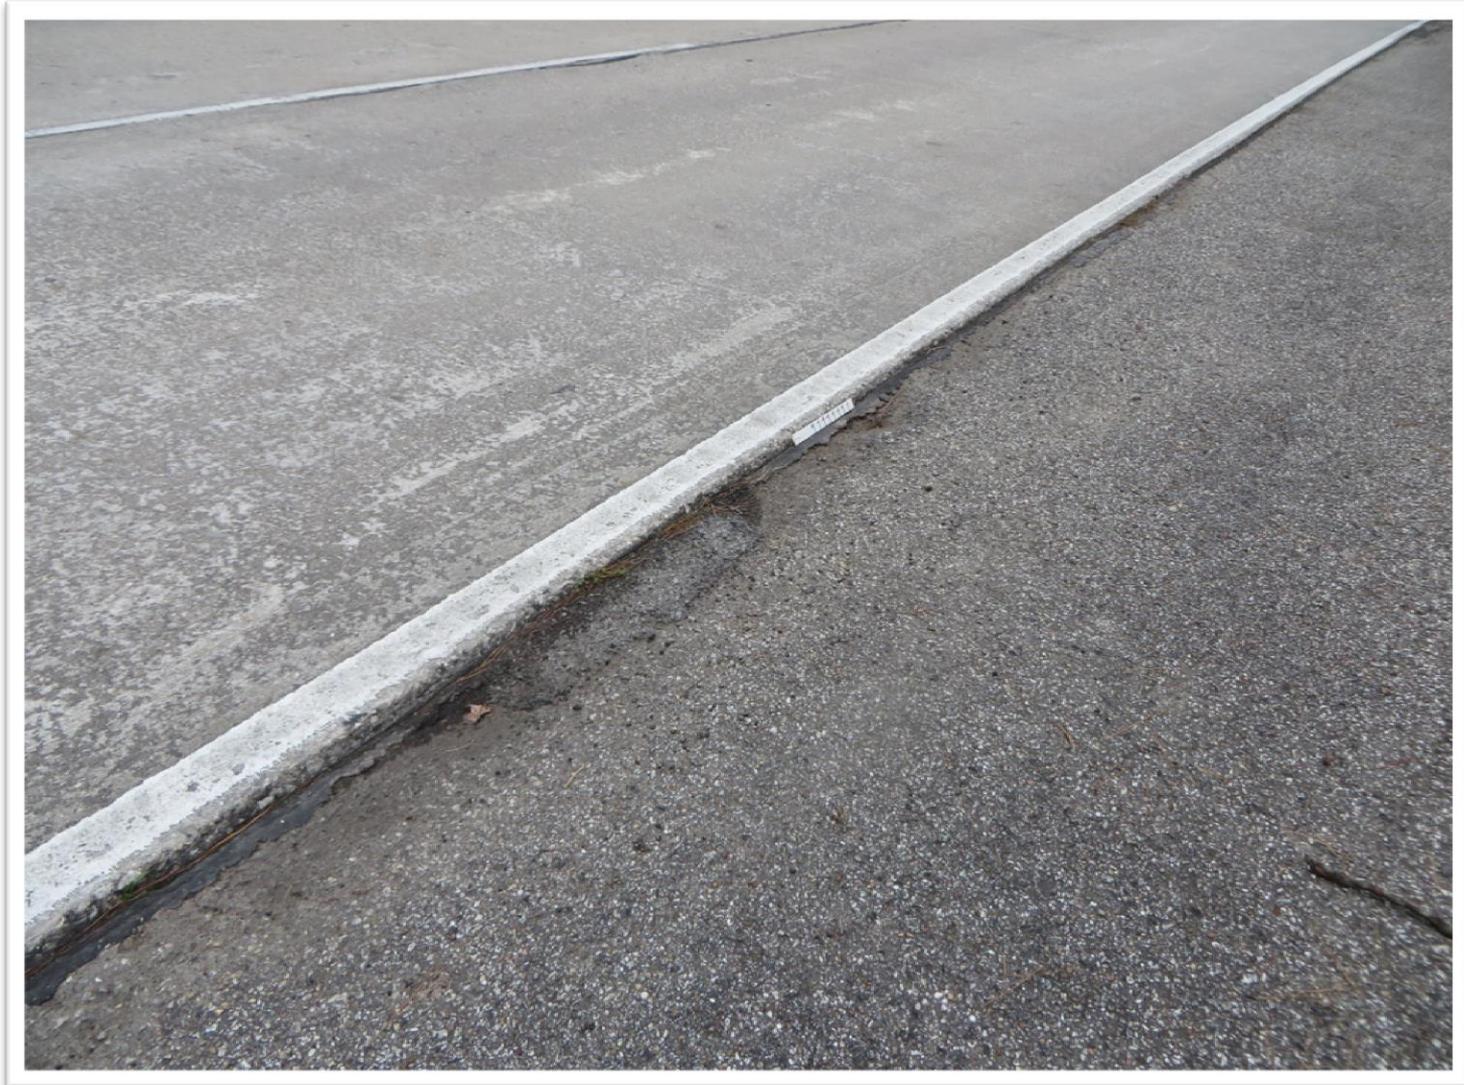
LW-24
Lake Woodlands
Eastbound

Hazard type: Rough and lip
Severity: 3

Lip > 1 1/2" in many parts of this area

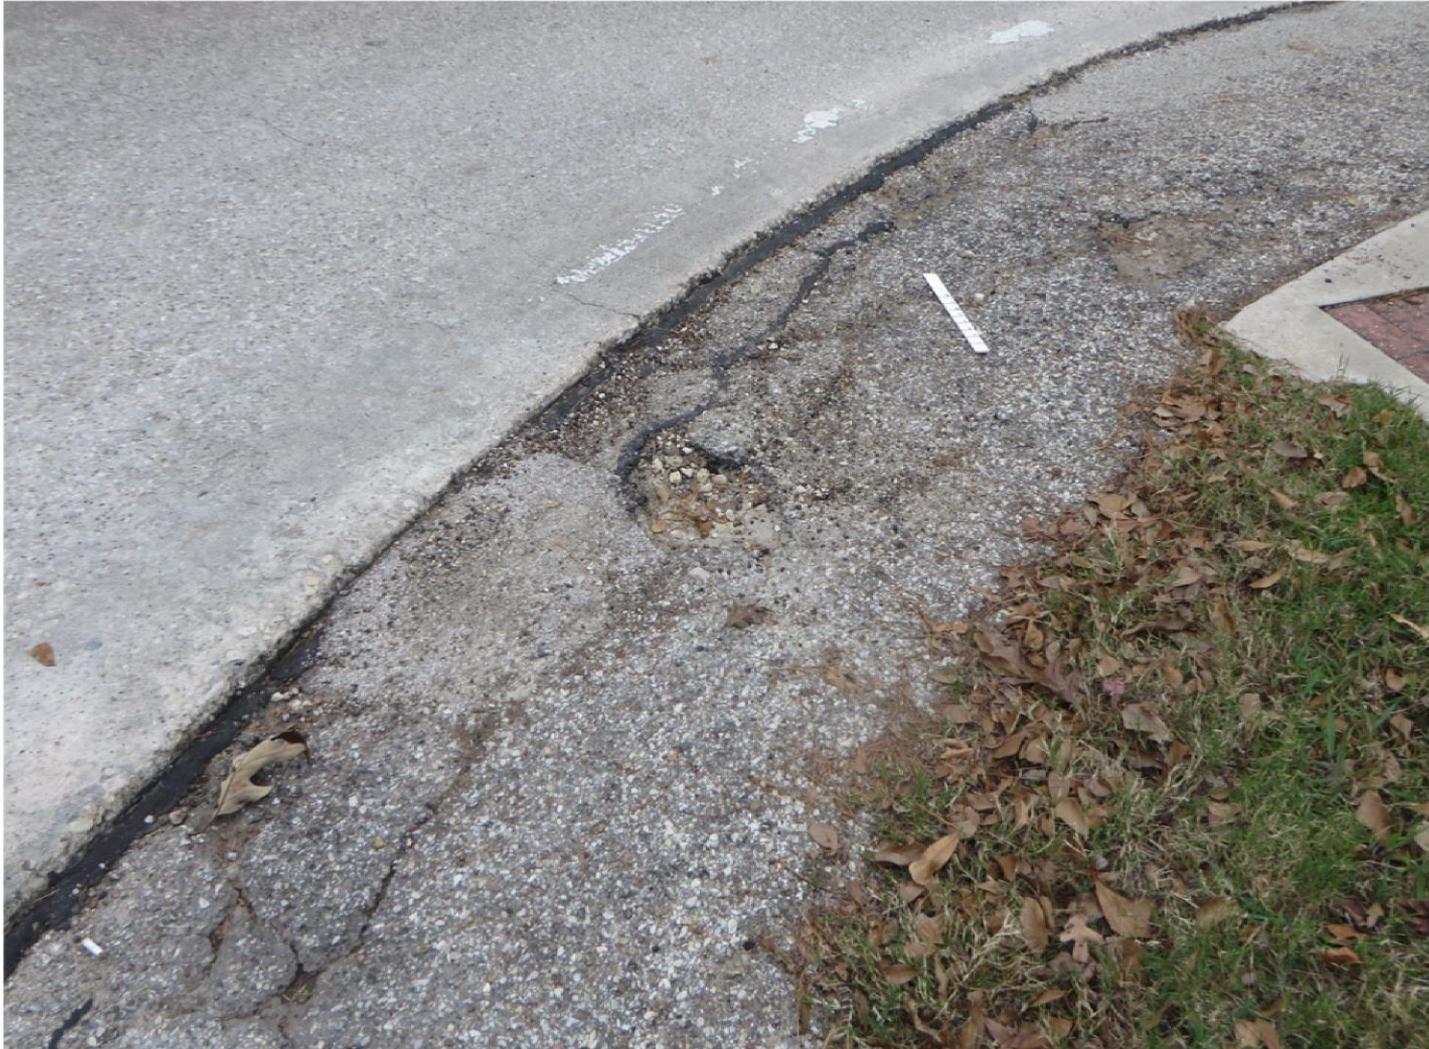
LW-25

Hazard type: Rough, Lip, Pothole

Severity: 3

Roughness and other problems along with
narrow shoulder could be a real hazard
