Road Shoulder Hazards along
Lake Woodlands – January 2015

Hazards on road shoulders, that could pose a risk to cyclists, were identified in January 2015 by volunteers from Bike The Woodlands Coalition.

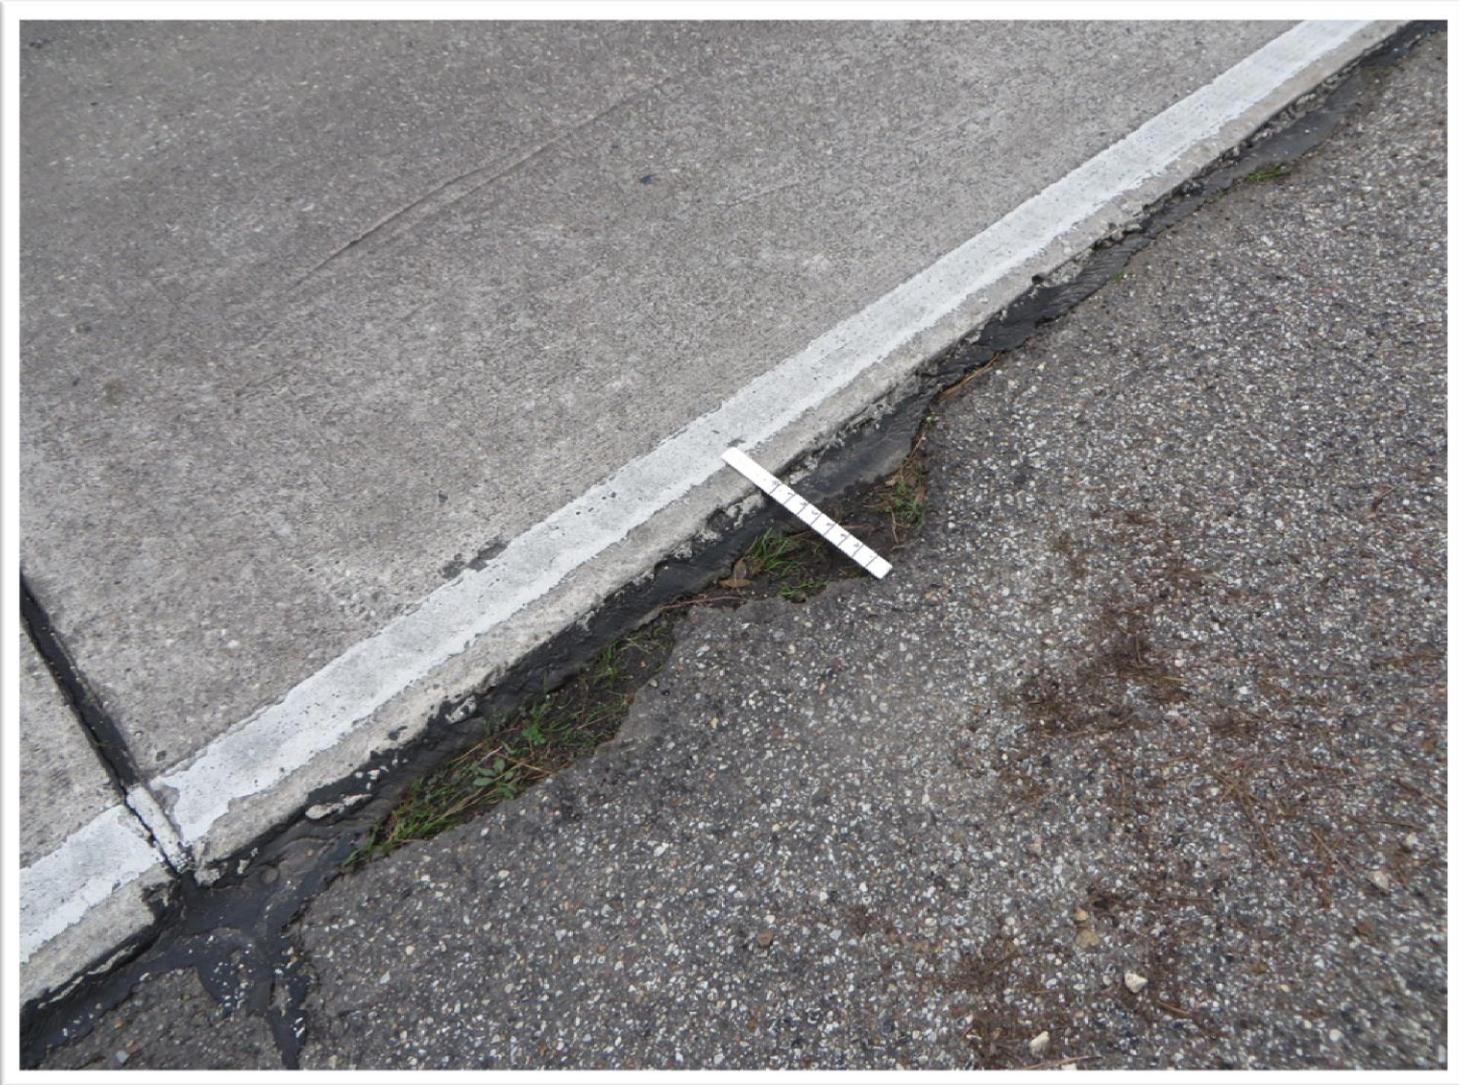
LW-26
Lake Woodlands
Eastbound

Hazard type: Pothole and gap
Severity: 3

This and following slides show serious potholes and
lips over 100+ ft section of shoulder, all called LW -26

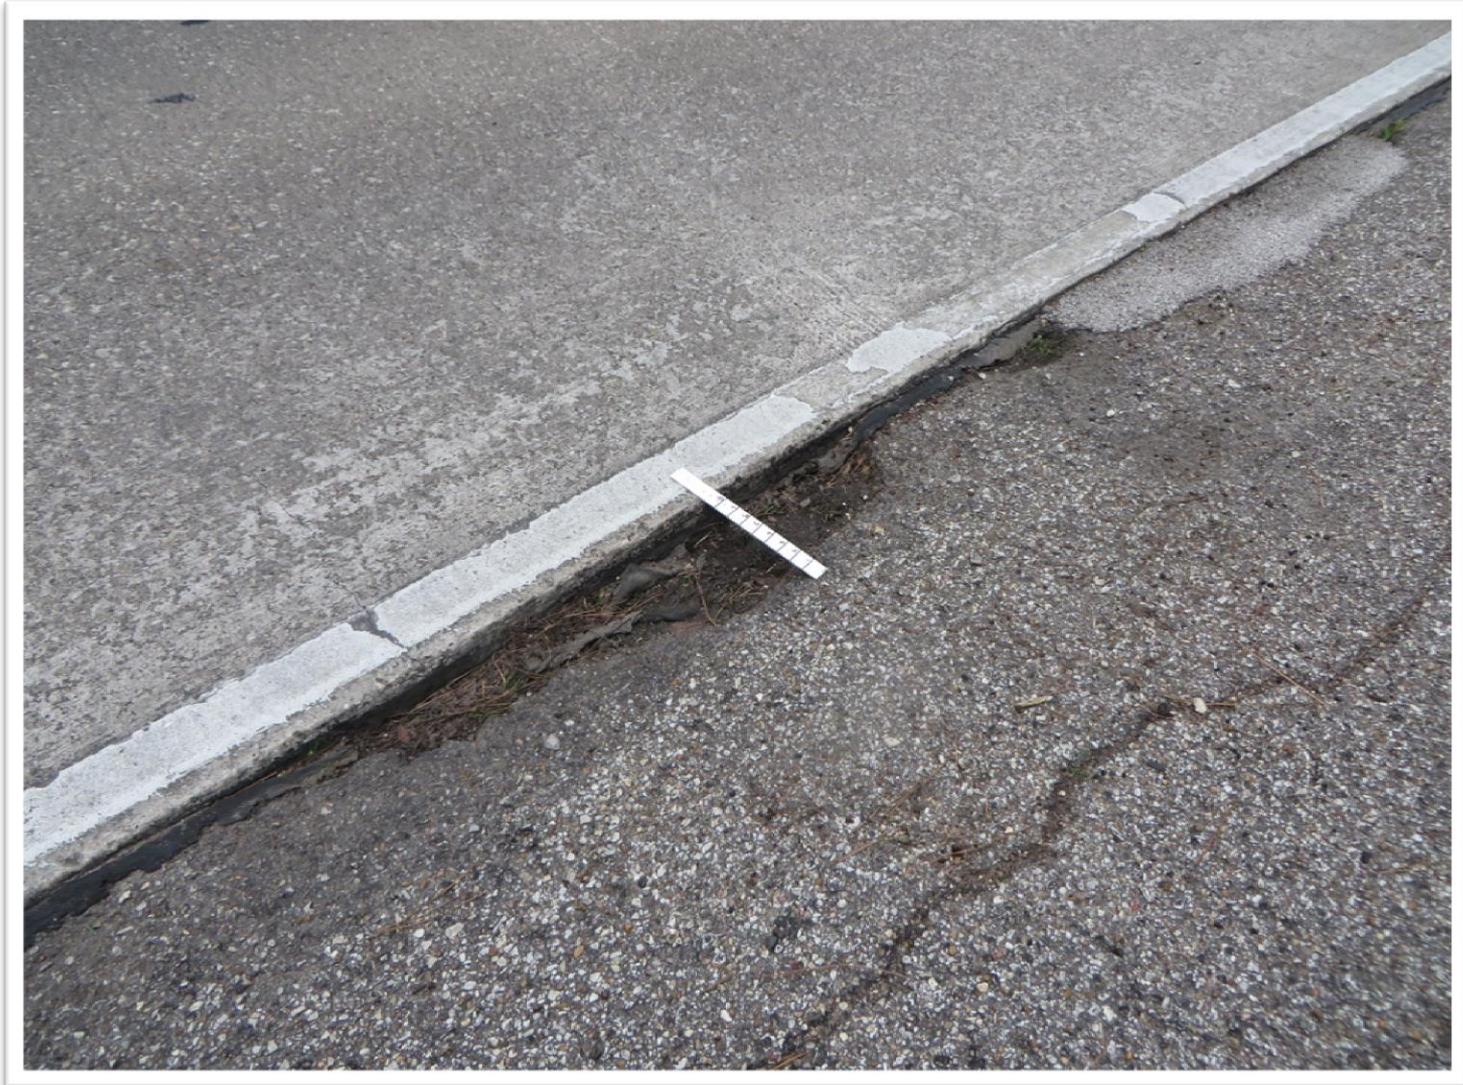
LW-26
Lake Woodlands
Eastbound

Hazard type: Pothole and gap

Severity: 3

This and following slides show serious potholes and
lips over 100+ ft section of shoulder, all called LW -26

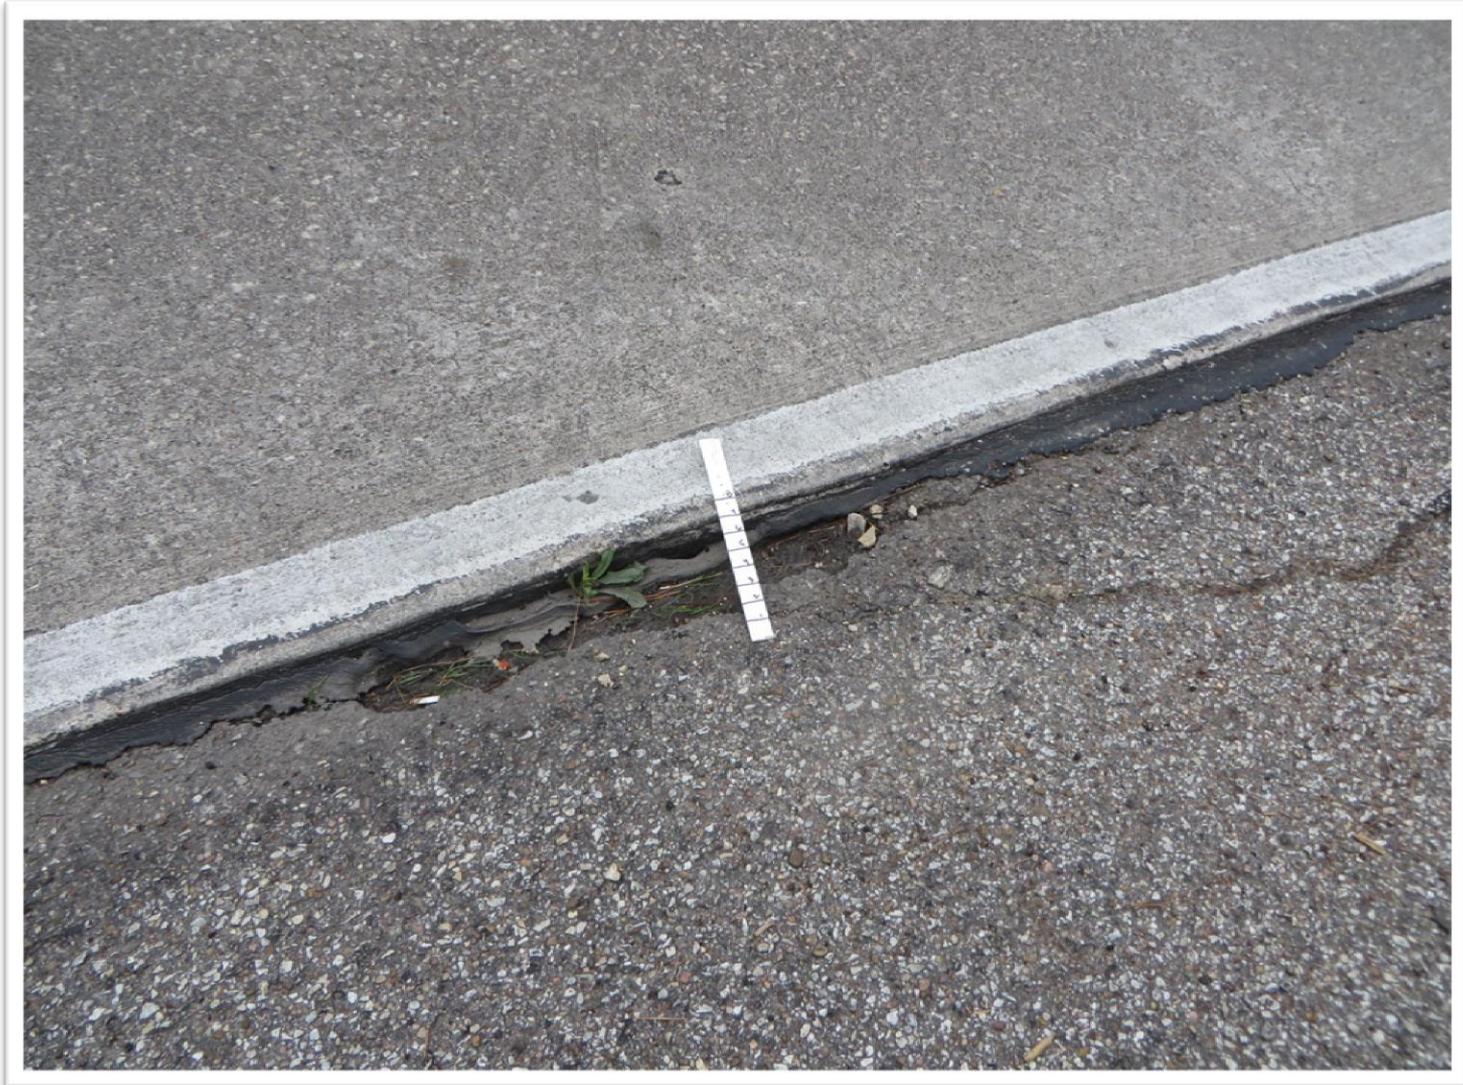
LW-26
Lake Woodlands
Eastbound

Hazard type: Pothole and gap
Severity: 3

This and following slides show serious potholes and
lips over 100+ ft section of shoulder, all called LW -26

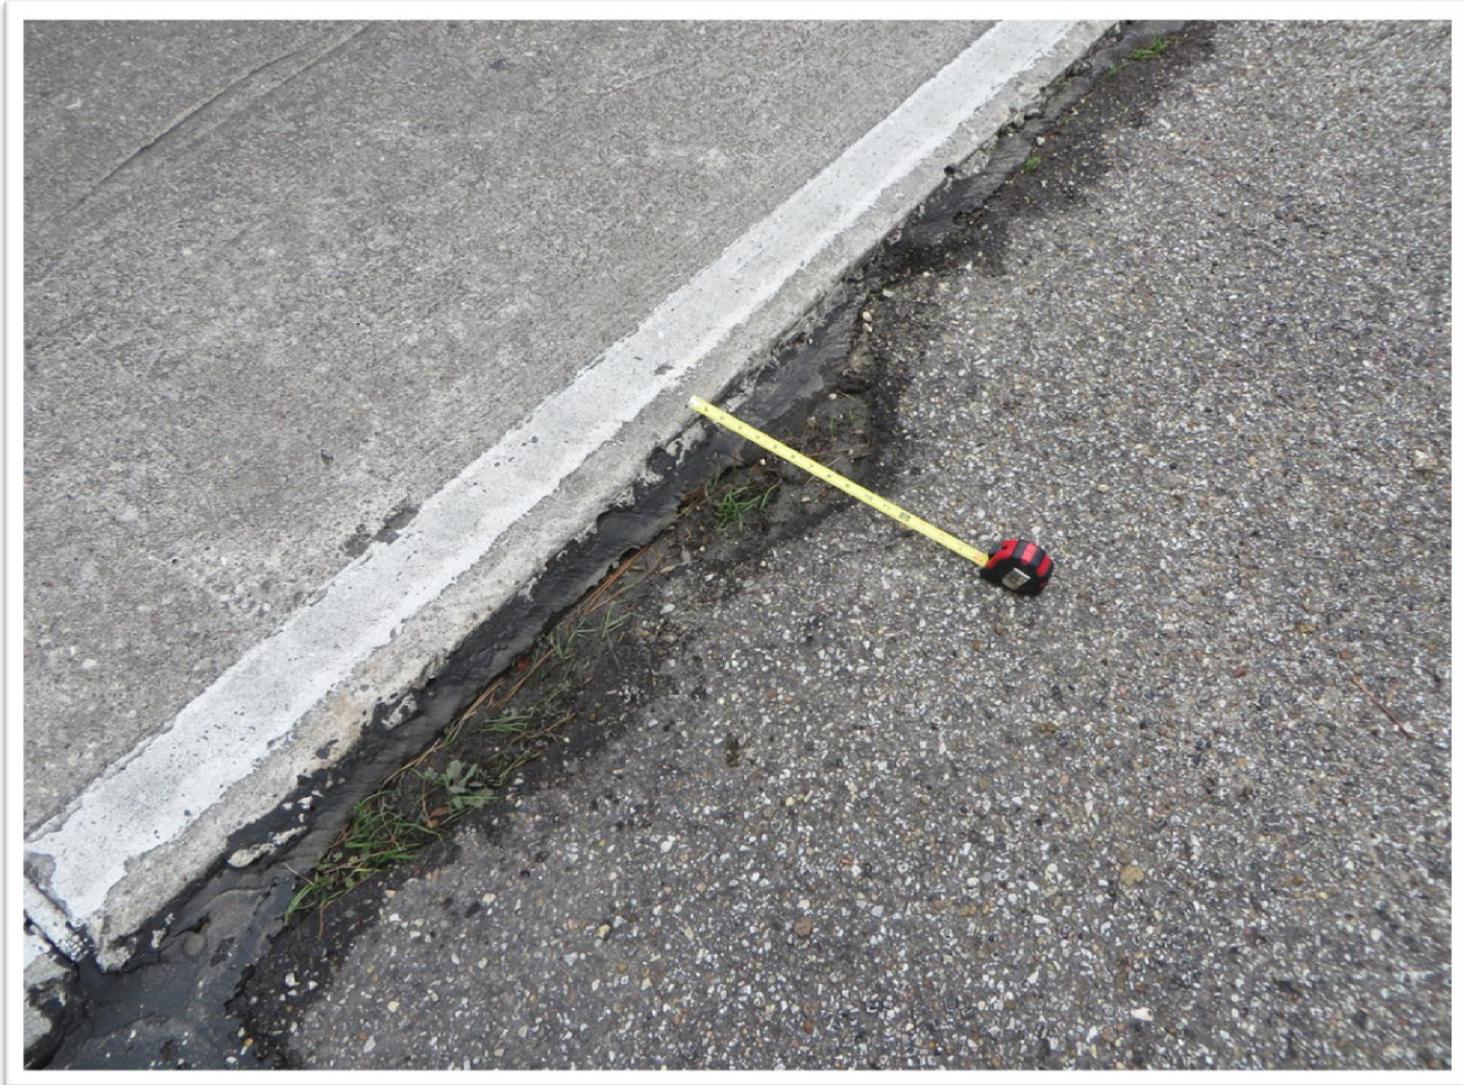
LW-26
Lake Woodlands
Eastbound

Hazard type: Pothole and lip
Severity: 3

This and following slides show serious potholes and
lips over 100+ ft section of shoulder, all called LW -26

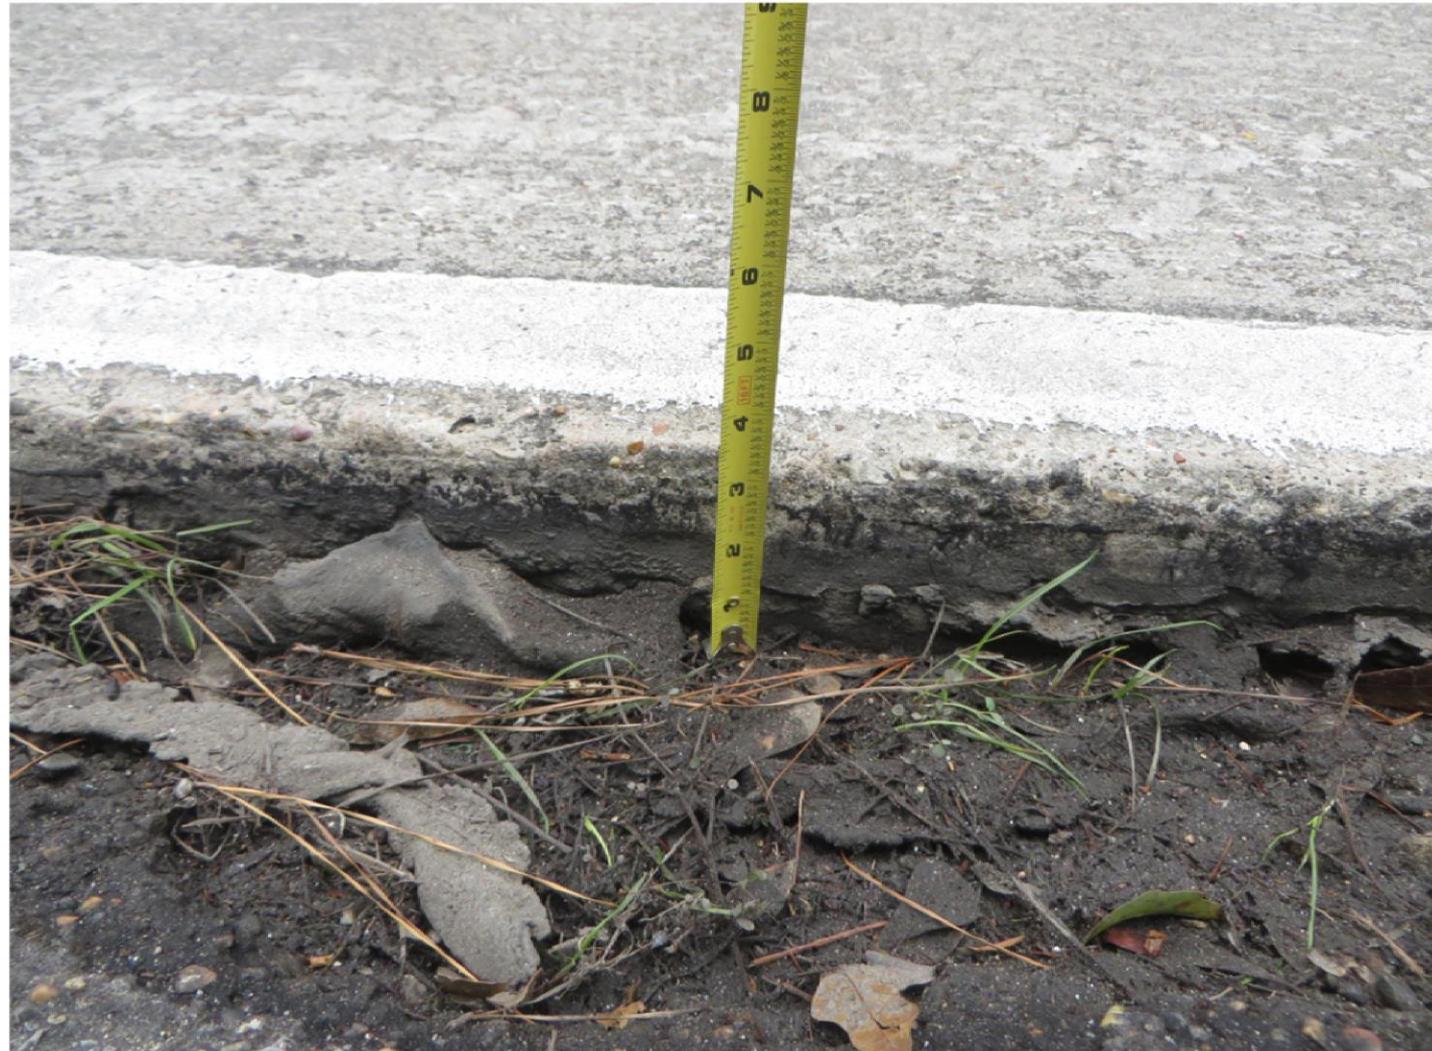
LW-26
Lake Woodlands
Eastbound

Hazard type: Pothole and lip
Severity: 3

This and following slides show serious potholes and lips over 100+ ft section of shoulder, all called LW -26

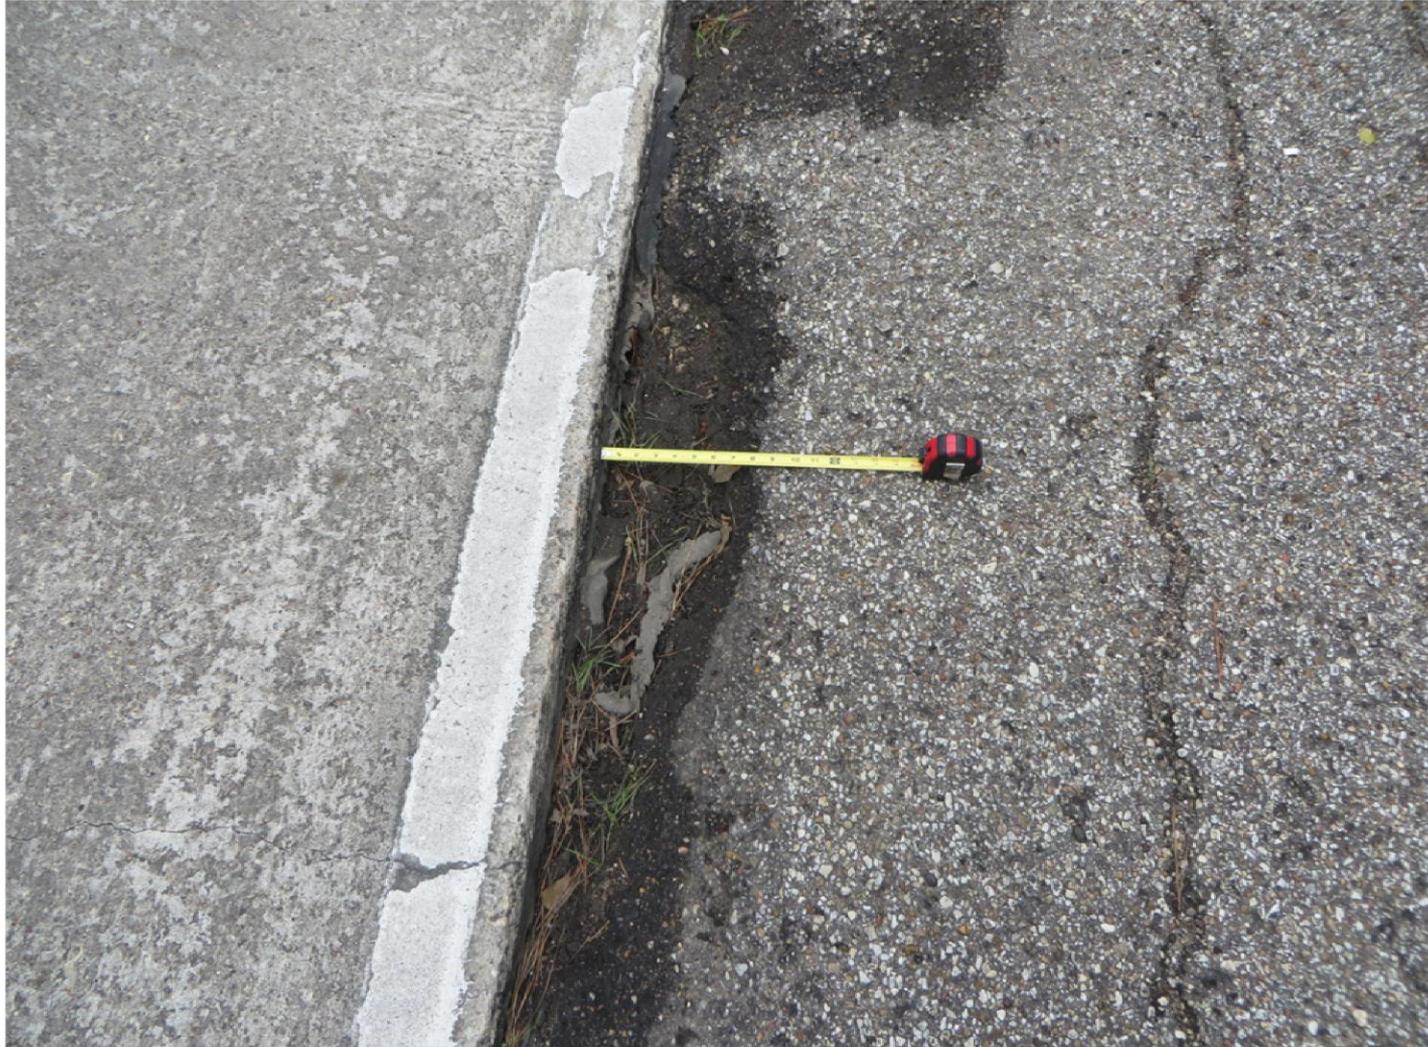
LW-26
Lake Woodlands
Eastbound

Hazard type:
Severity: 3

In same area as previous slide

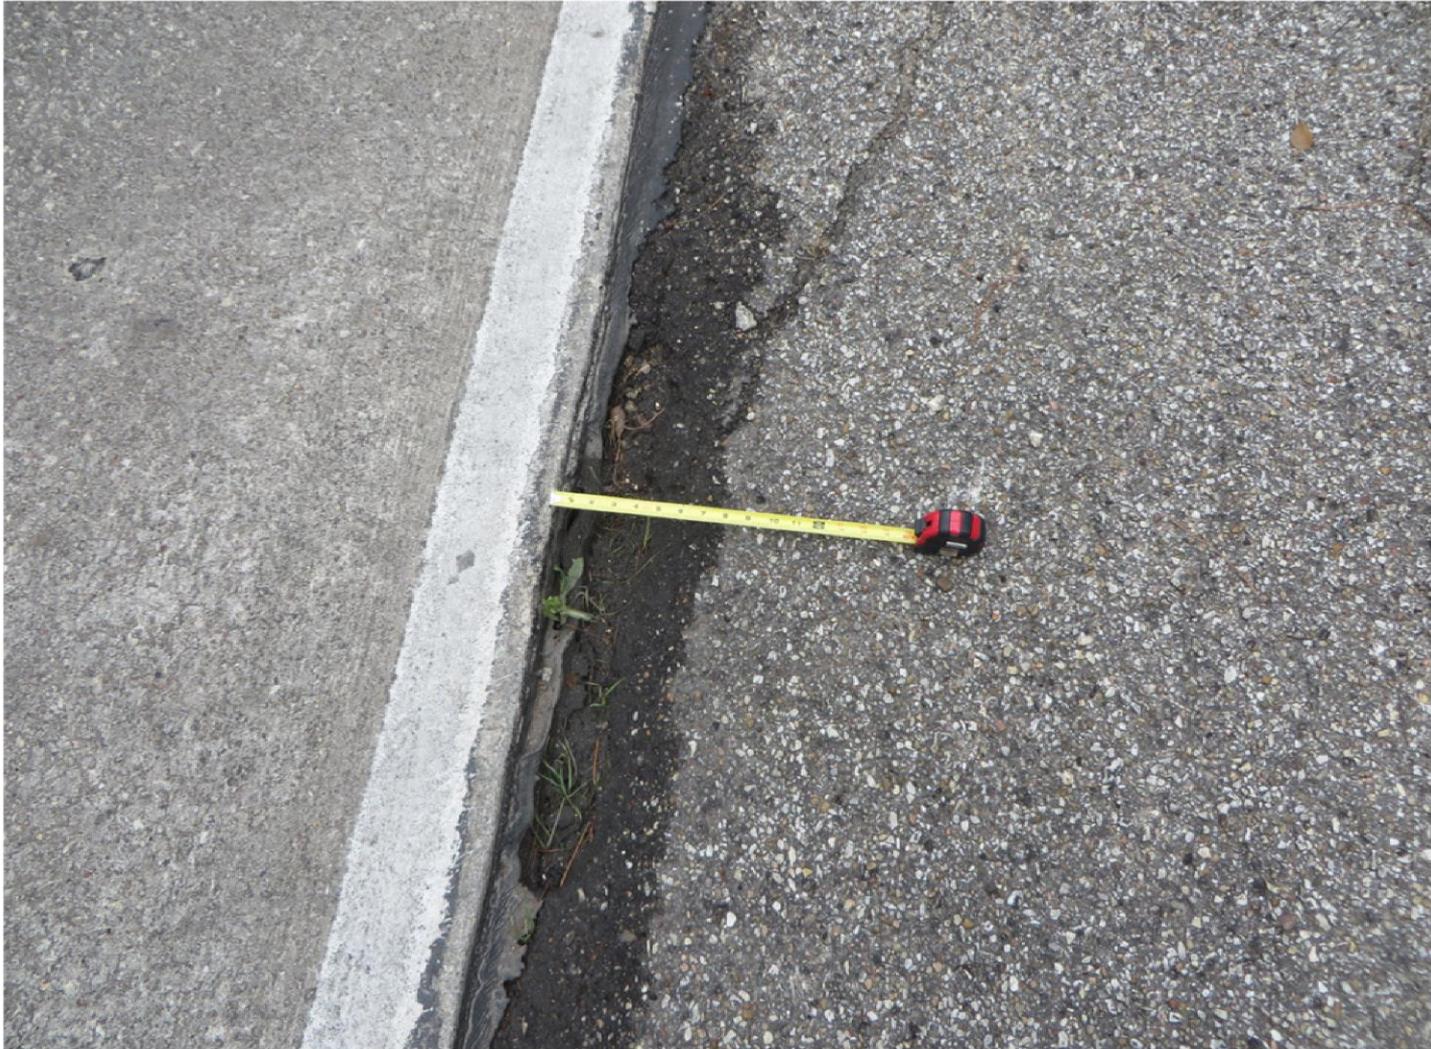
LW-26
Lake Woodlands
Eastbound

Hazard type: Pothole and gap

Severity: 3

In same area as previous slide

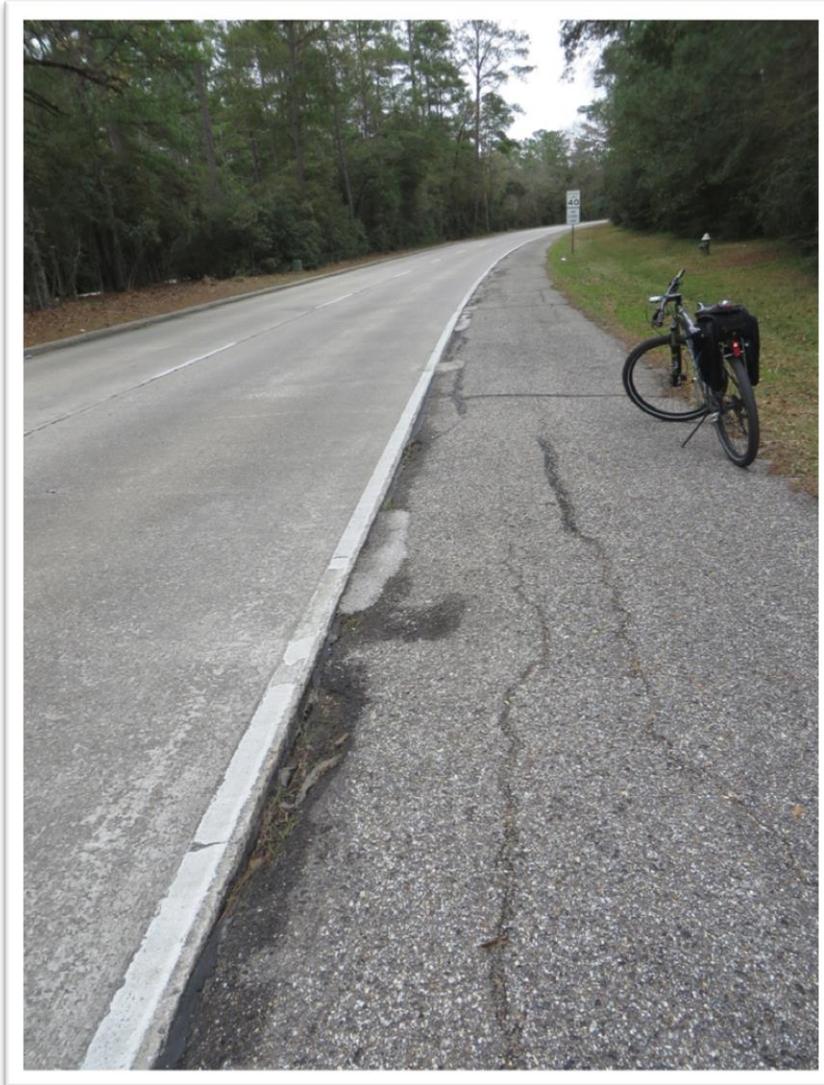
LW-26
Lake Woodlands
Eastbound

Hazard type:
Severity: 3 p

Shot of area LW-26 with numerous lips
and potholes.

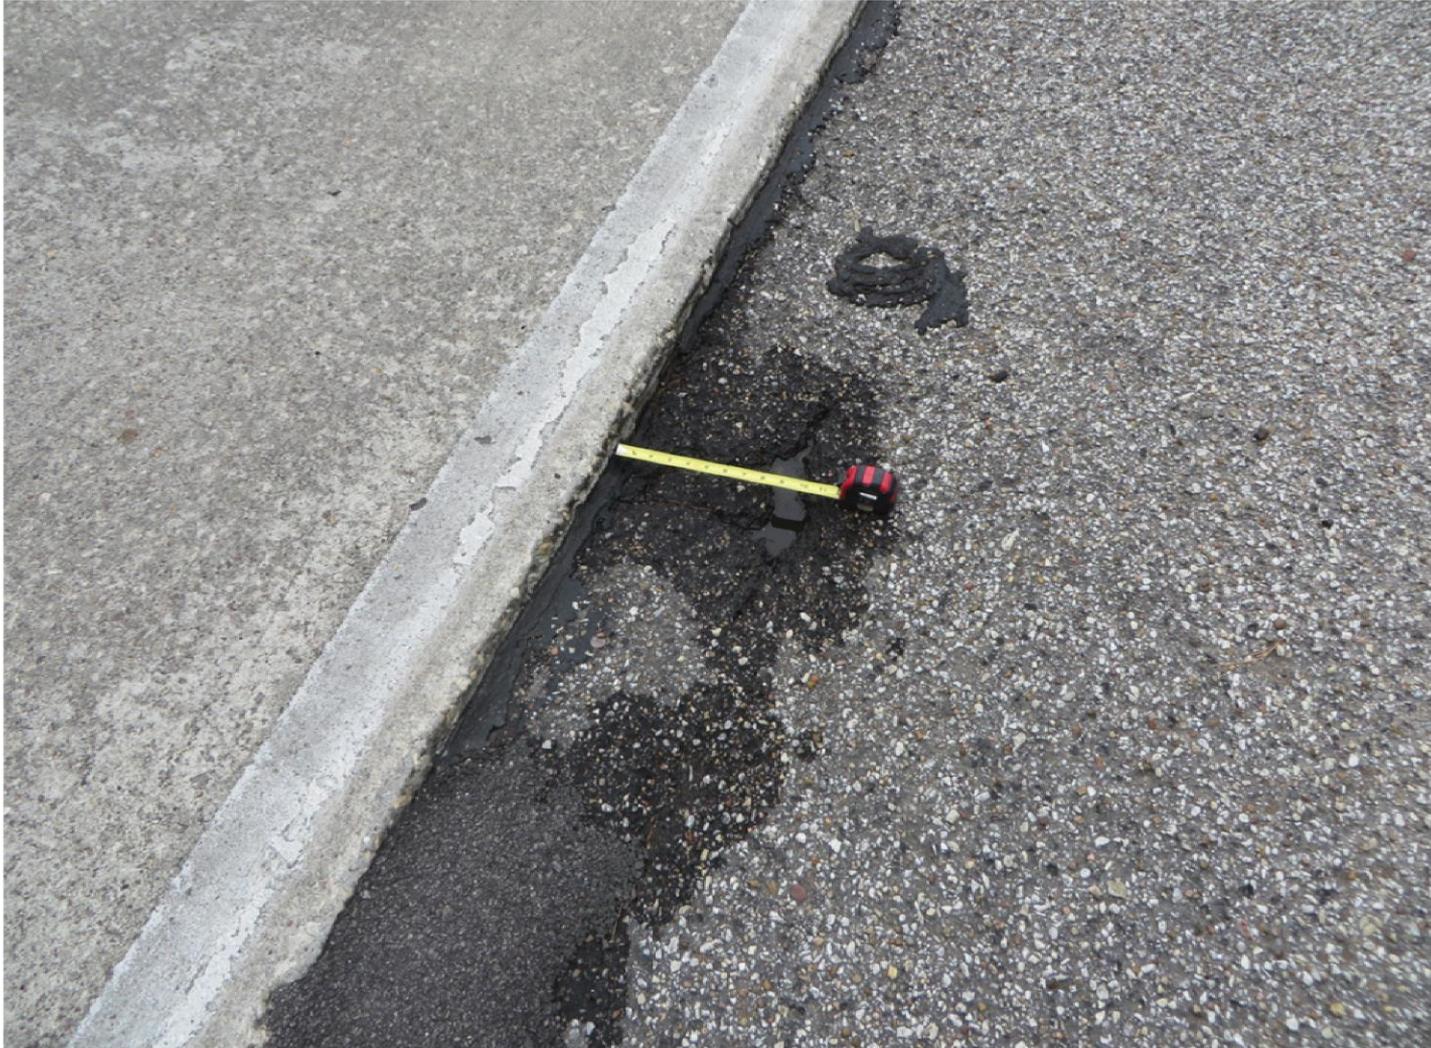
LW-27
Lake Woodlands
Eastbound

Hazard type: Pothole
Severity: 2

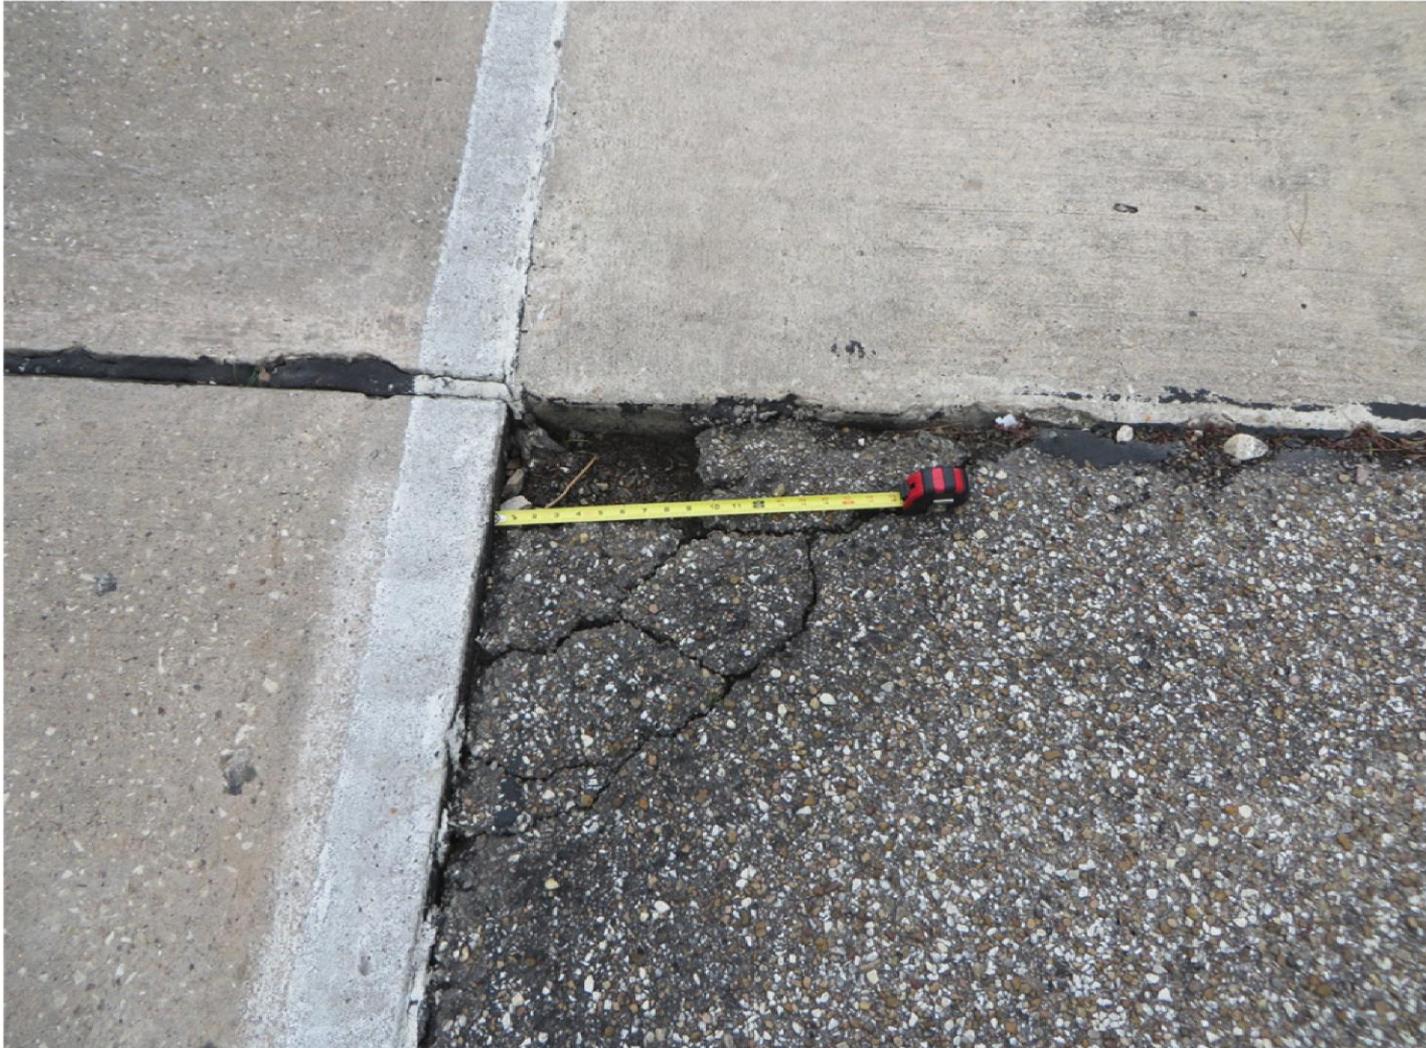
LW-28
Lake Woodlands
Eastbound

Hazard type: Pothole
Severity: 2
