Road Shoulder Hazards in The Woodlands – January 2015

Levels 3 and 4 only

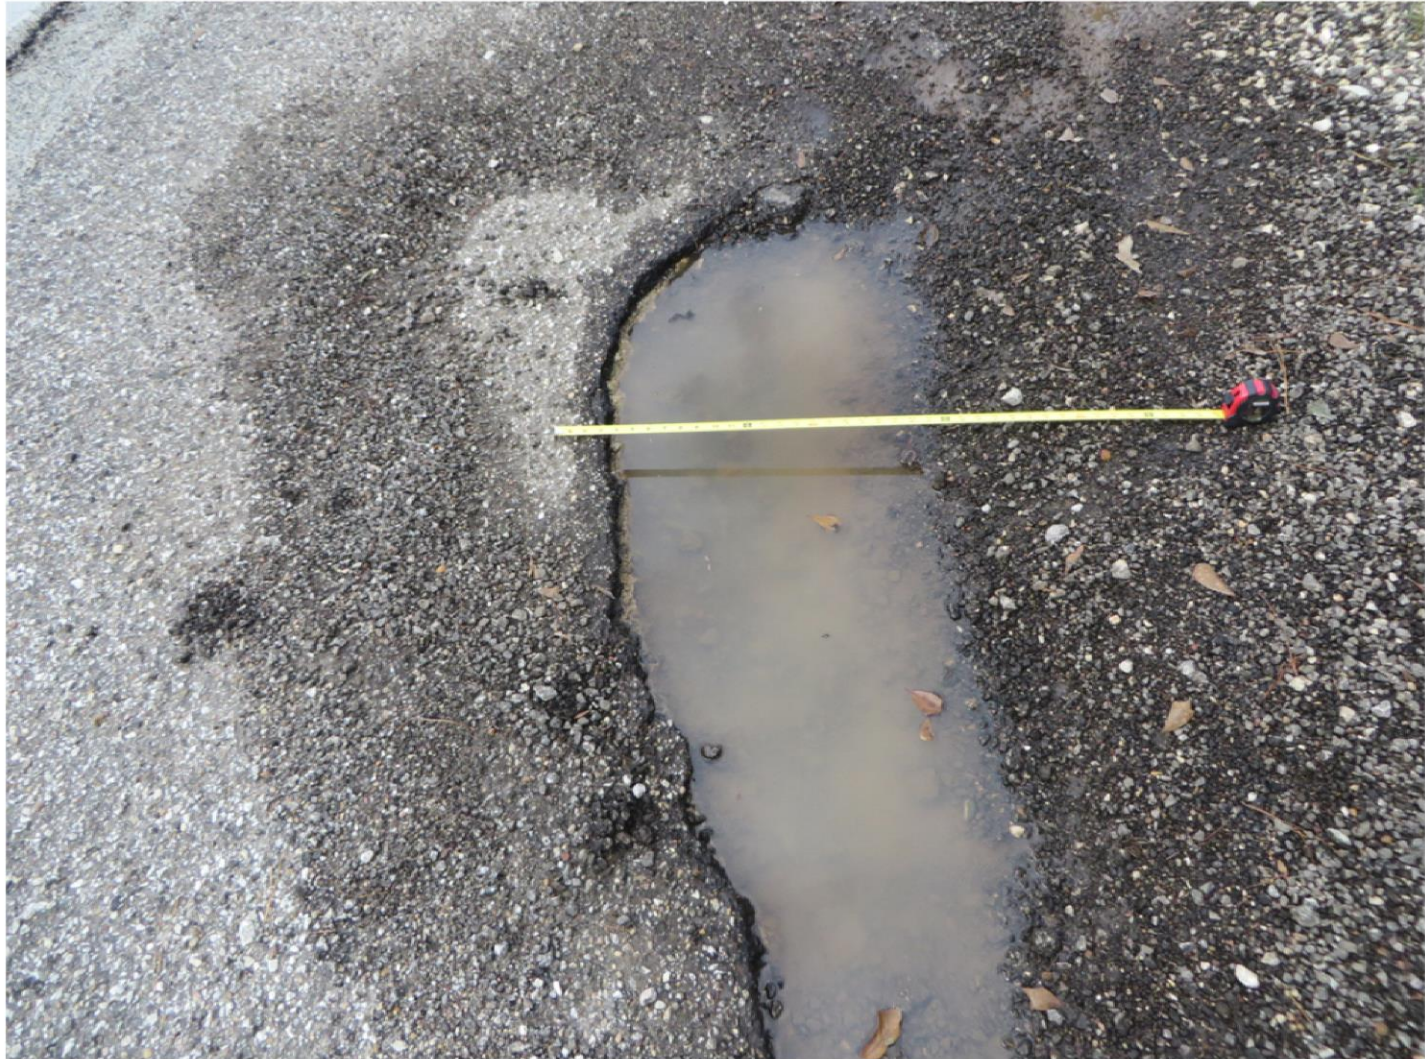
LW-7
Lake Woodlands
Westbound

Hazard type: Pothole
Severity: 4

Serious pothole

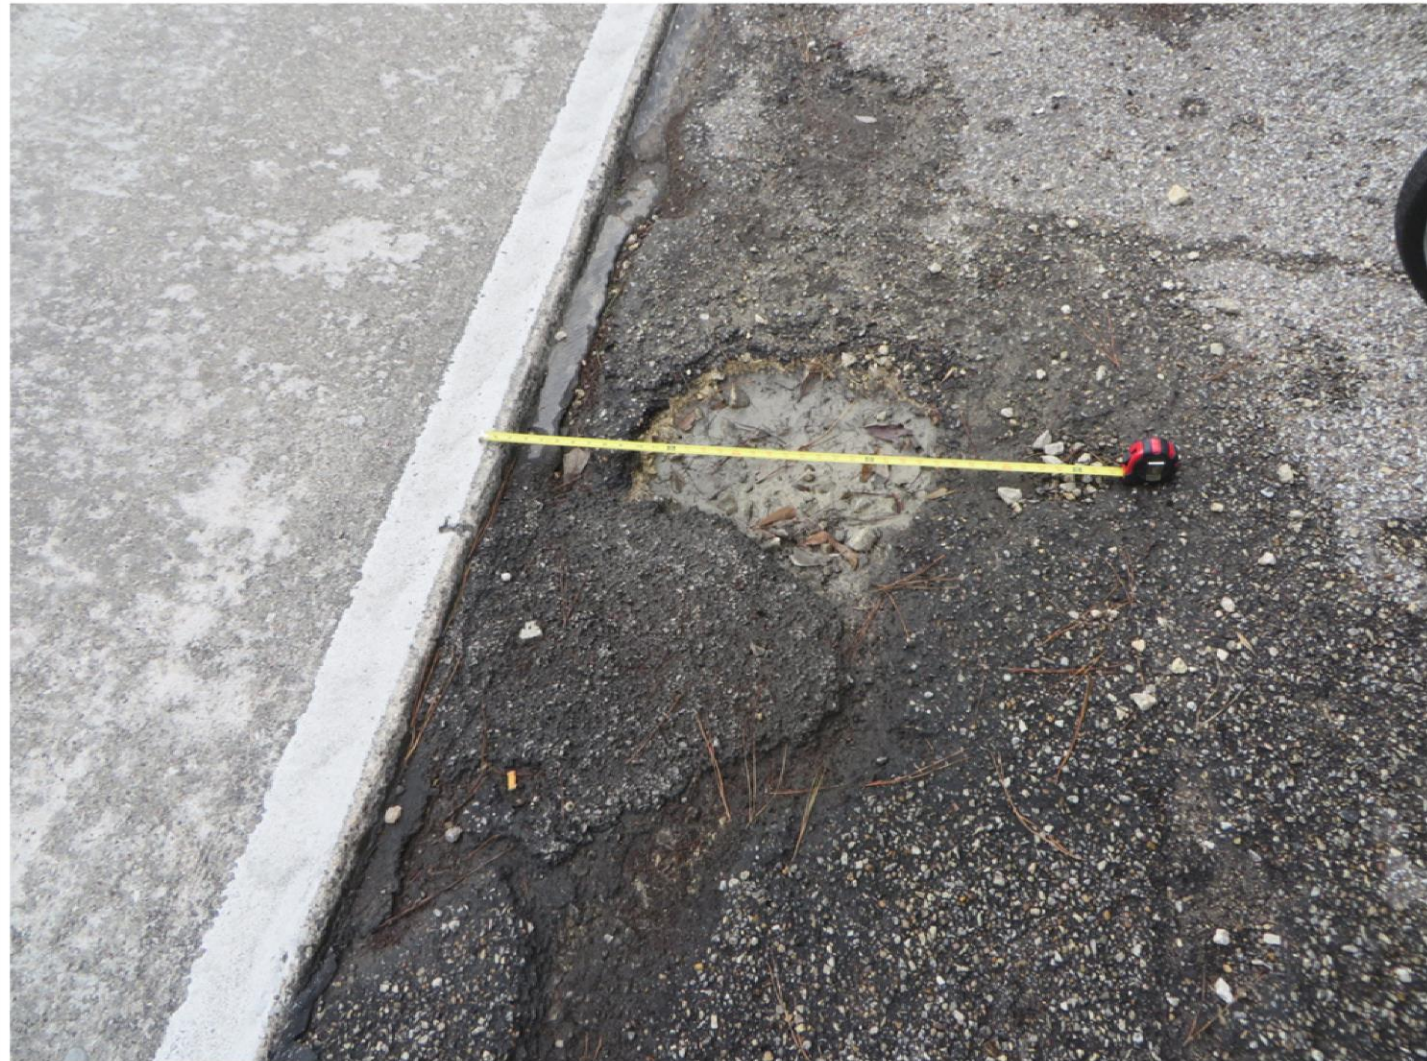
LW-15
Lake Woodlands
Westbound

Hazard type: Rough area and Pothole
Severity: 3

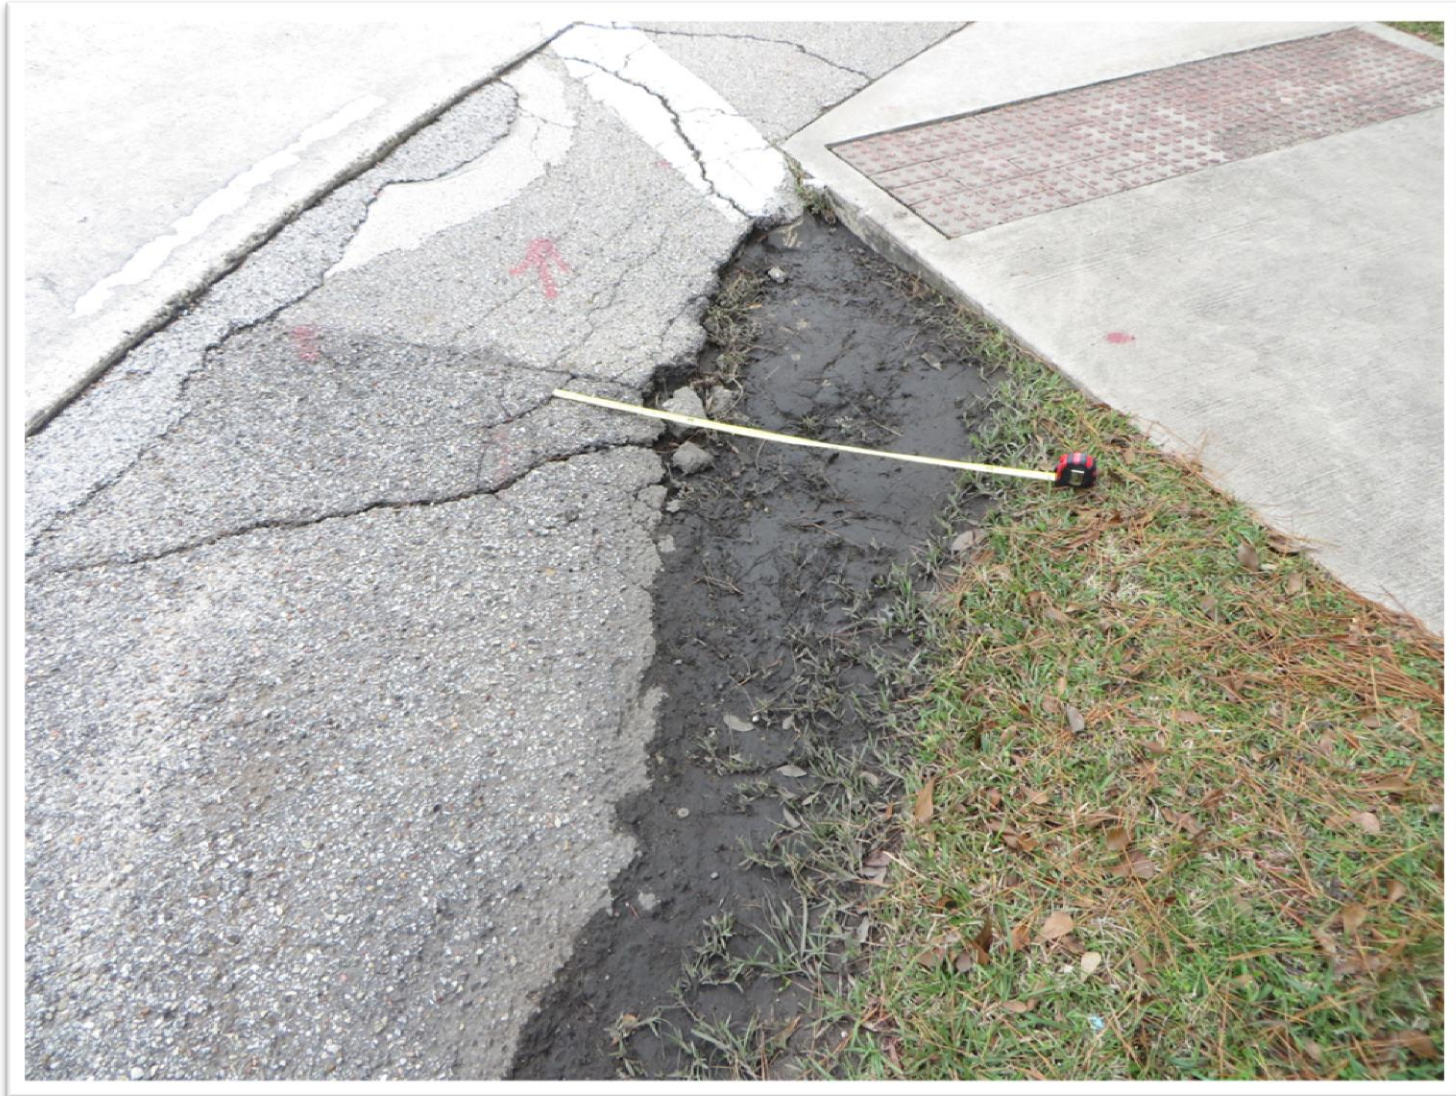
LW-20
Lake Woodlands
Eastbound

Hazard type: Rough area
Severity: 3

Shoulder deterioration
leading to narrower-than-
expected shoulder.

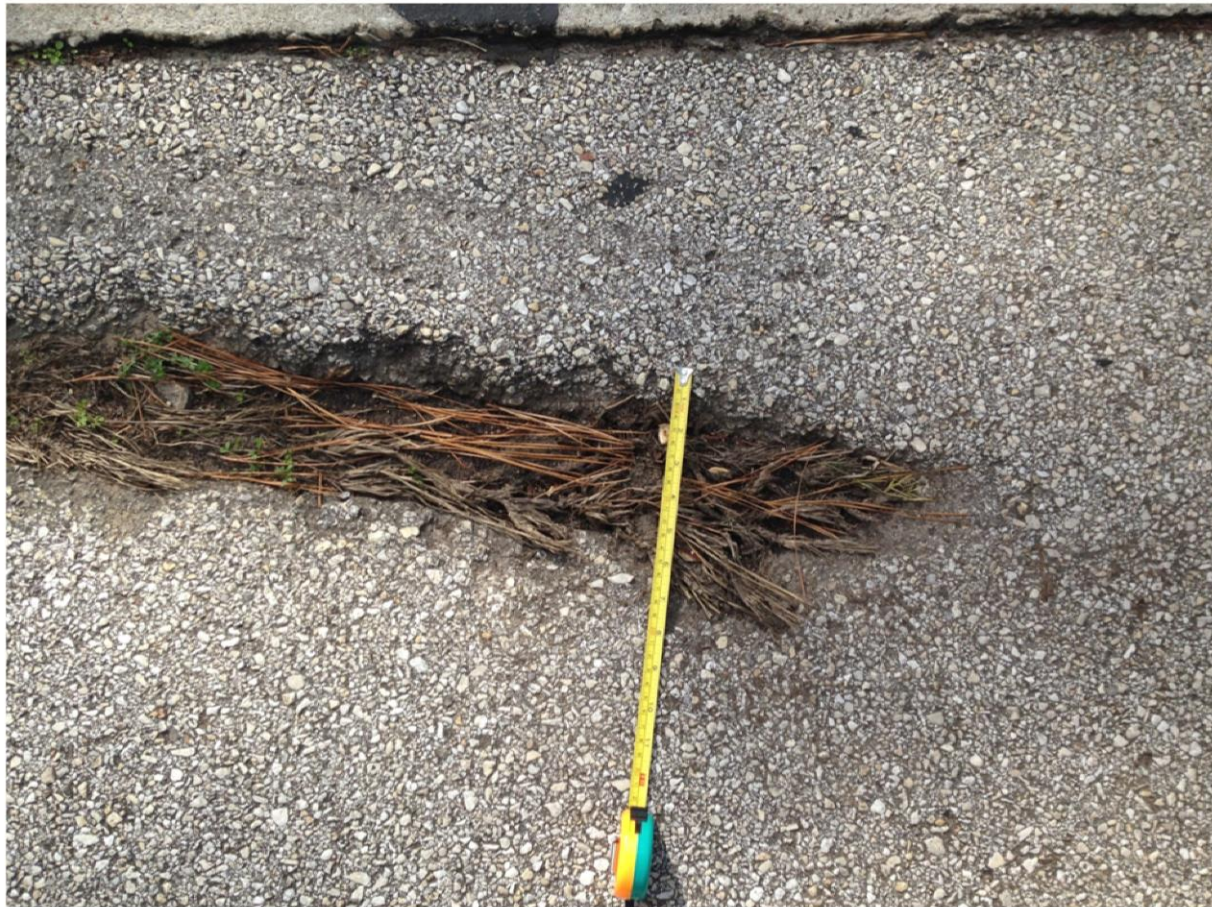
Location WP 6
Woodlands Pkwy
Eastbound

Hazard Type: Pothole
Severity: 2

6" wide gouge in the shoulder over 4 feet long which cyclists tire could get stuck in and cause bike to fall. Unlike Flintridge, Shoulder is wider on this stretch of and cyclists are able to ride to the right of the damaged shoulder comfortably if they see the pot hole in time.

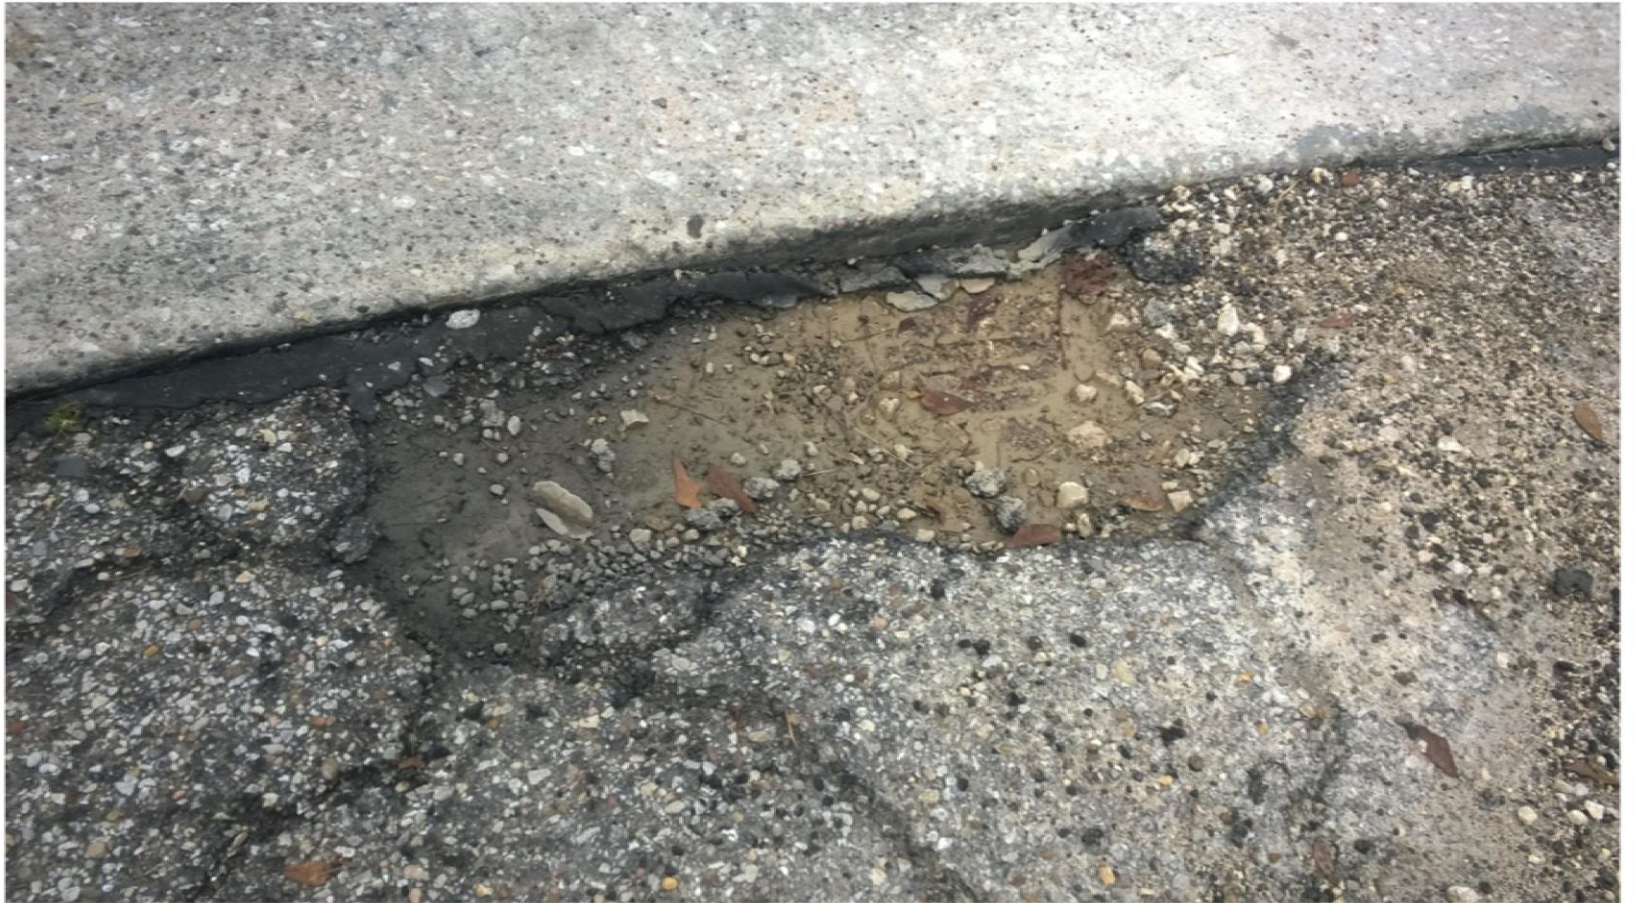
Location Sh-13
Shadowbend
Northbound

Hazard Type: Pothole
Severity: 4

3.5" drop from road surface to shoulder at
intersection with LW Photo 1

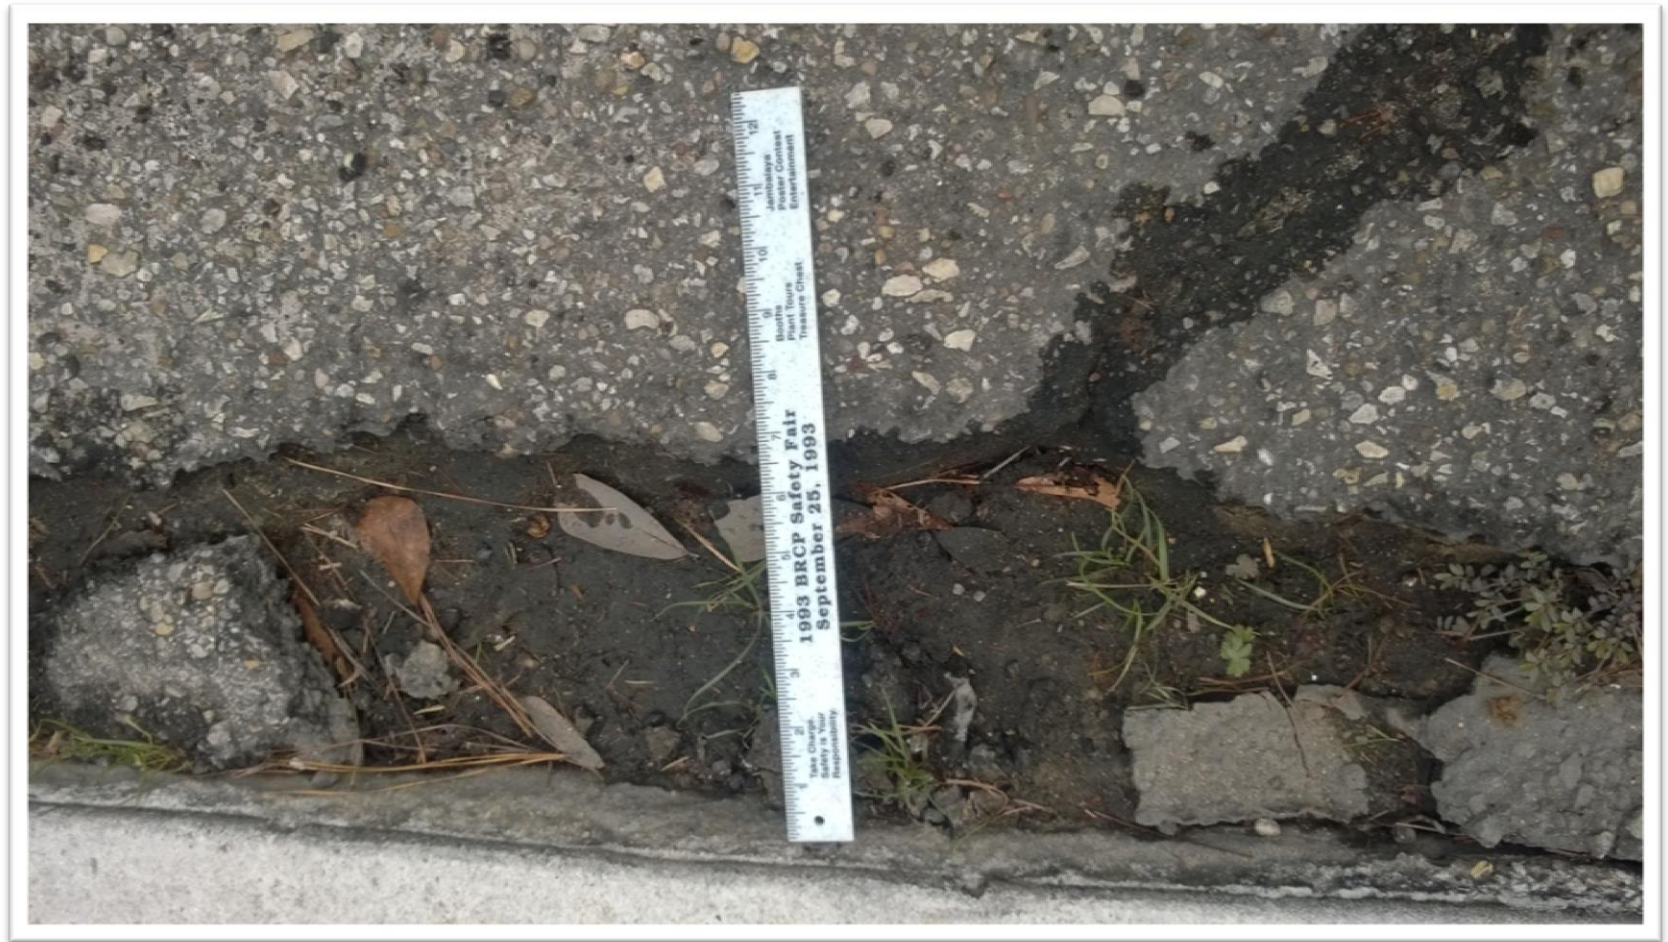
Location Sh-20
Shadowbend
Northbound

Hazard Type: Lip
Severity: 3

Eroded Section from Roadway 1.5" deep-
Photo 1

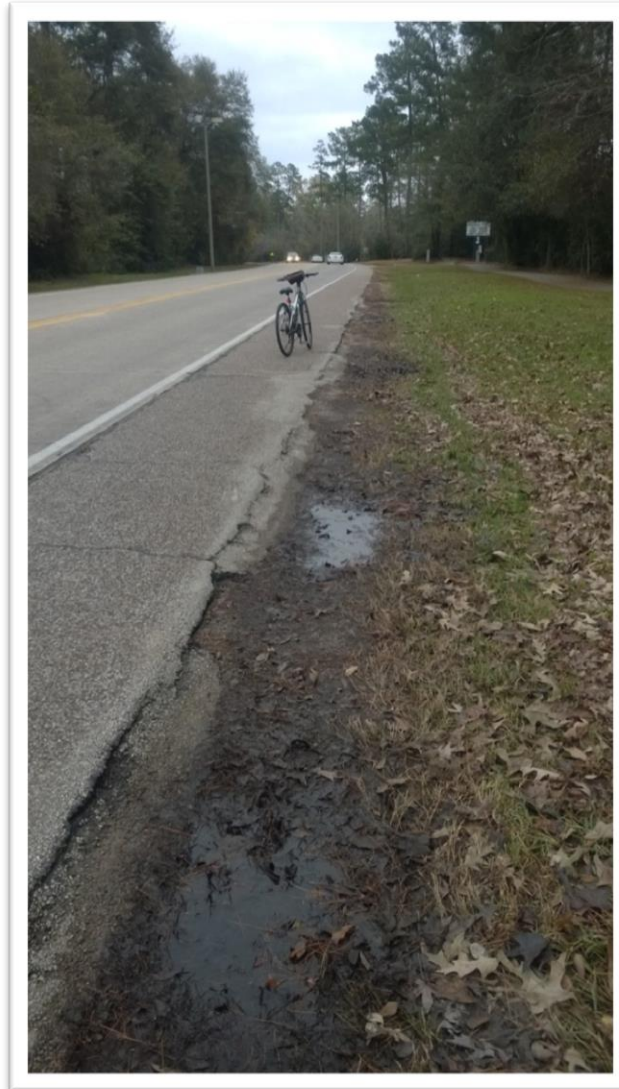
Location Sh-22
Shadowbend
Northbound

Hazard Type: Maint.
Severity: 2

Degraded shoulder edge due to car parking
near Collins Intermediate School

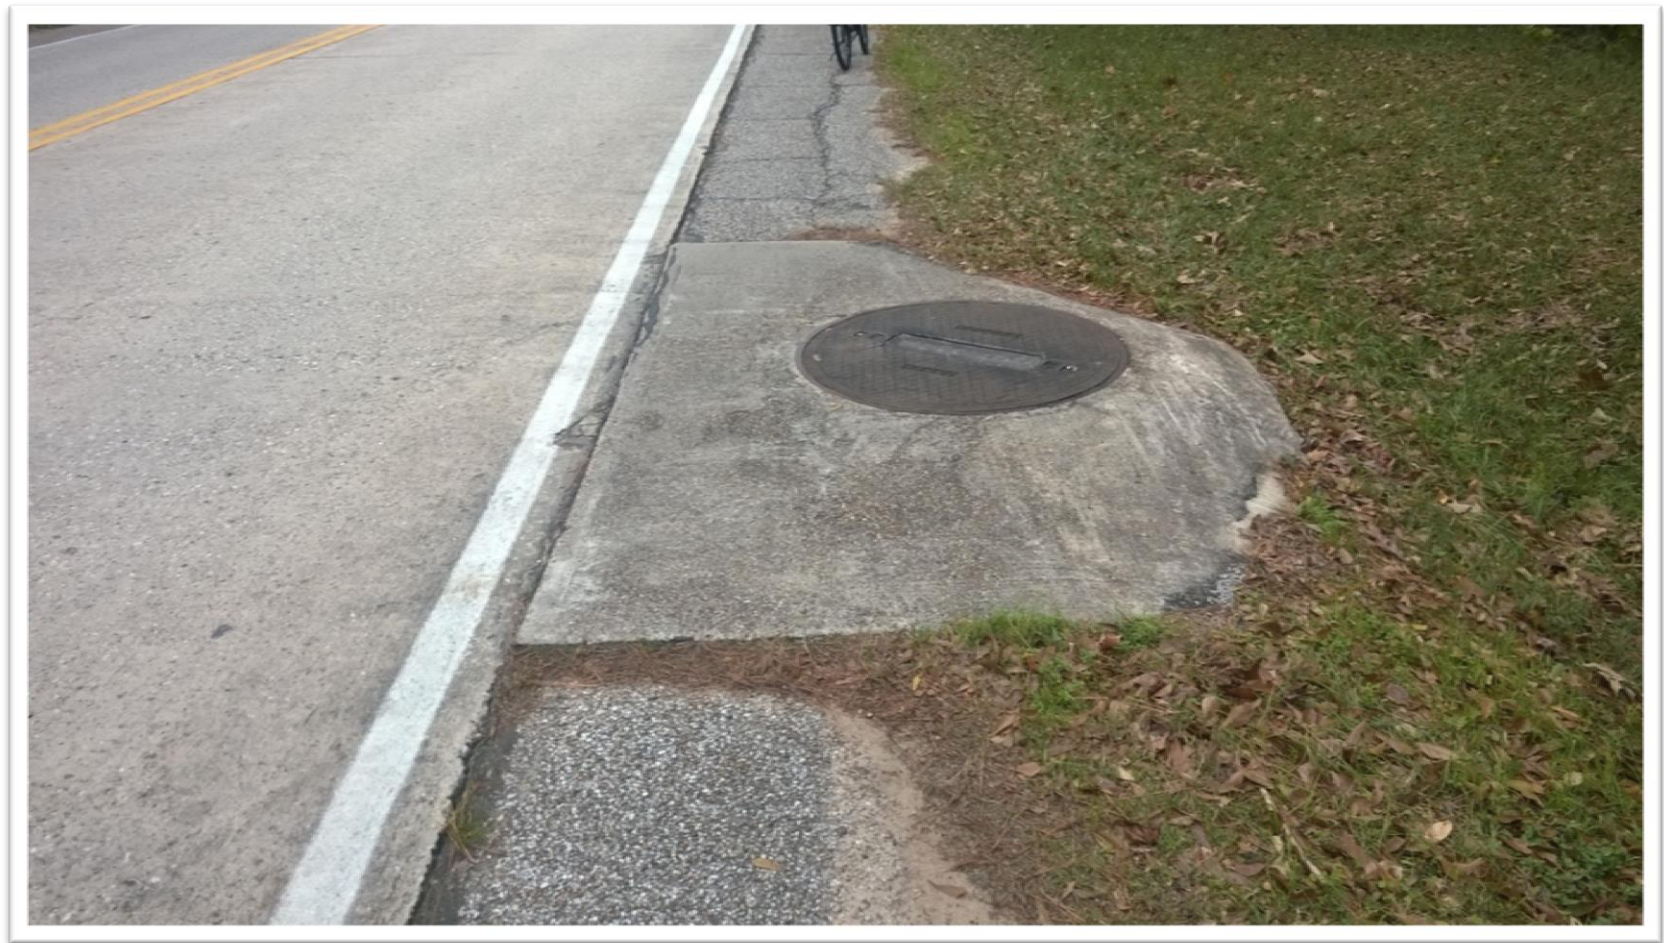
Location Sh-27
Shadowbend
Southbound

Hazard Type: Other
Severity: 2

Sewer Structure 1" above shoulder

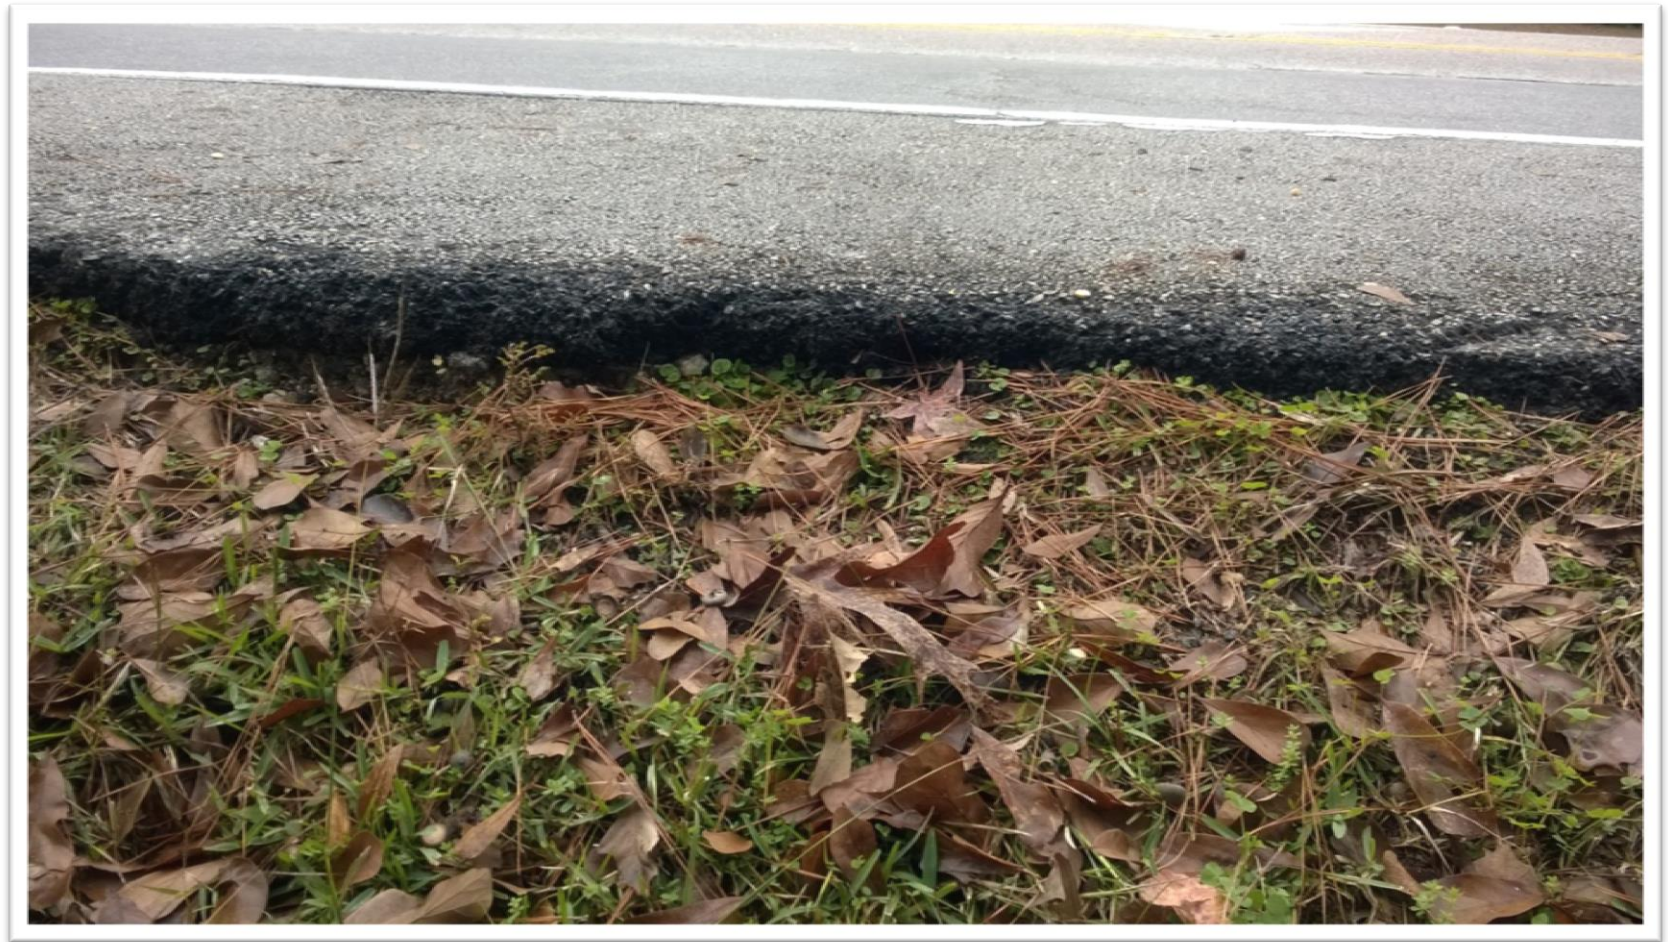
Location Sh-31a
Shadowbend
Southbound

Hazard Type: Other
Severity: 2

Degraded Edge near Intersection with LW

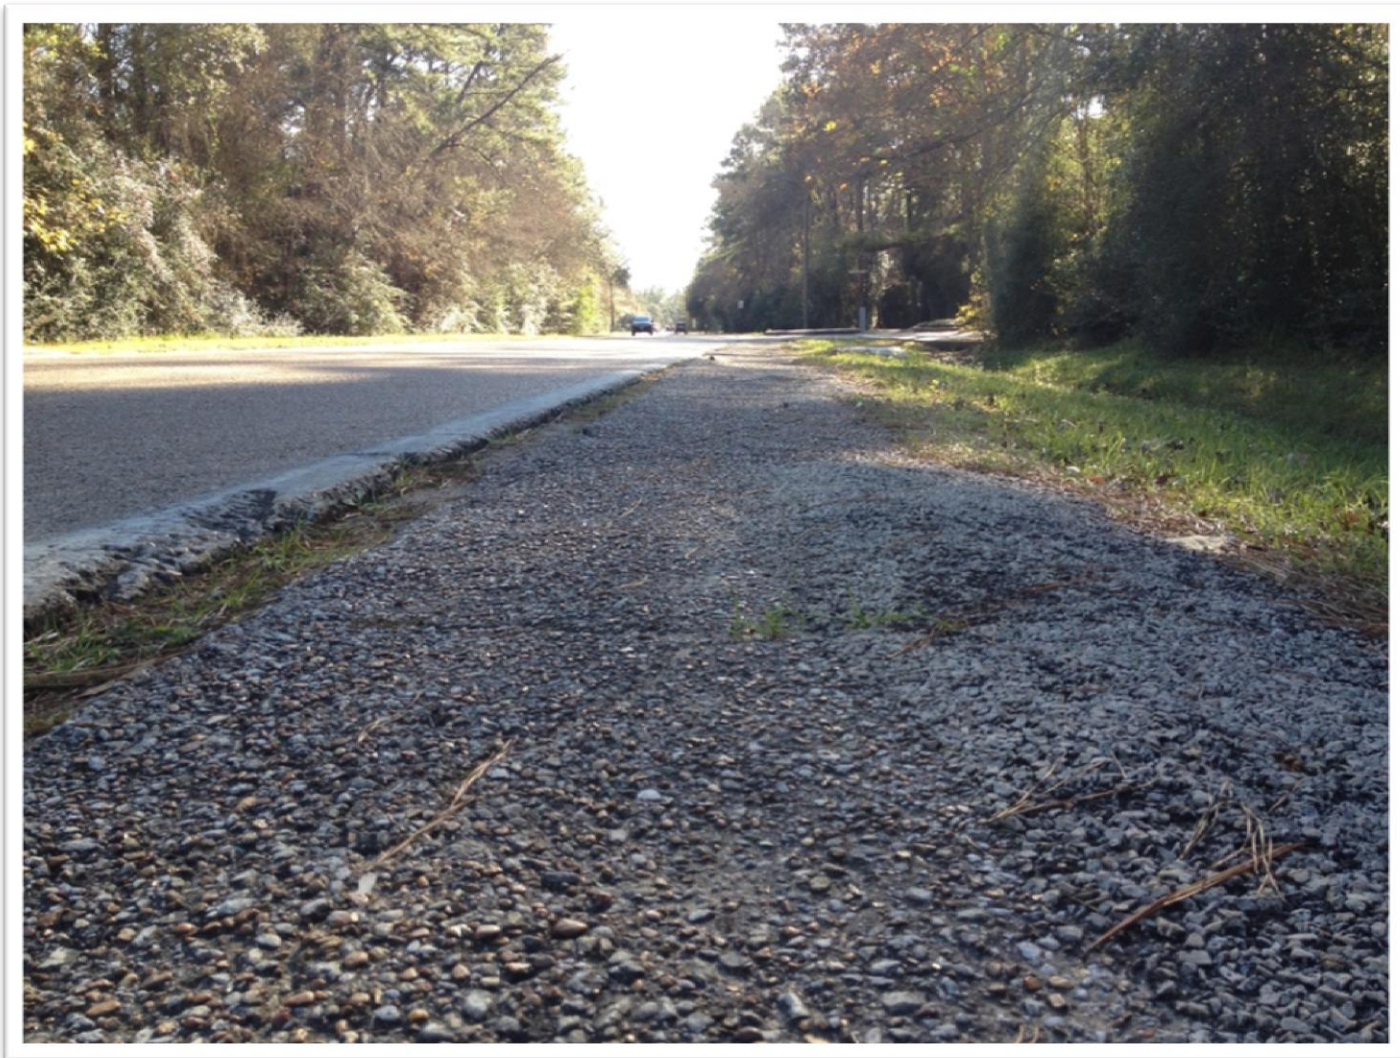
Location WPC-3
West Panther Creek
Southbound

Hazard Type: Rough area; lip
Severity: 4

Poorly repaired shoulder over more than 50
feet coupled with gap and 2 inch lip

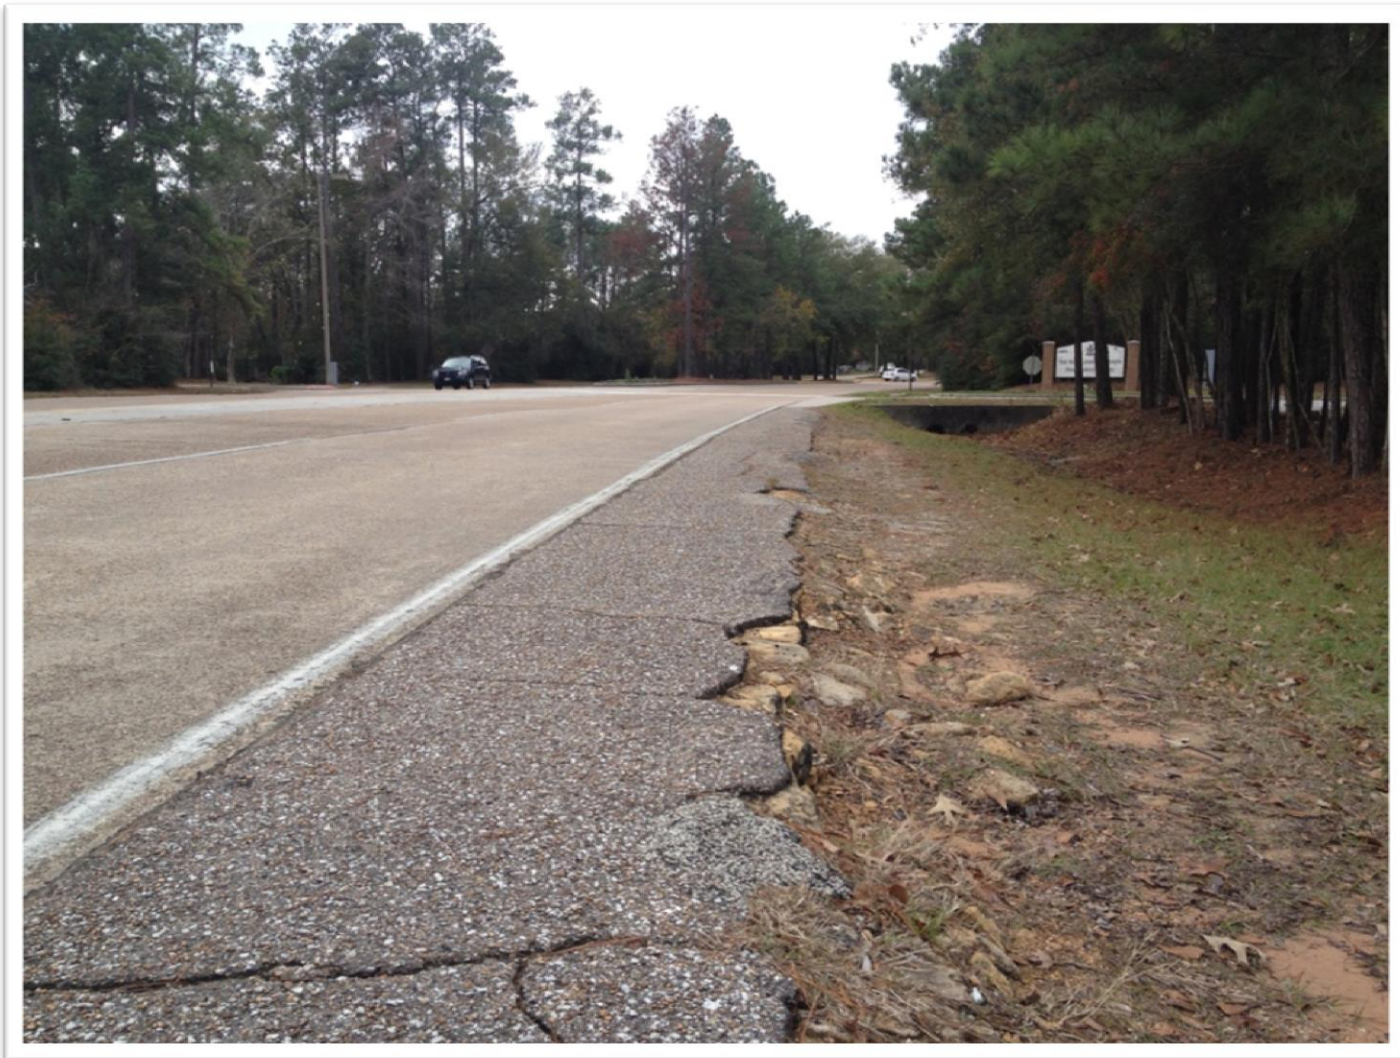
Location WPC-5
West Panther Creek
Southbound

Hazard Type: Rough area
Severity: 3

Crumbled shoulder with exposed large rocks

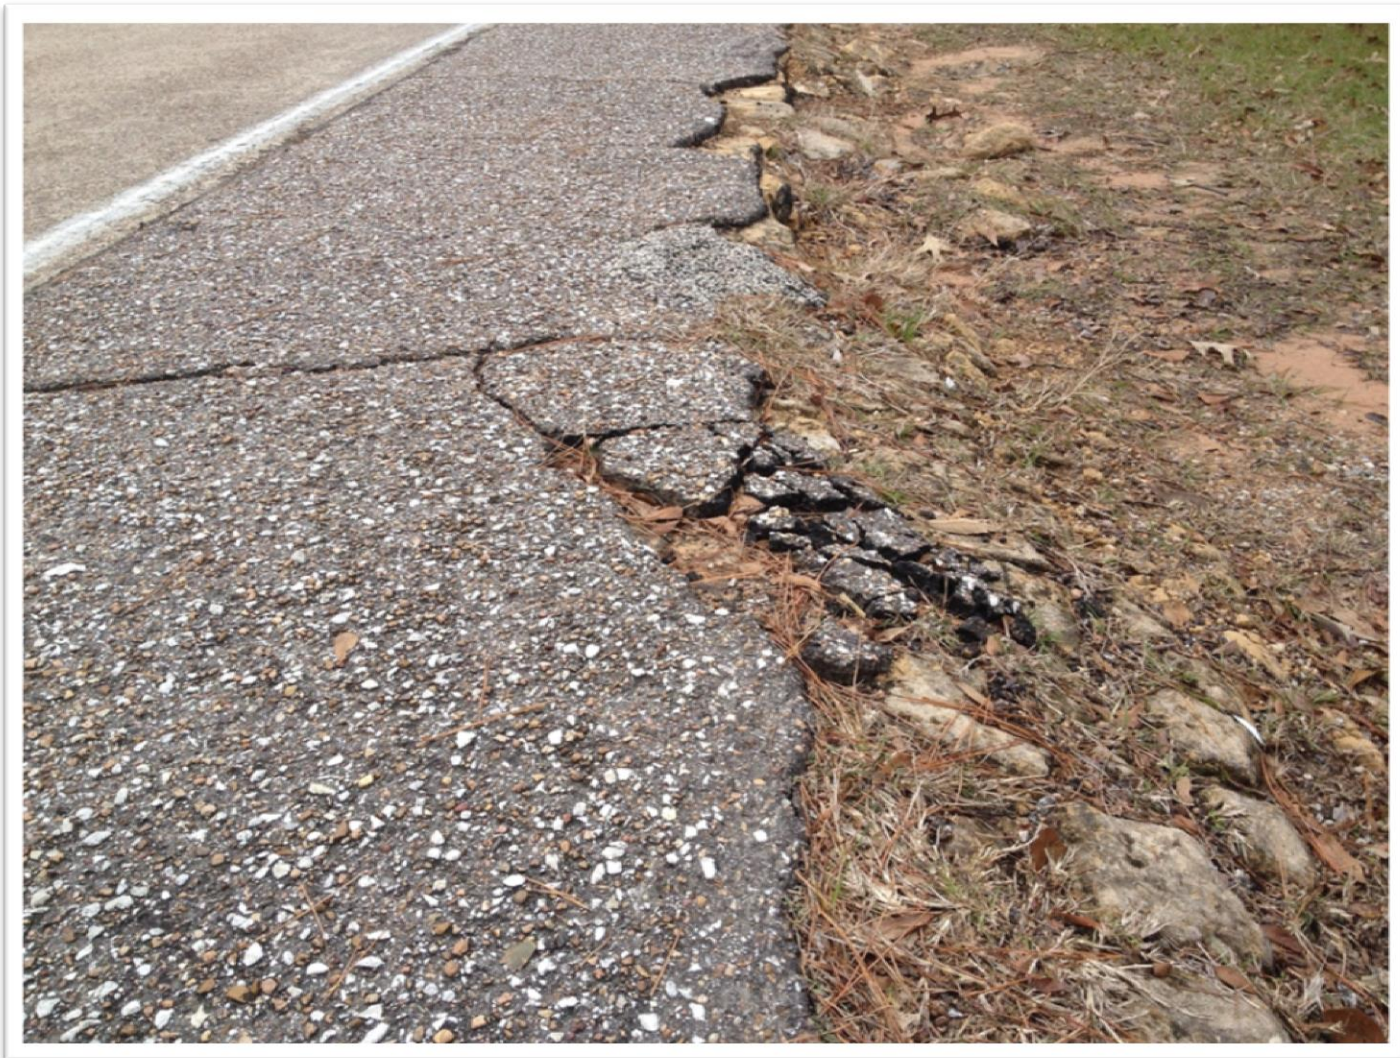
Location WPC-6
West Panther Creek
Southbound

Hazard Type: Rough area
Severity: 3

Close up of IMG3588 shoulder area

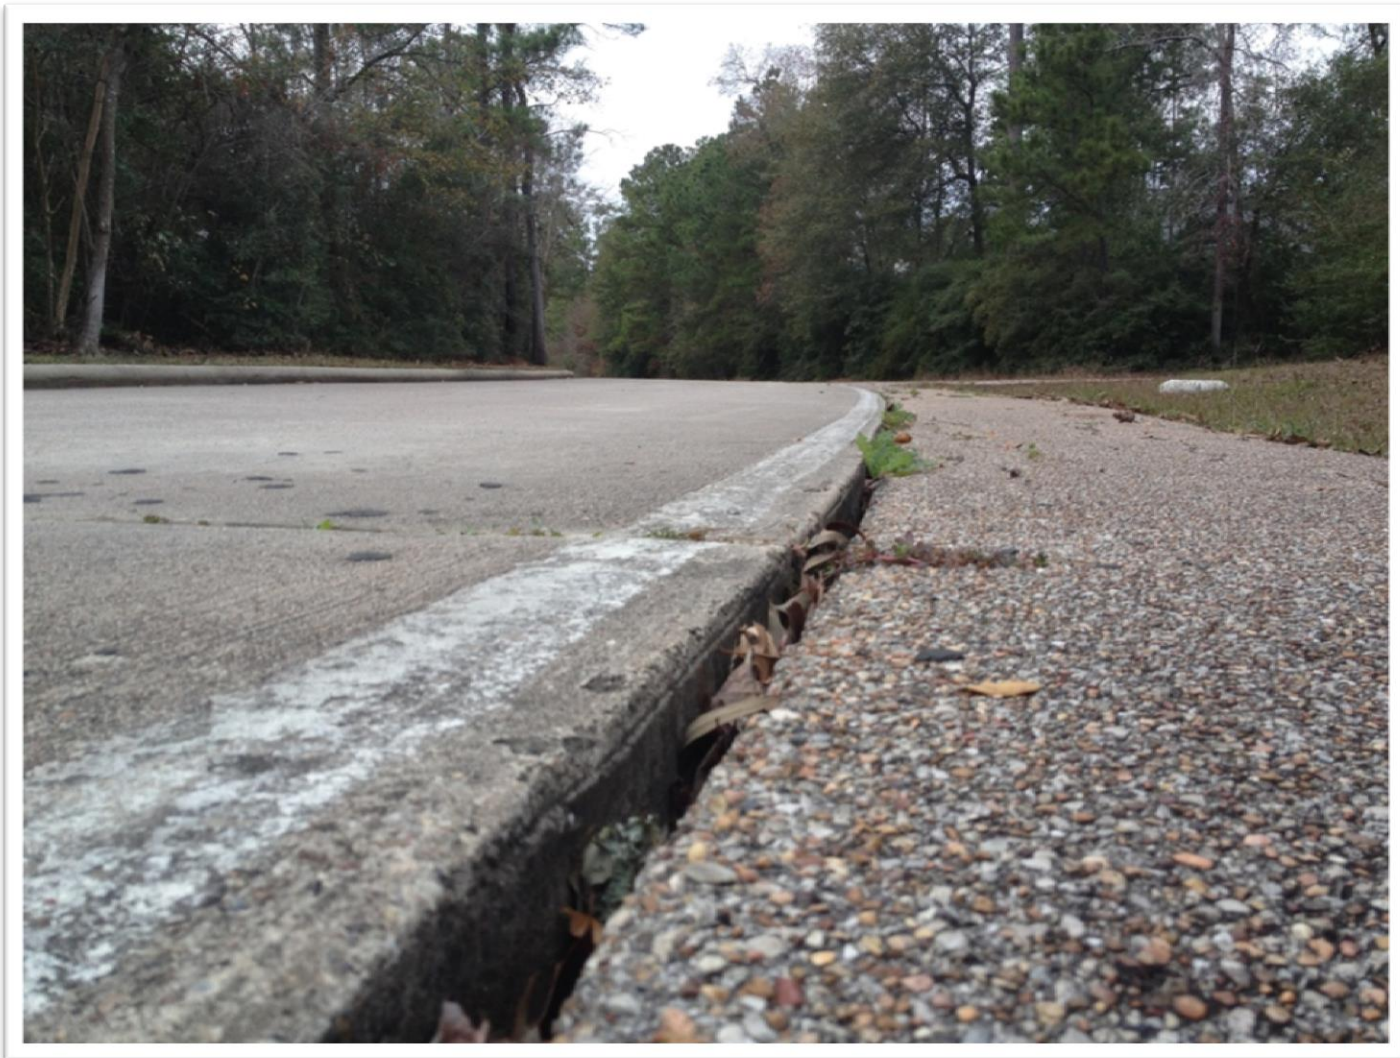
Location NPC-3
North Panther Creek
Northbound

Hazard Type: Gap; Lip
Severity: 4

Large, deep gap 15 to 20 feet in length
