Road Shoulder Hazards along
Woodlands Parkway – January 2015

Hazards on road shoulders, that could pose a risk to cyclists, were identified in January 2015 by volunteers from Bike The Woodlands Coalition.

Woodlands Parkway Hazard Locations – Pathway (not shoulder)

Woodlands Parkway Hazard Locations – Shoulder

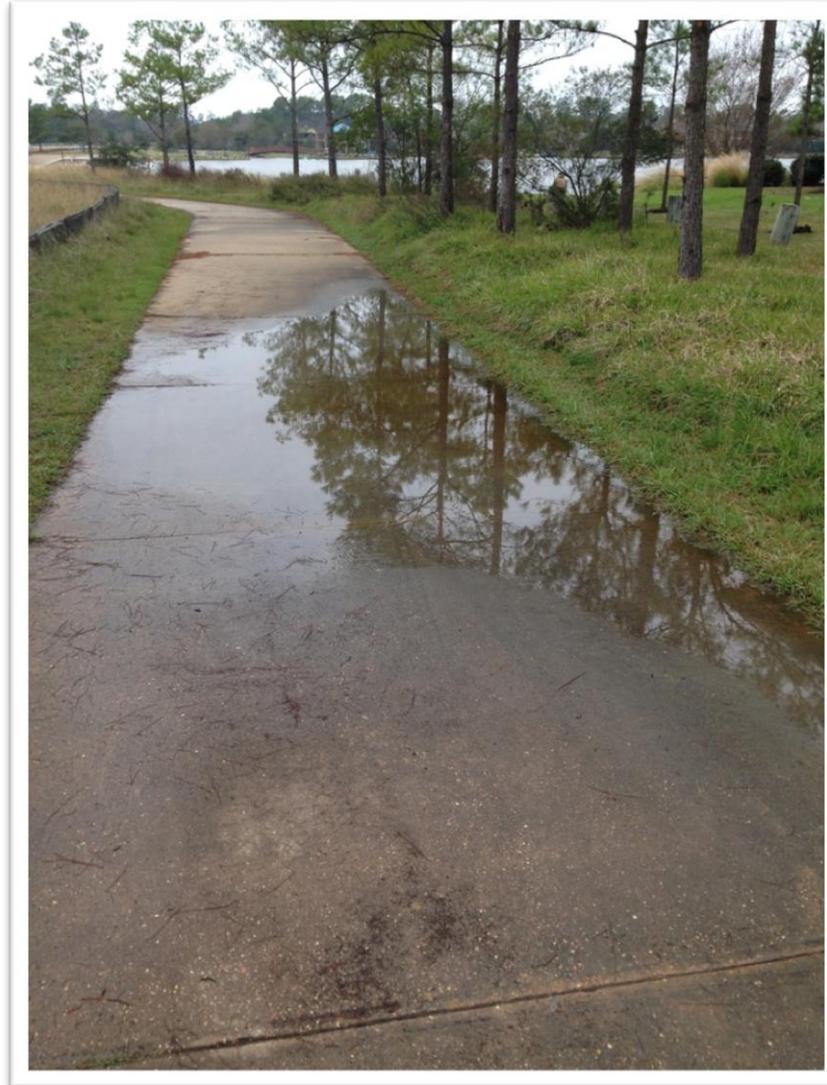
Location WP 1
Woodlands Pkwy
Westbound

Hazard Type: Other
Severity: 2

Westbound pathway before bridge....poor
water drainage causes pathway flooding even
two days after rainfall.

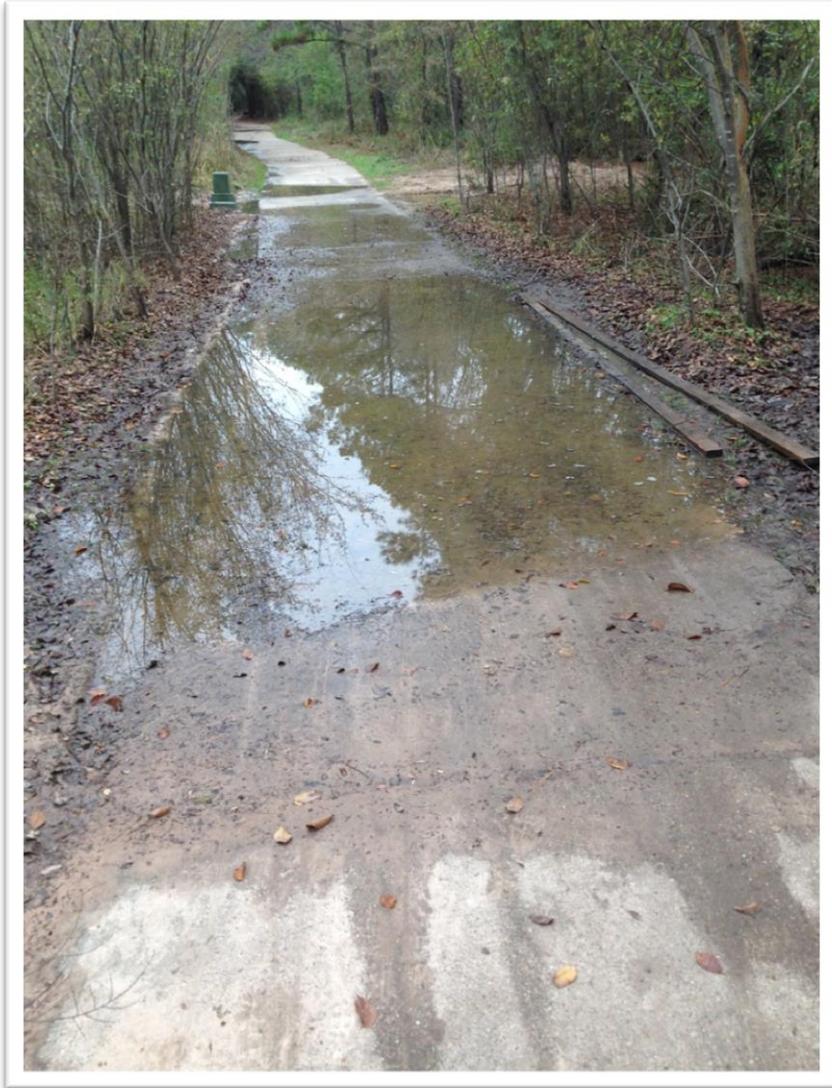
Location WP 2
Woodlands Pkwy
Westbound

Hazard Type: Other
Severity: 4

Westbound pathway after SouthShore Park...poor water drainage causes pathway flooding (photo taken 2 days after rainfall). The water is 3-4 inches deep with no way around the water. Even a week after the rainfall, the water remains on the pathway. Mud pools on the bottom and this section can be very dangerous for cyclists since it is both deep and slick with mud/water/wet leaves which can cause small bike tires to skid and accidents to occur.

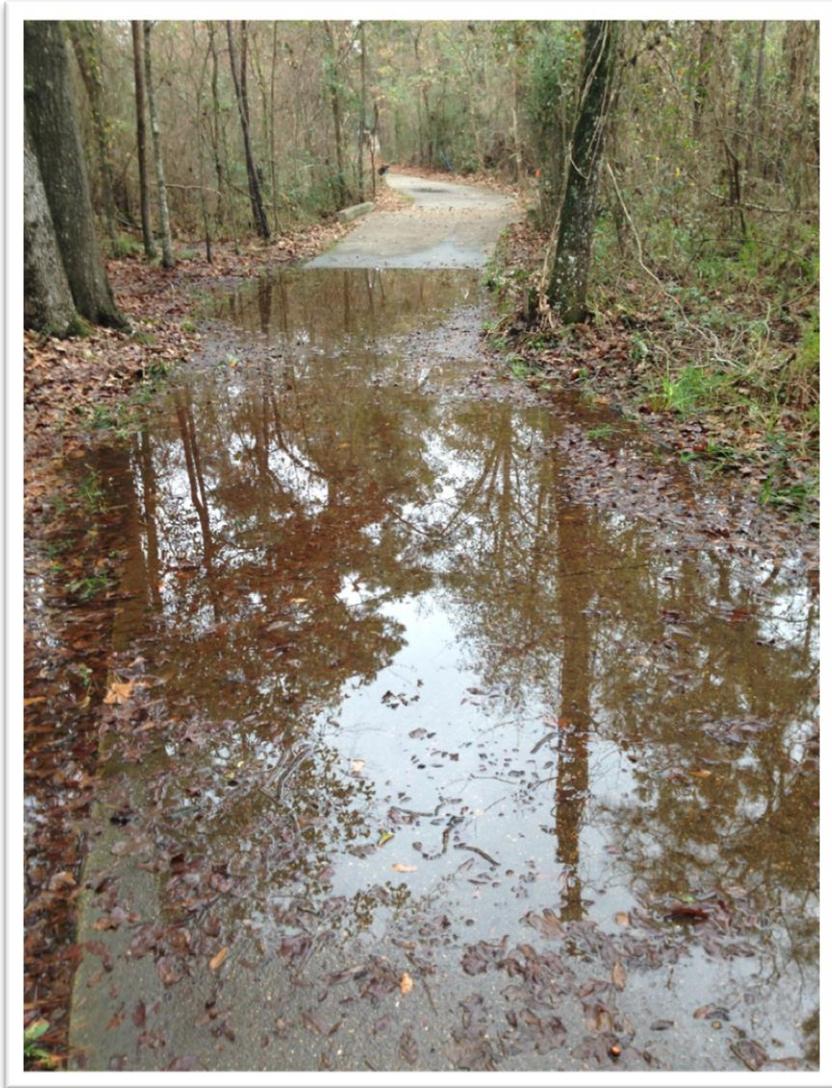
Location WP 3
Woodlands Pkwy
Westbound

Hazard Type: Other
Severity: 3

Westbound pathway after SouthShore Park...poor water drainage causes pathway flooding (photo taken 2 days after rainfall). The water is not as deep as previous pathway hazard, but this stretch is longer and accumulates mud/wet leaves causing slick conditions for cyclists. There is no way to go around pooled water as it covers the width of the path. This area dries up after about 4-5 days after heavy rainfall.

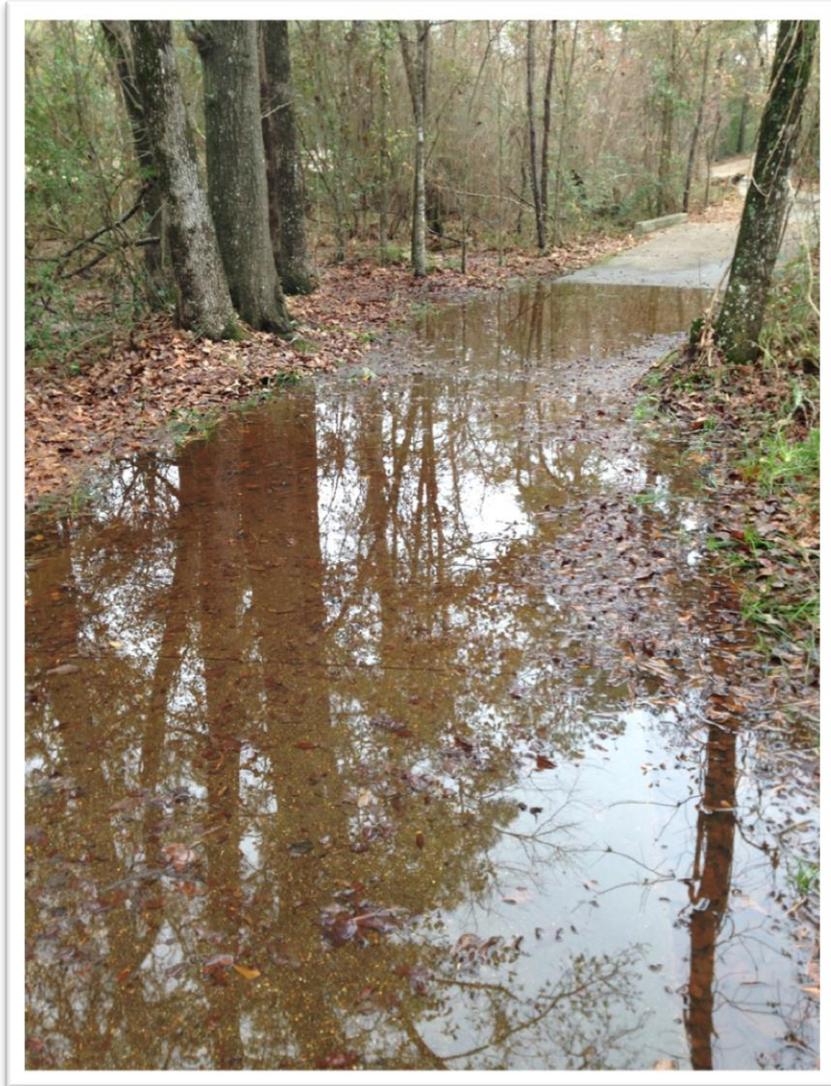
Location WP 4
Woodlands Pkwy
Westbound

The next slide is illustrates the same problem in a nearby location.

Hazard Type: Other
Severity: 3

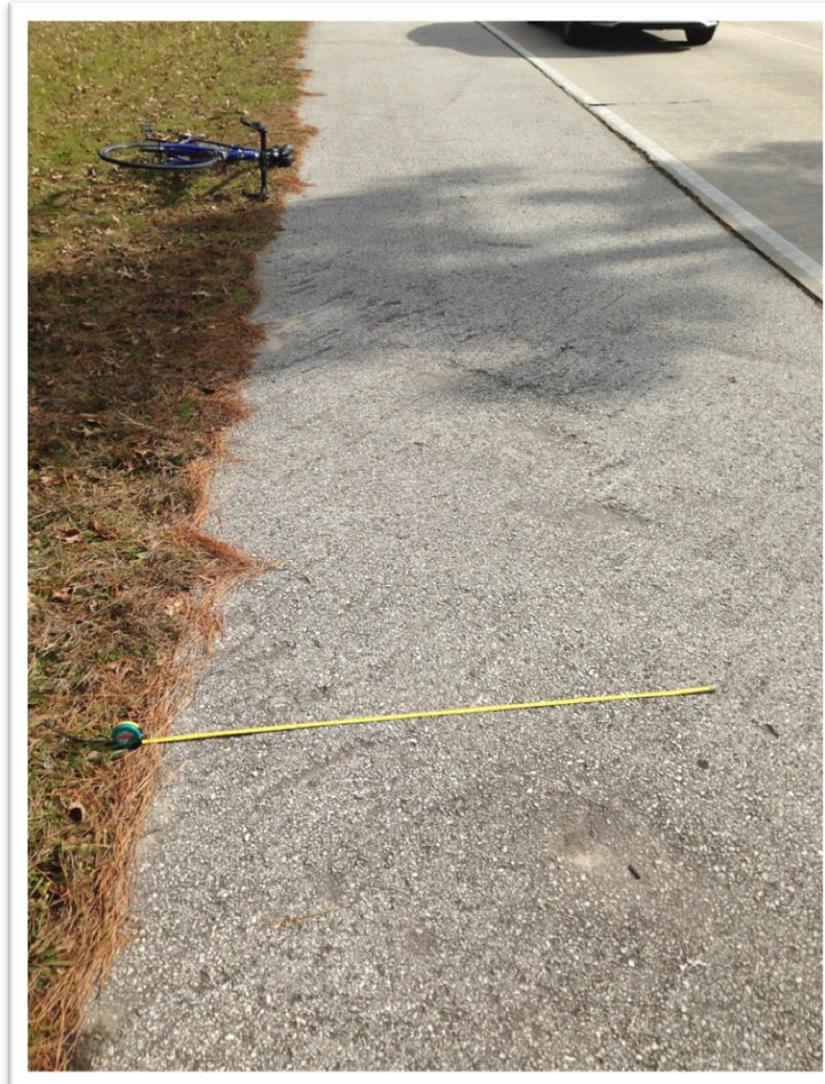
Location WP 5
Woodlands Pkwy
Eastbound

Hazard Type: Maintenance item
Severity: 2

rough road with pot marks embedded in asphalt which causes indentations on the shoulder and rough pavement.

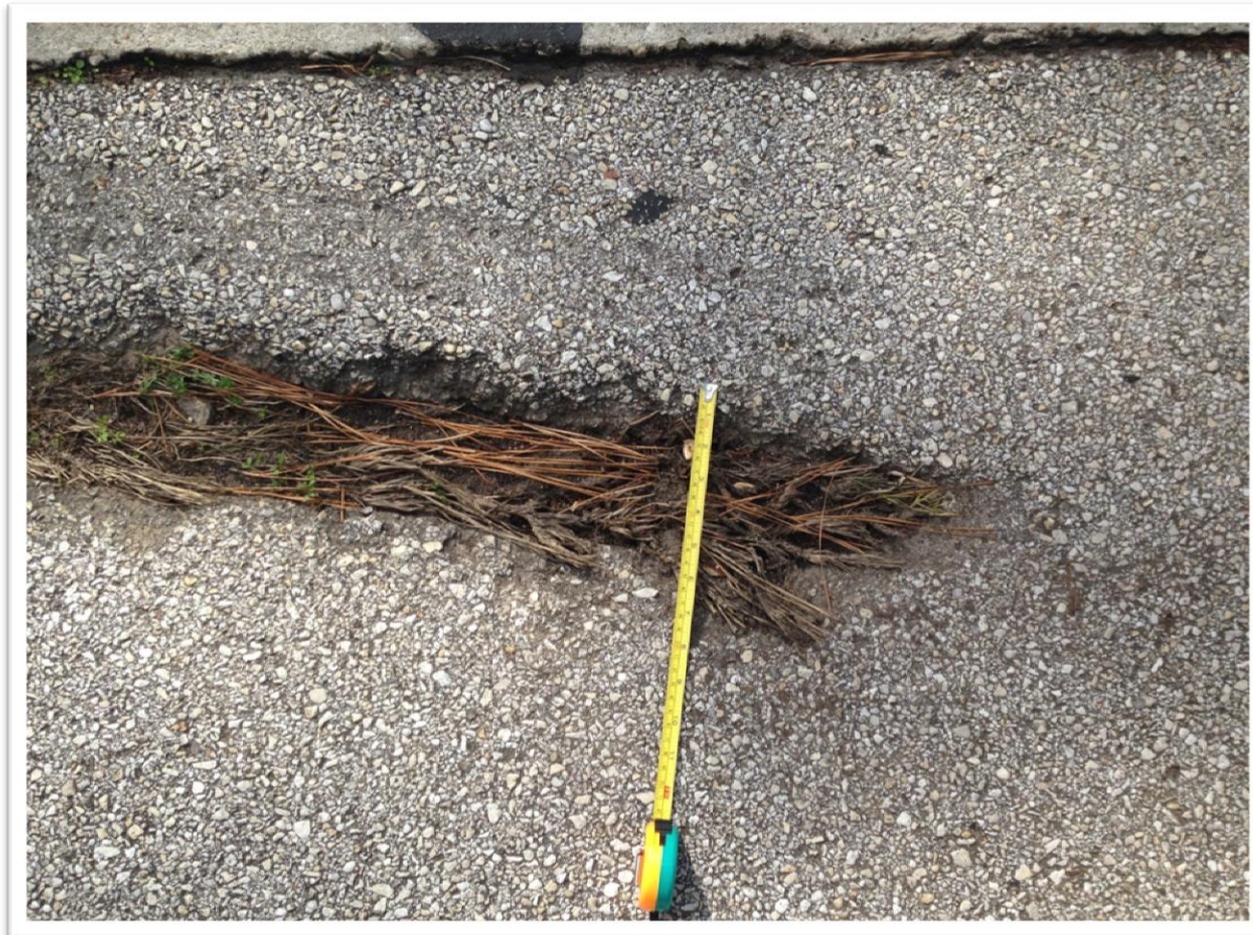
Location WP 6
Woodlands Pkwy
Eastbound

Hazard Type: Pothole
Severity: 2

6" wide gouge in the shoulder over 4 feet long which cyclists tire could get stuck in and cause bike to fall. Unlike Flintridge, Shoulder is wider on this stretch of and cyclists are able to ride to the right of the damaged shoulder comfortably if they see the pot hole in time.

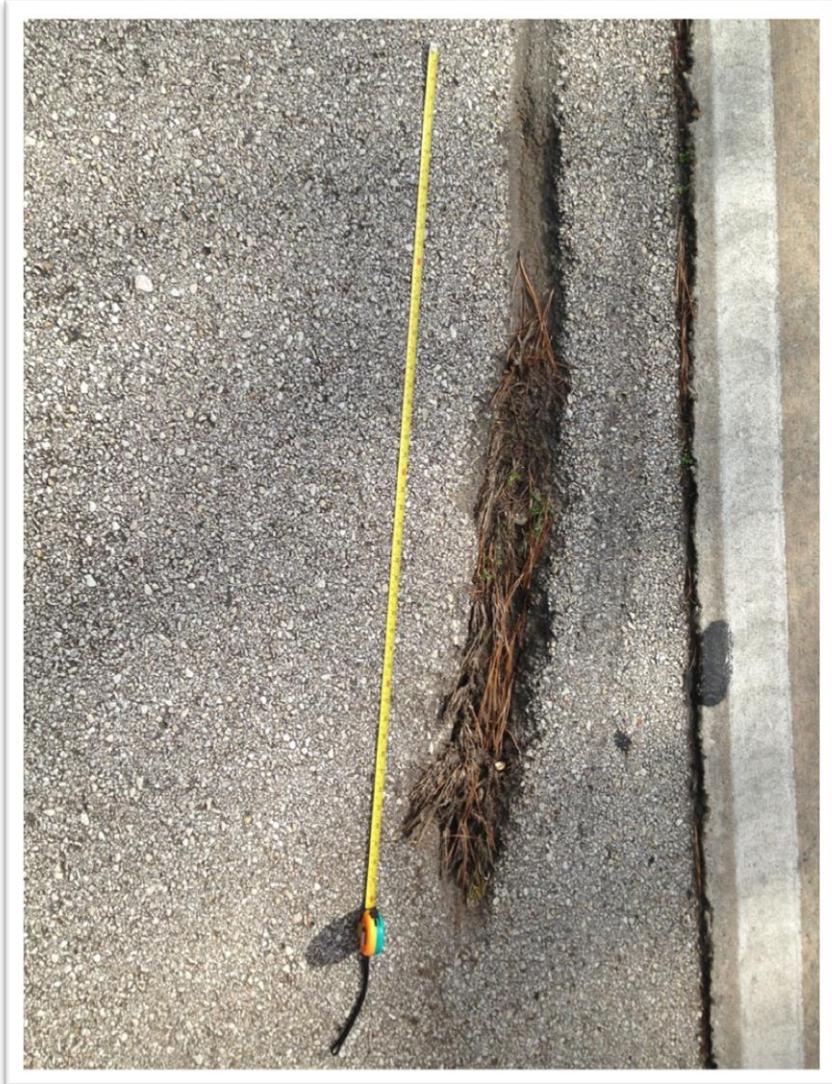
Location WP 7
Woodlands Pkwy
Eastbound

Hazard Type: Pothole
Severity: 2

6" wide gouge in the shoulder over 4 feet
long. Same comments as location WP 6.

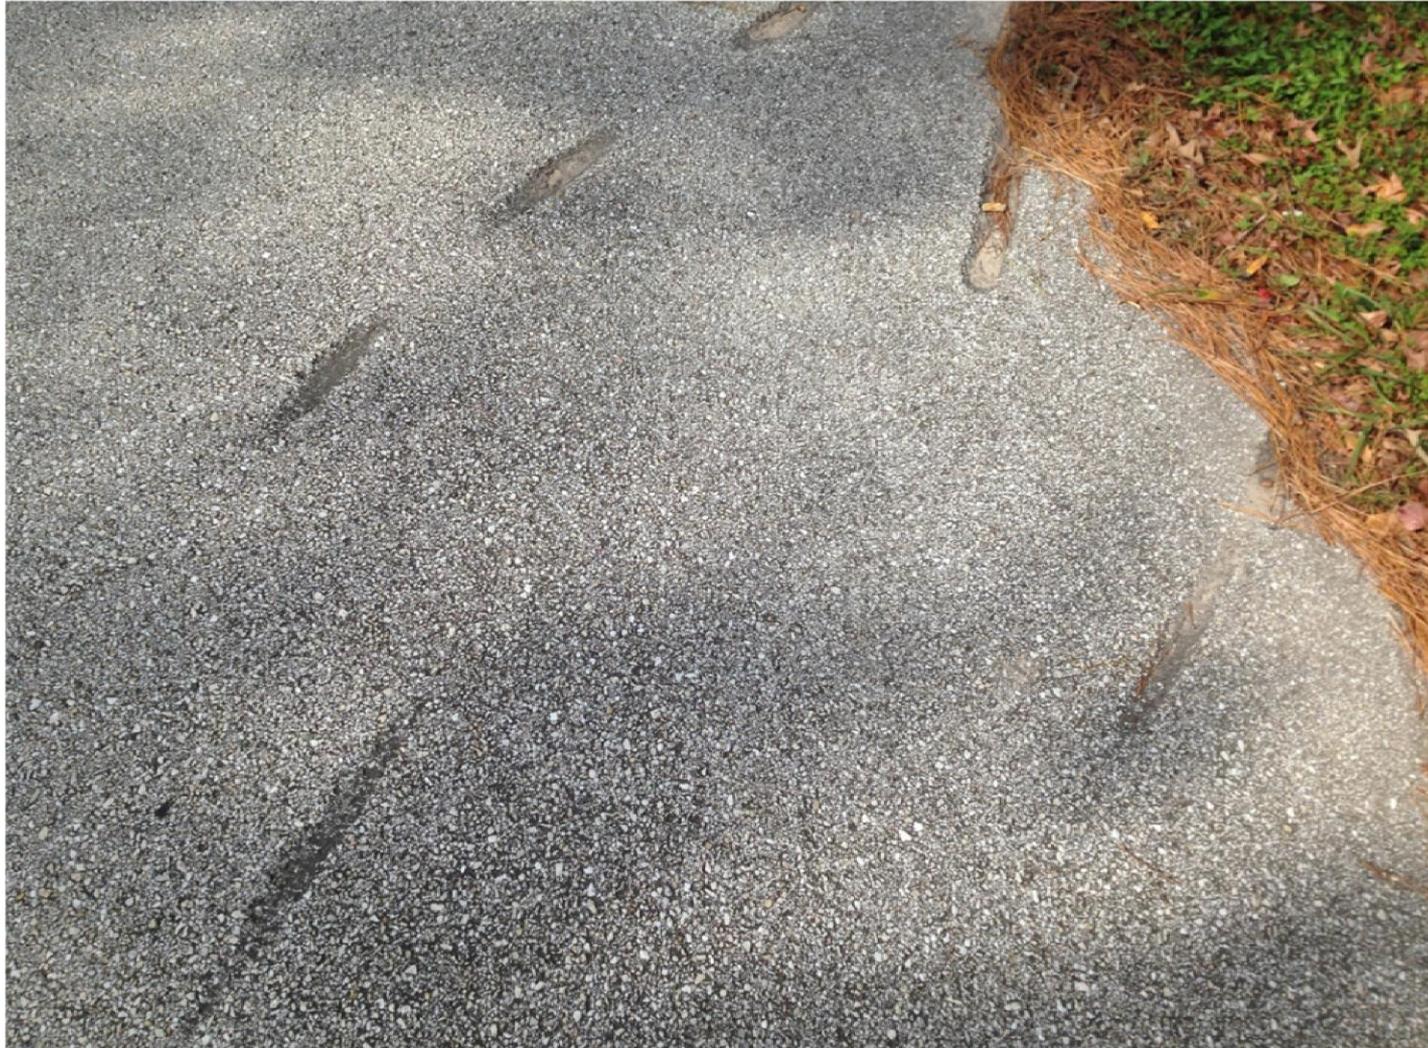
Location WP 8
Woodlands Pkwy
Eastbound

Hazard Type: Maintenance item
Severity: 2

rough road with pot marks embedded in asphalt which causes indentations on the shoulder and rough pavement.

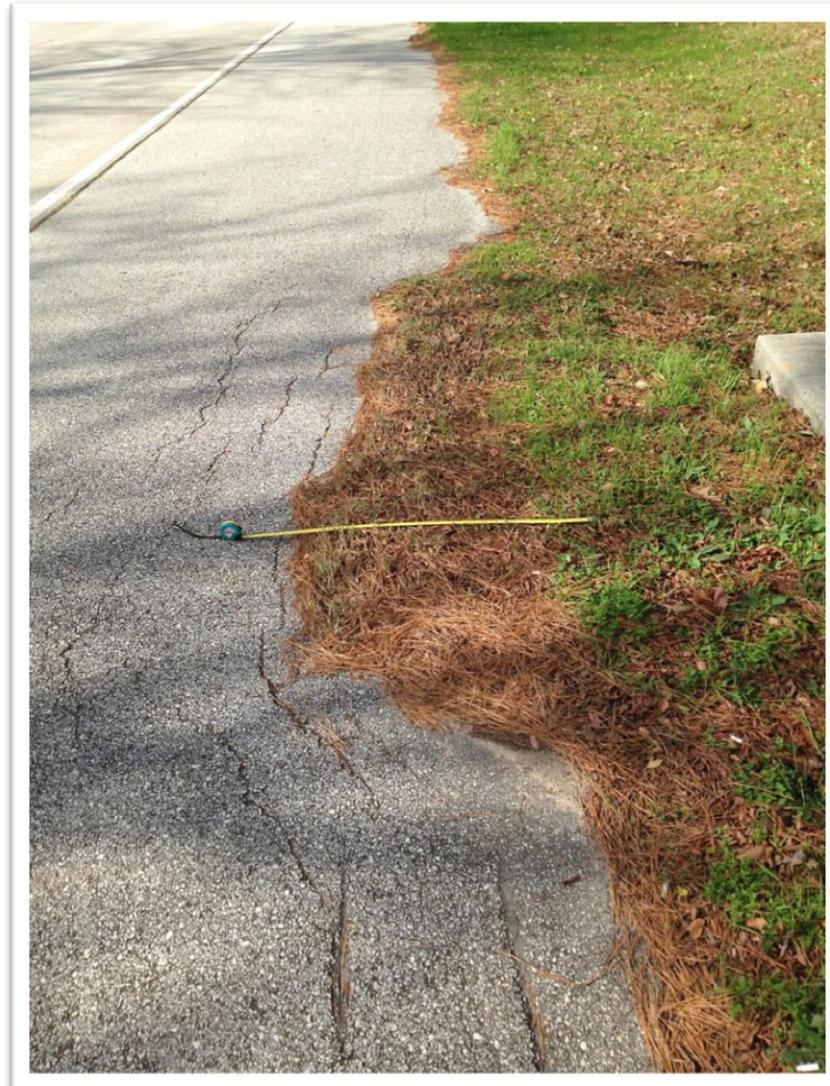
Location WP 9
Woodlands Pkwy
Eastbound

Hazard Type: Maintenance item
Severity: 2

2 feet of encroaching grass/weeds/sand on
shoulder

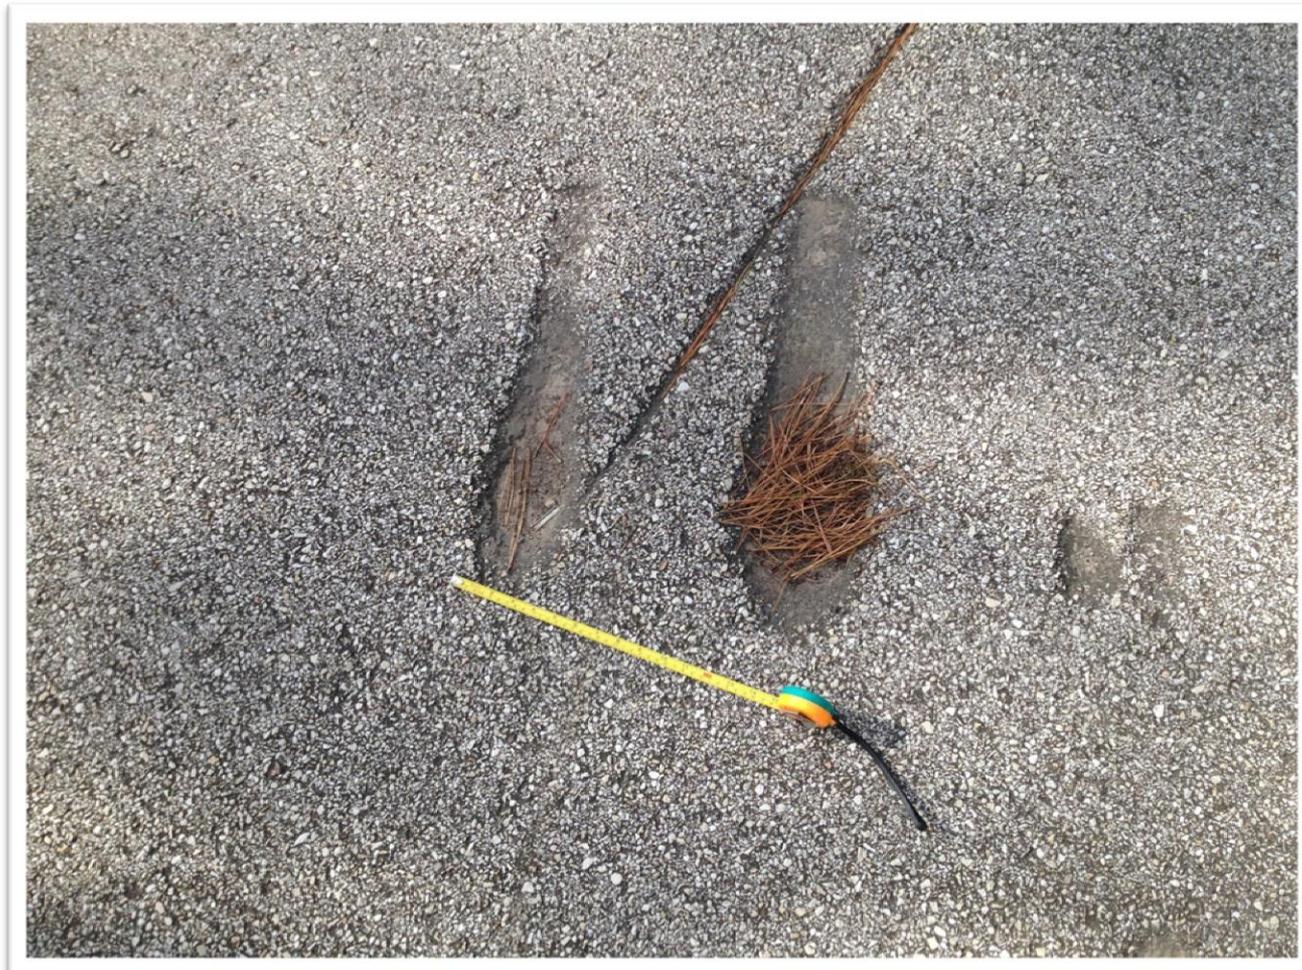
Location WP 10
Woodlands Pkwy
Eastbound

Hazard Type: Pothole
Severity: 2

Gouges in the shoulder over a 3-6 feet area which cyclists tire could get stuck in and cause bike to fall. Unlike Flintridge, Shoulder is wider on this stretch of and the cyclists are able to ride to the left of the damaged shoulder comfortably if they see the gauges in time.

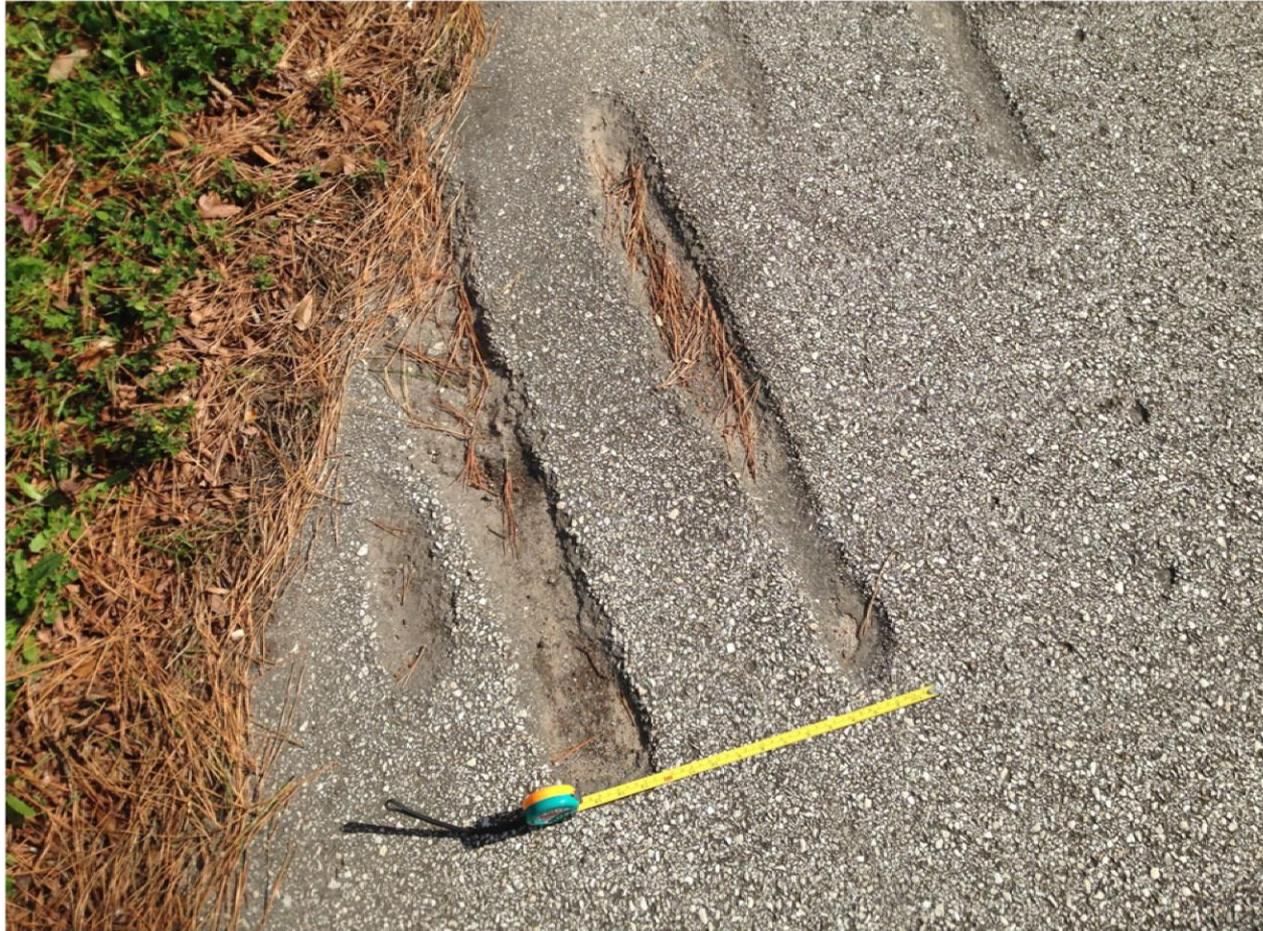
Location WP 11
Woodlands Pkwy
Eastbound

Hazard Type: Pothole
Severity: 2

Gouges in the shoulder. Same comments as
location WP 10.
